PETITION FOR VARIANCE
BEFORE THE HEARING BOARD OF THE
SOUTH COAST AIR QUALITY MANAGEMENT DISTRICT

PETITIONER: LOS ANGELES DEPARTMENT OF WATER AND POWER

CASE NO: 1263-76

EXHIBIT 3

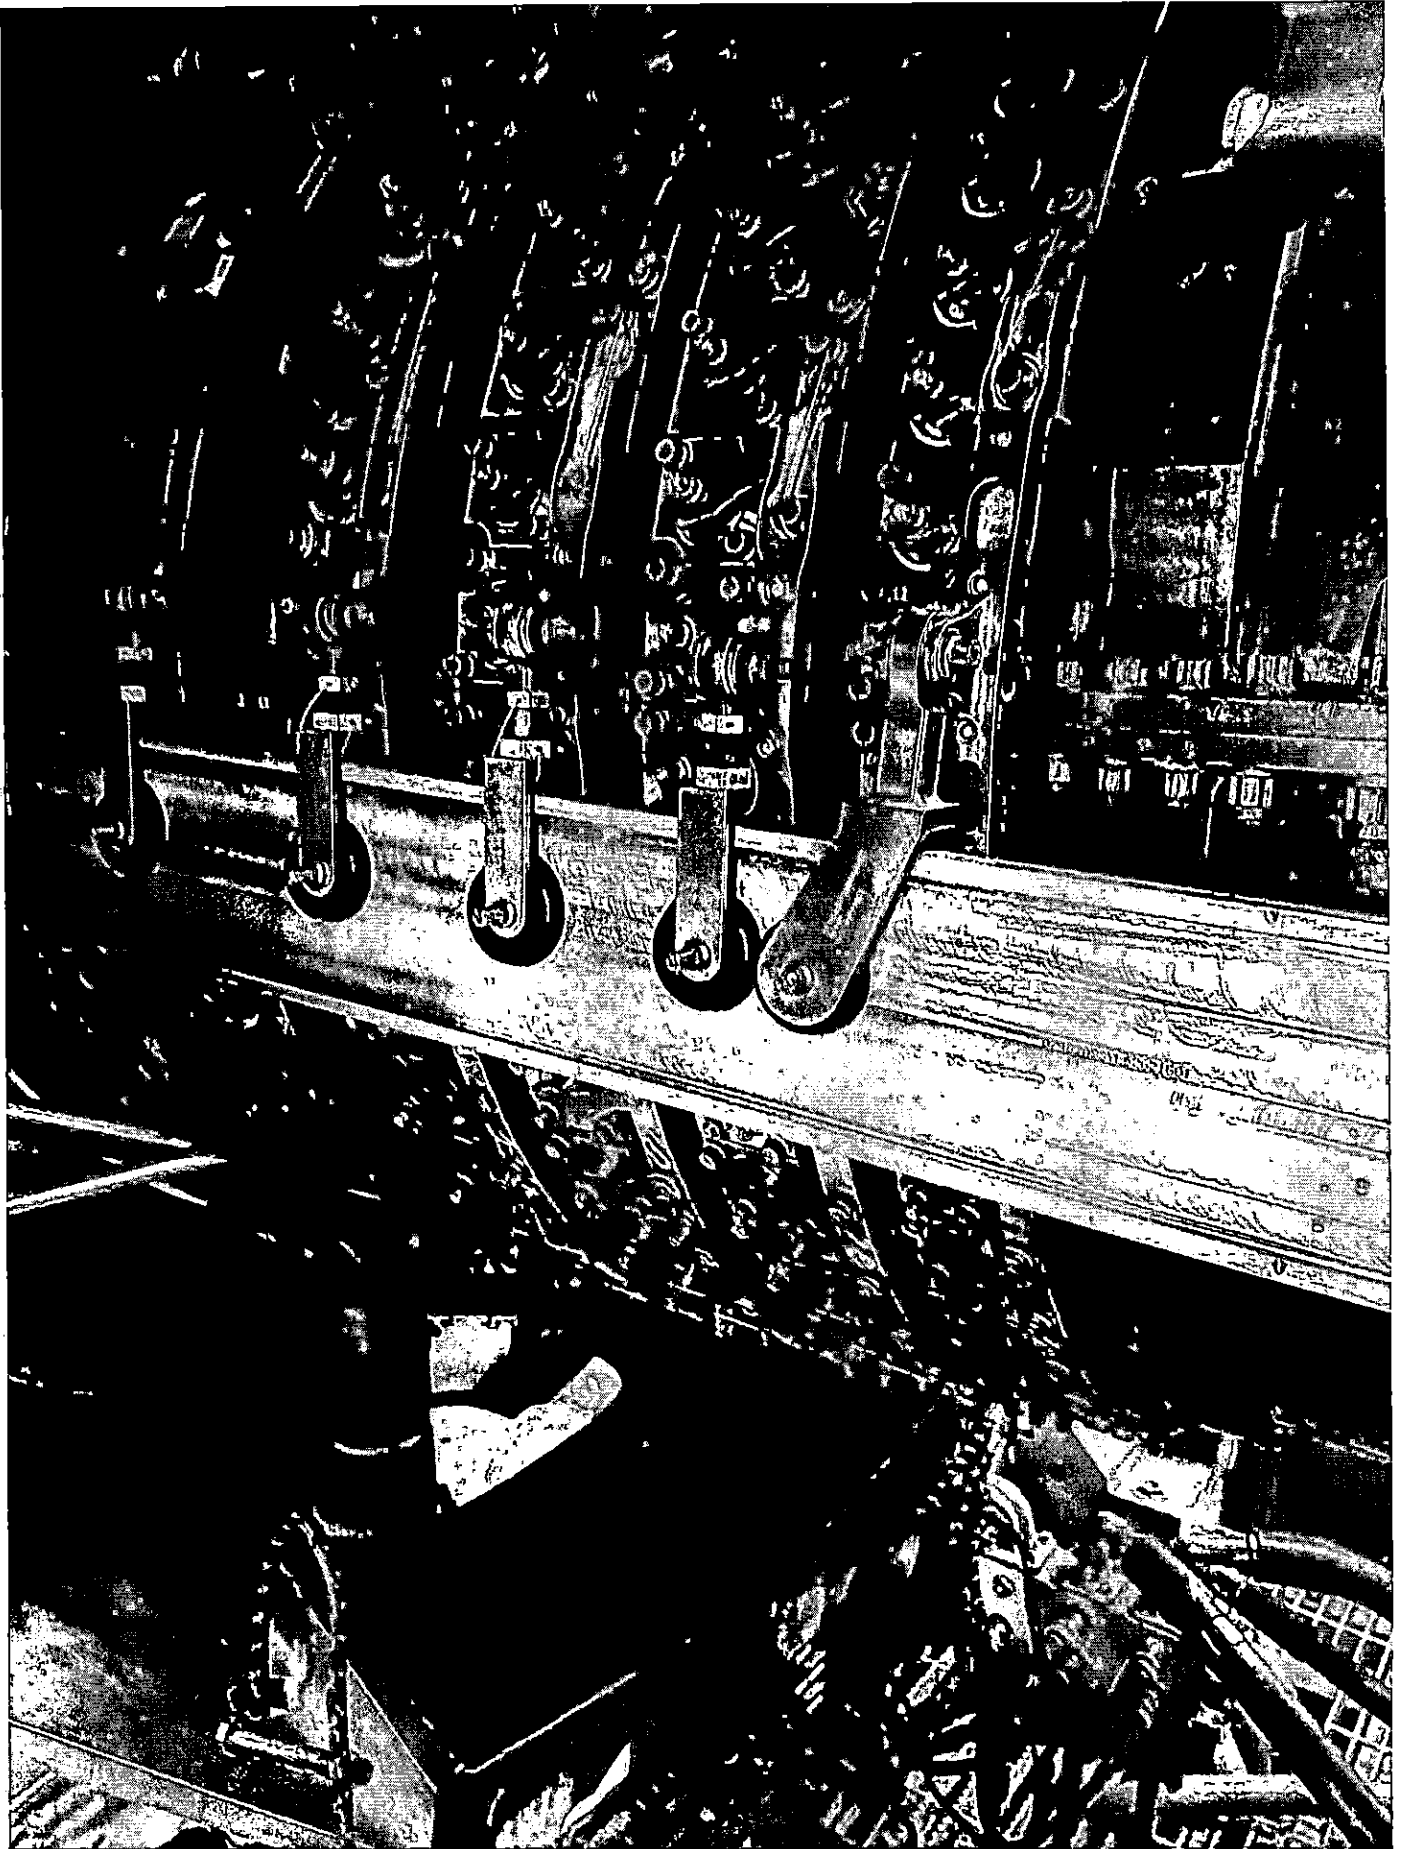
PHOTO OF DAMAGED SUPERCORE IN UNIT 15

It is beyond the LADWP's reasonable control to perform the CO RATA by December 31, 2022 due to unexpected failure of Unit 15's supercore and ensuing damage to other parts. (See Exhibit 3, photo of damaged supercore in Unit 15.) Unit 15 has not been available to run since it first stalled on August 23, 2022, and LADWP has now confirmed with GE Power Systems that comprehensive repairs are required and will not be completed in time to meet the December 31, 2022 testing deadline.

After the August 23, 2022 stall event, LADWP conducted a boroscope inspection of Unit 15 with GE Power Systems representatives. (See Exhibit 4, Boroscope Inspection Report.) After careful research and review, LADWP has determined that Unit 15 had a catastrophic event when a stage 2 or stage 3 blade in the high-pressure compressor broke off and caused extensive damage as it disintegrated and traveled downstream into the engine. The damage was so extensive that the engine could not be rotated for a full inspection, because the blades in the supercore were bent into the vanes.

Boroscope Inspection Report and visual inspections of the machinery, which have demonstrated that damage can be seen in the HPC starting from stages 3 and downstream, along with impact damage to the Intermediate Pressure Turbine and the Power Turbine. The final supporting piece of information is the fact that a v-seal on the LPC was also found to be loose.

1. Extract the damaged supercore. 3-5 days.
2. Extract the Power Turbine. 3-5 days.
3. Remove top-case of the Booster (LPC). 2-3 days.
4. Remove v-seal in the LPC. 1 day.
5. Inspect exposed Booster for other damage, including bearings, oil lines, blades, vanes, etc. 3-5 days process.
6. Repair/replace Booster bearings, if damaged. 1-2 weeks.
7. Install replacement Power Turbine. 3-5 days.
8. Install replacement Supercore. 3-5 days.
9. Alignment of the booster - supercore - power turbine train. 1-2 weeks.
10. Reconnect mechanical, electrical, instrumentation in the Unit 15. ~1 week.
11. Reassembly of the Unit 15 package, including package roof, inlet air ducts, various piping, etc. ~1 week.
12. Haynes Unit 15 Restart.
13. CO RATA Test.
