April 22, 2024  
File No. 01204123.25, Task 10

Subject: March 2024 Monthly Report for Modified Stipulated Order for Abatement (Case No. 6177-4), Chiquita Canyon Landfill (Facility ID 119219), Castaic, California

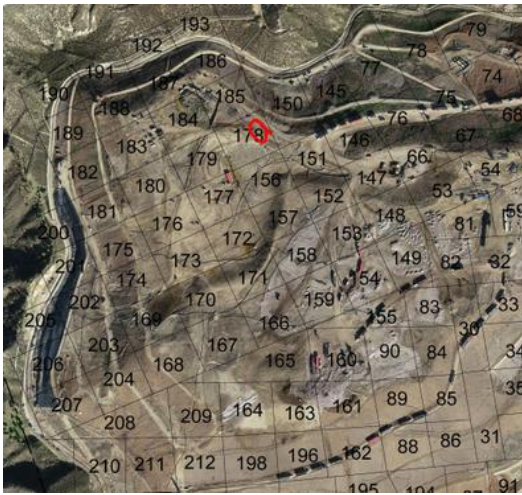
178

Yes

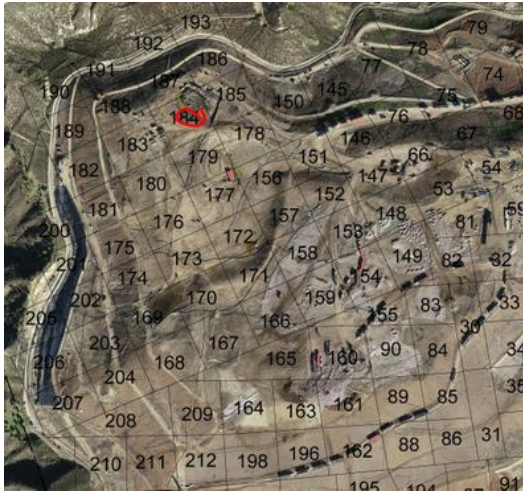
184

Yes

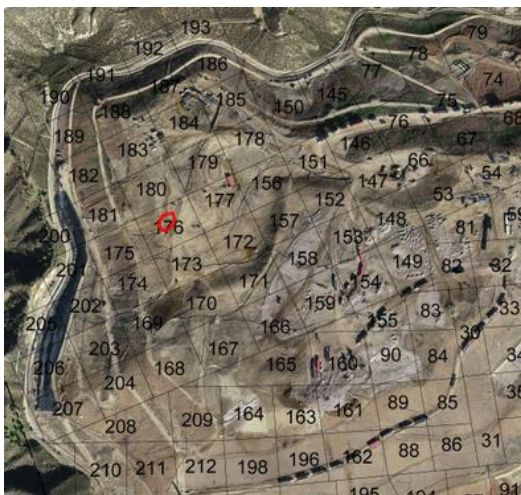
176

Yes

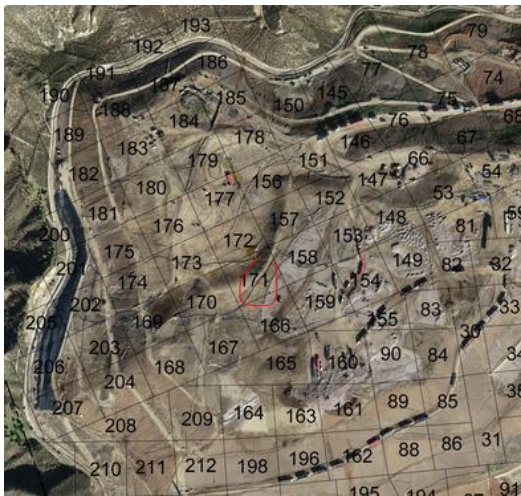
171

Yes

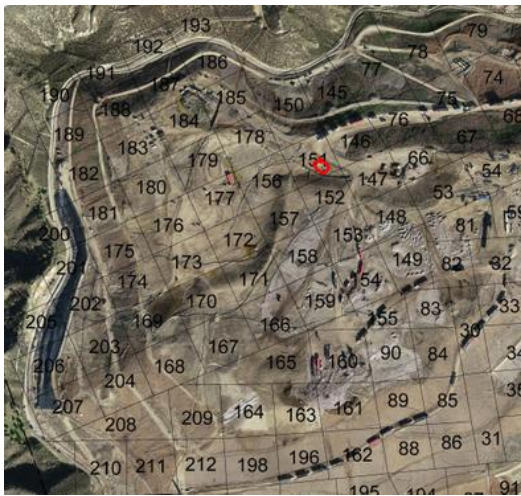
151

Yes

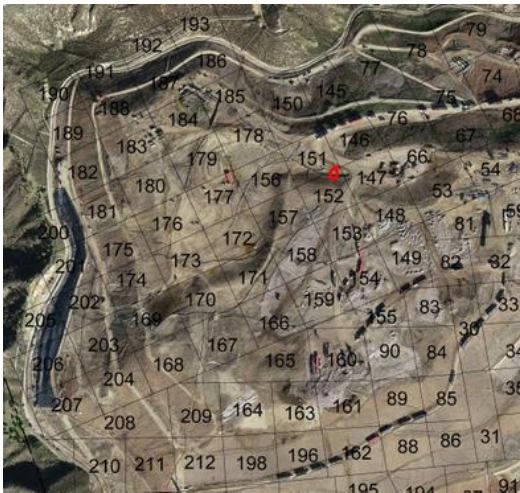
152

Yes

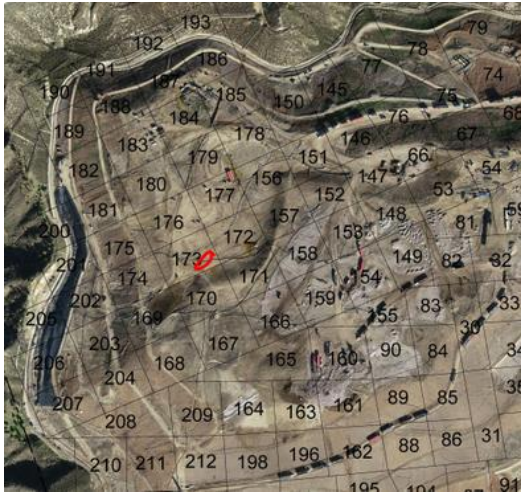
173

Yes

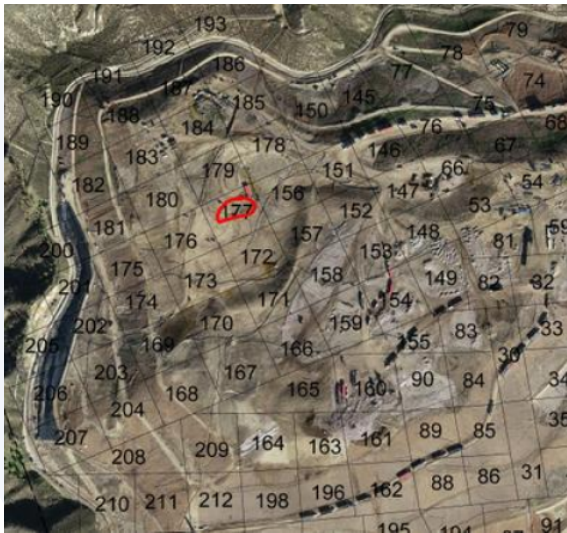
177

Yes

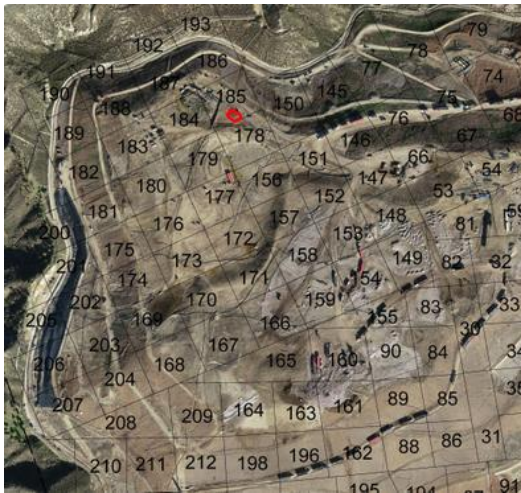
185

Yes

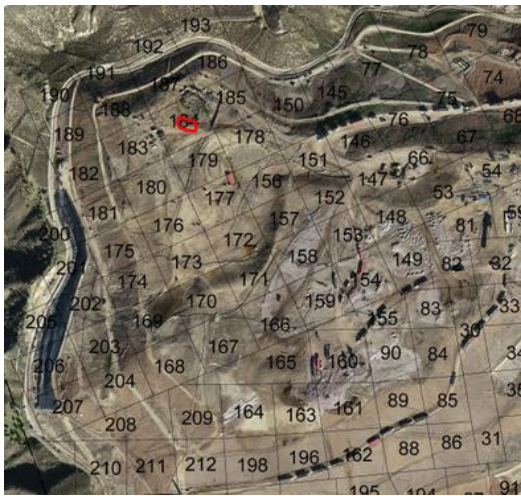
184

Yes

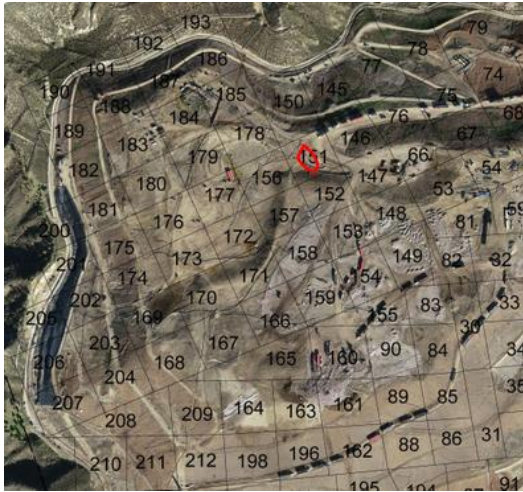
151

Yes

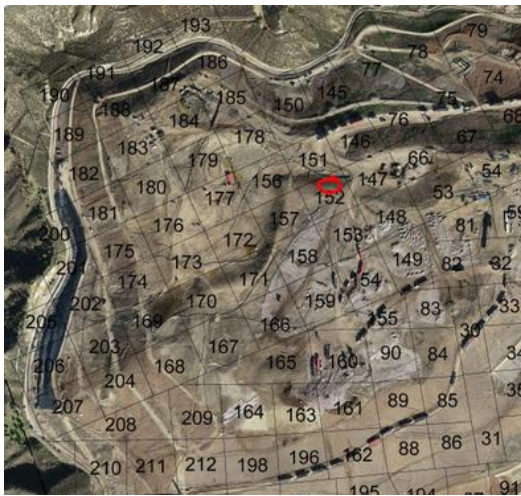
152

Yes

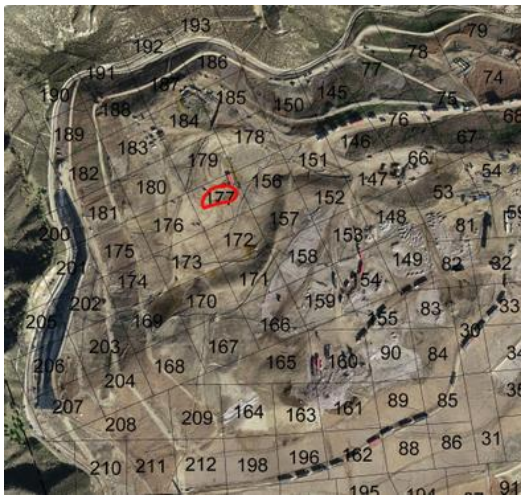
177

Yes

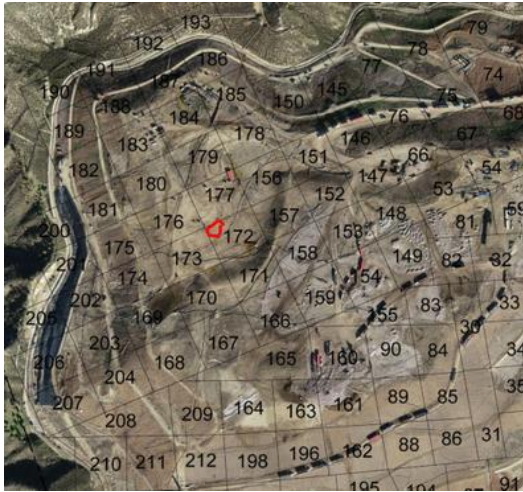
172

Yes

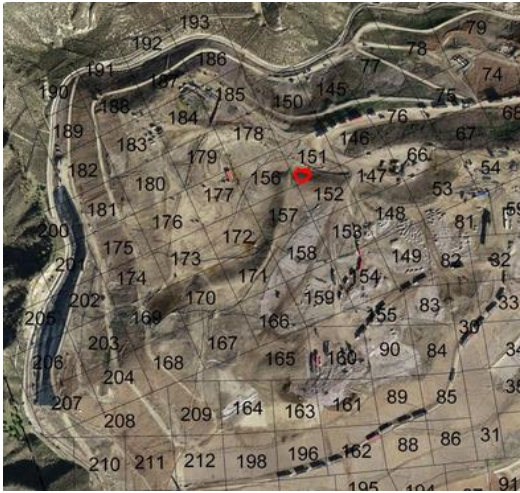
151

Yes

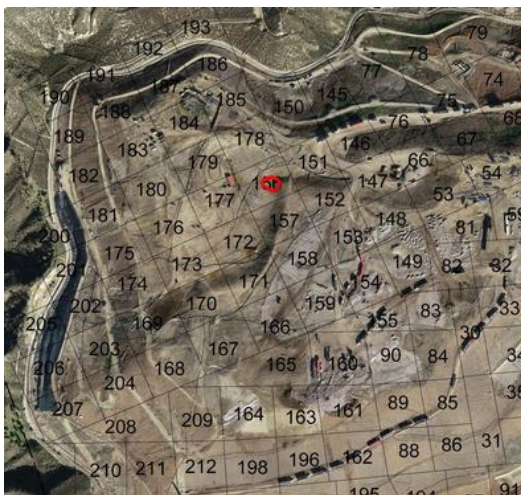
156

Yes

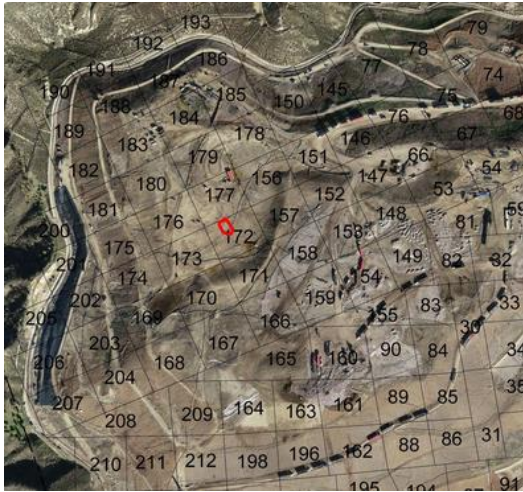
172

Yes

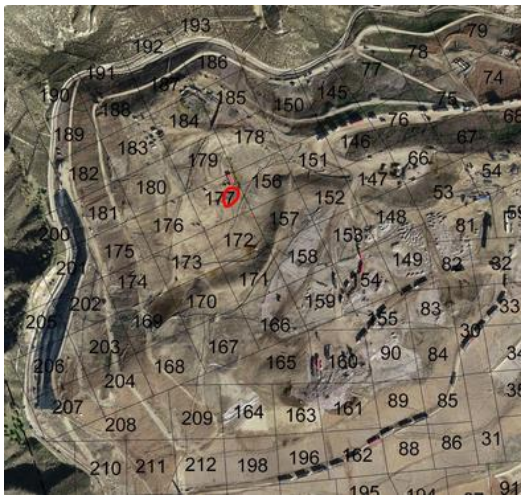
177

Yes

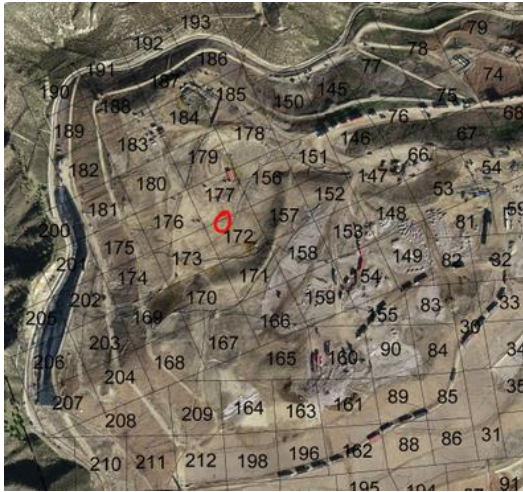
172

Yes

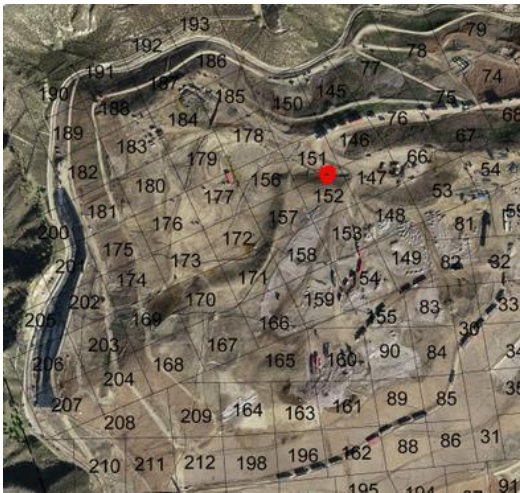
152

Yes

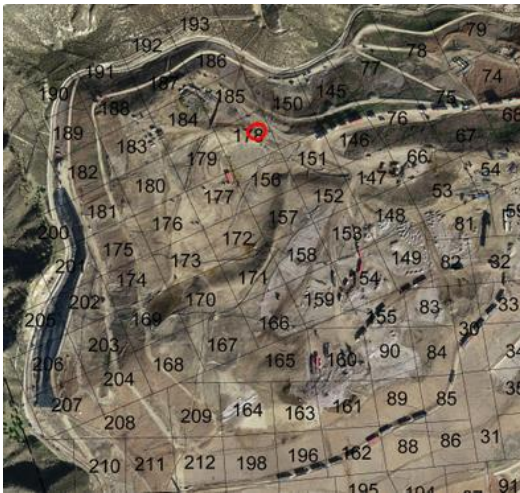
178

Yes

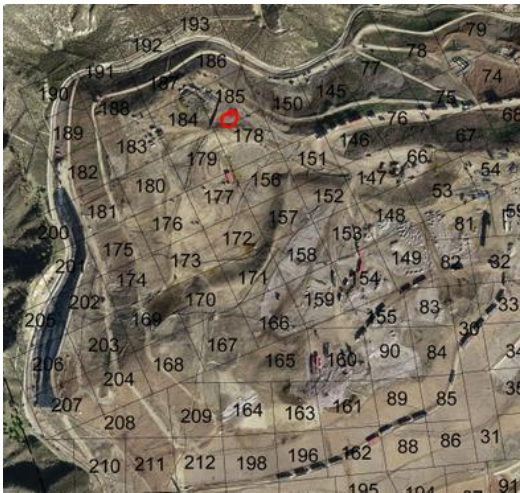
185

Yes

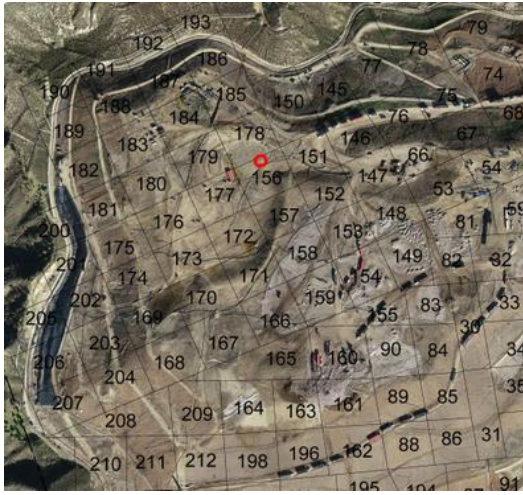
156

Yes

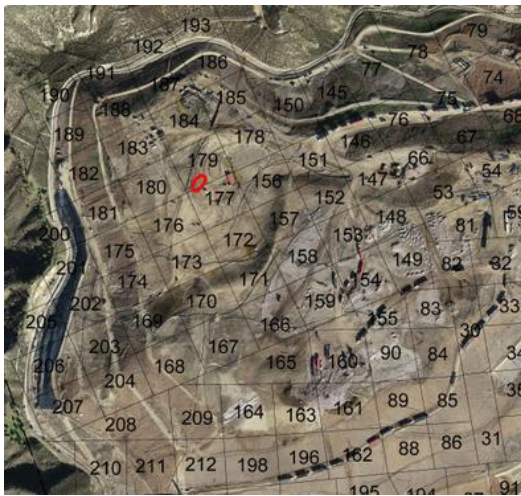
179

Yes

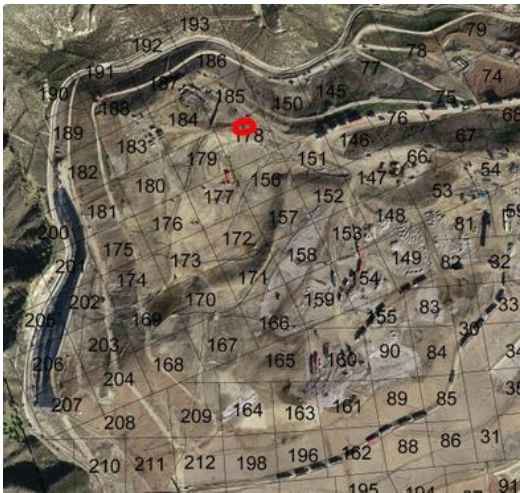
178

Yes

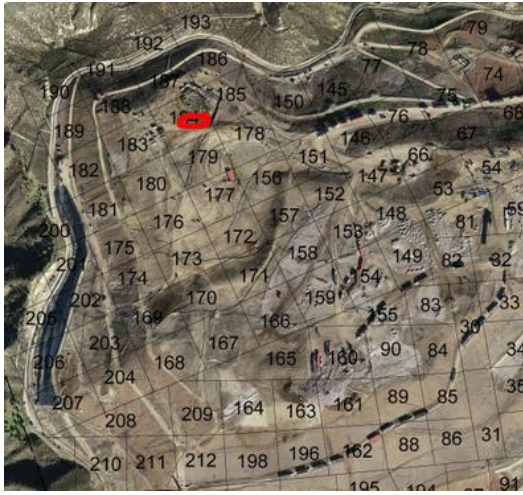
184

**Fissure or Tension Crack Found?** Yes

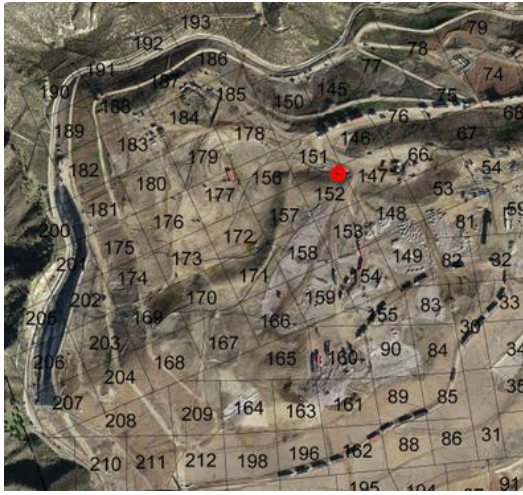
152

Yes

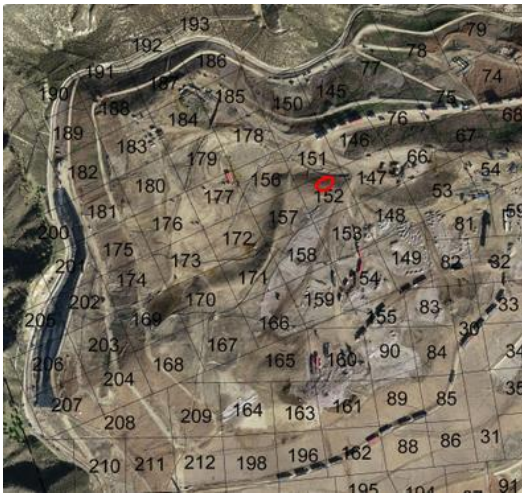
152

Yes

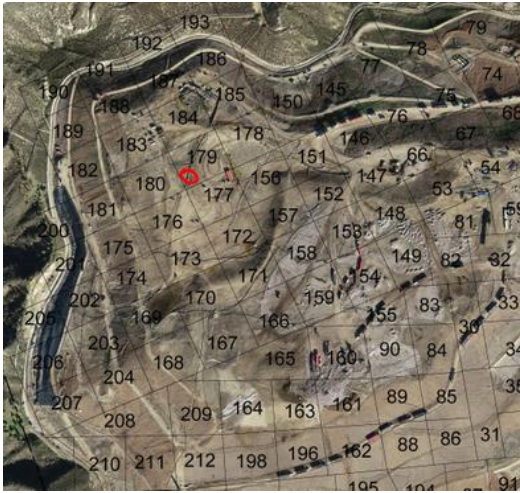
179

Yes

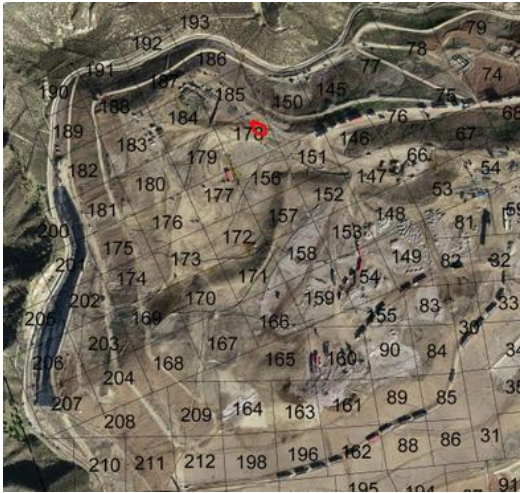
178

Yes

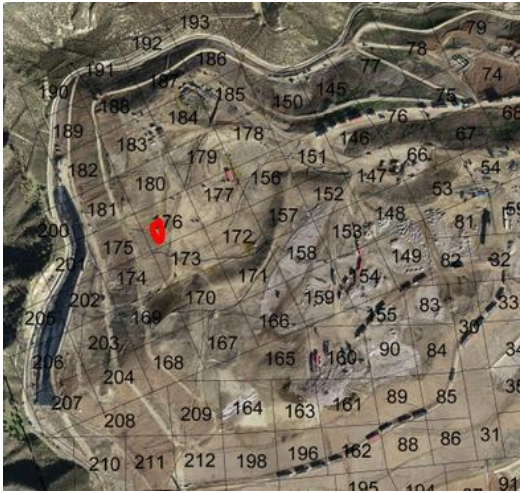
176

Yes

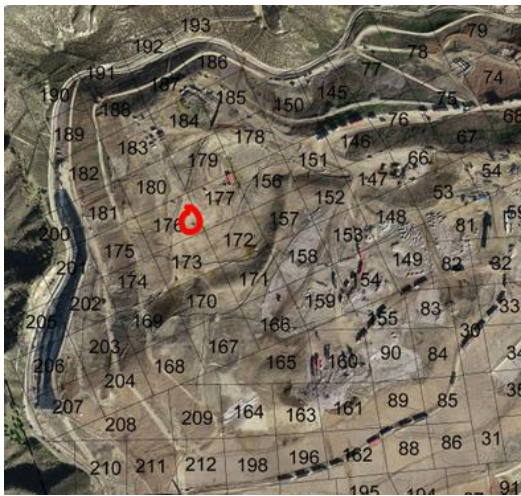
176

Yes

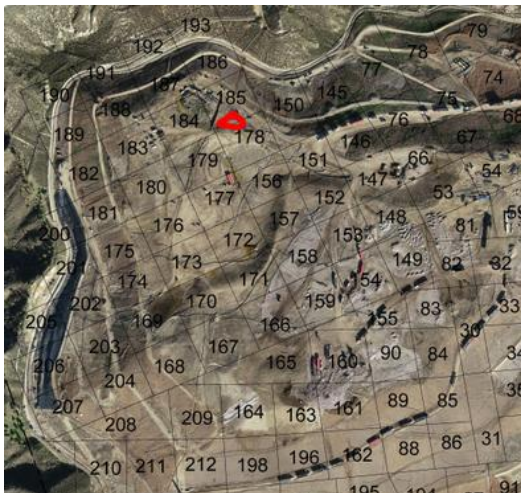
185

Yes

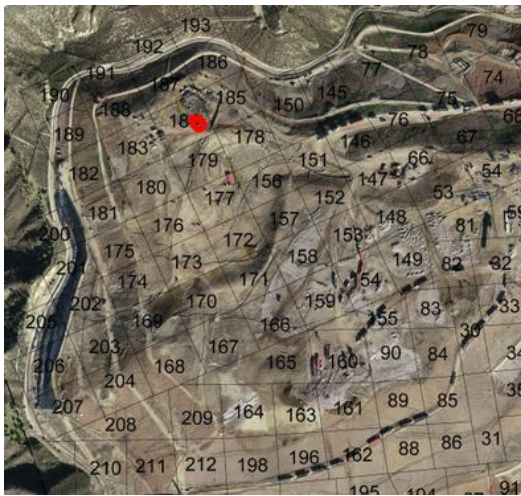
184

Yes

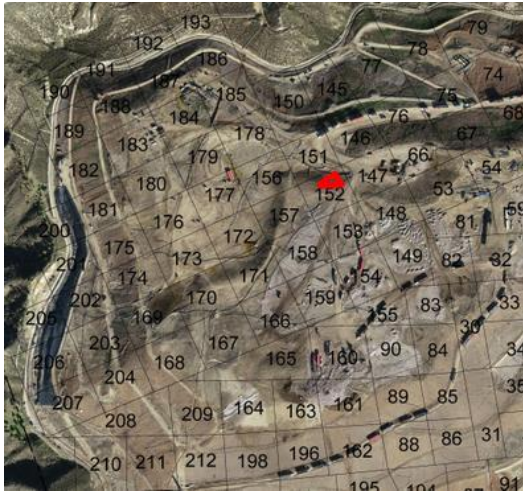
152

Yes

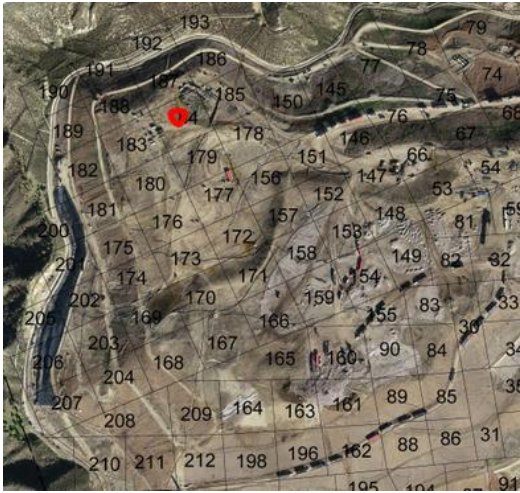
184

Yes

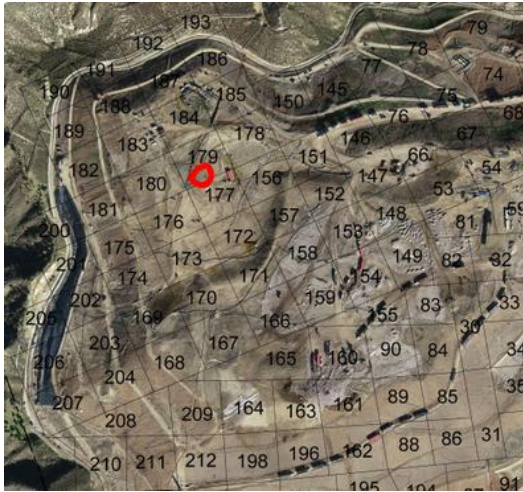
179

Yes

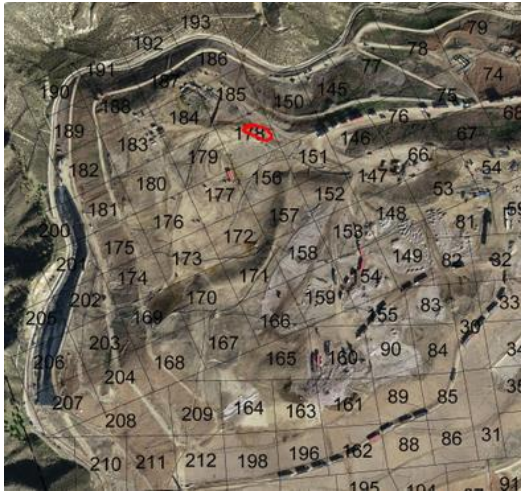
178

Yes

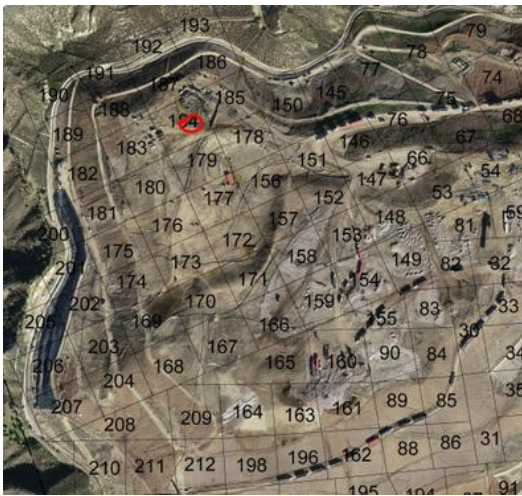
184

Yes

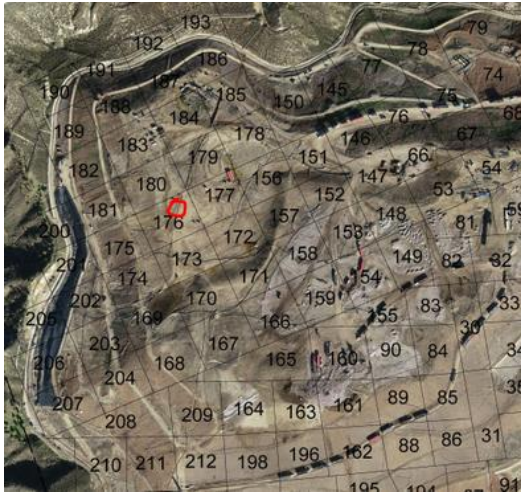
176

Yes

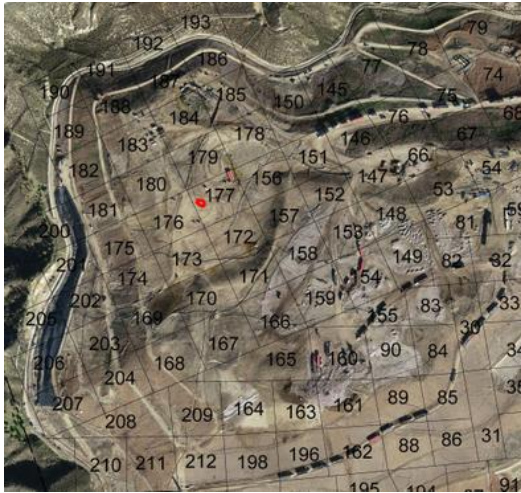
177

Yes

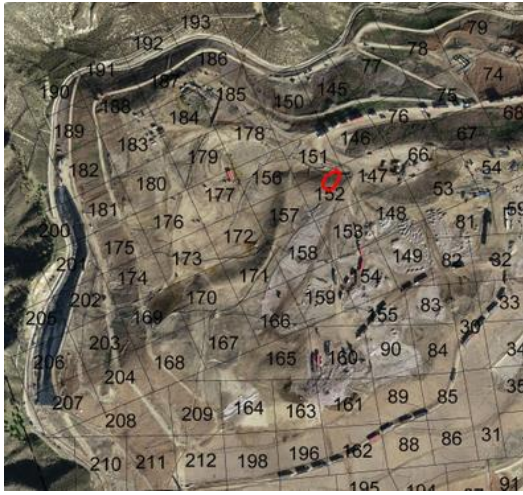
152

Yes

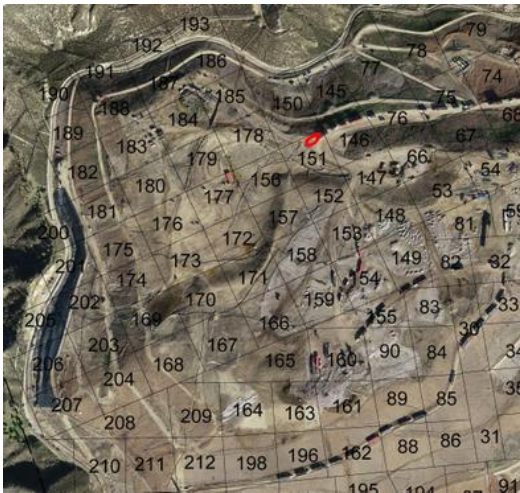
151

Yes

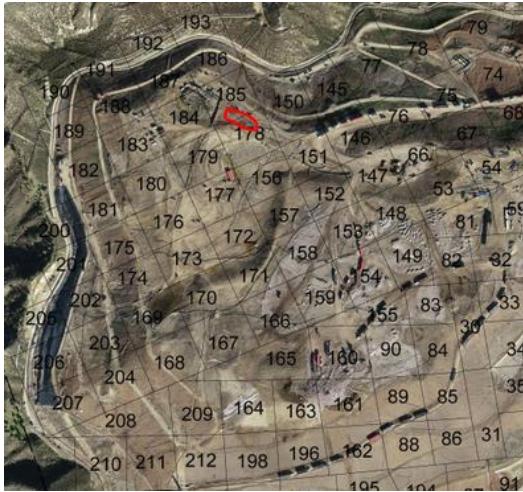
185.178

Yes

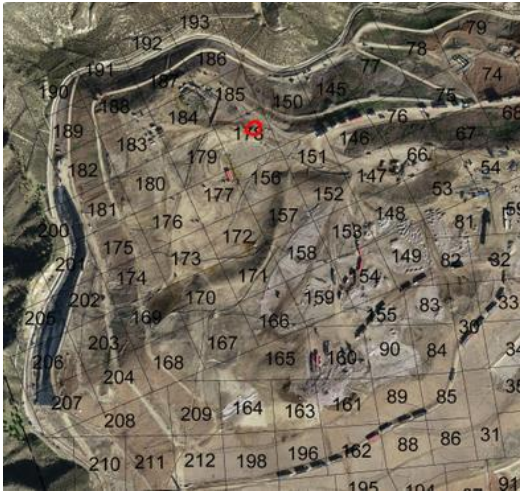
178

Yes

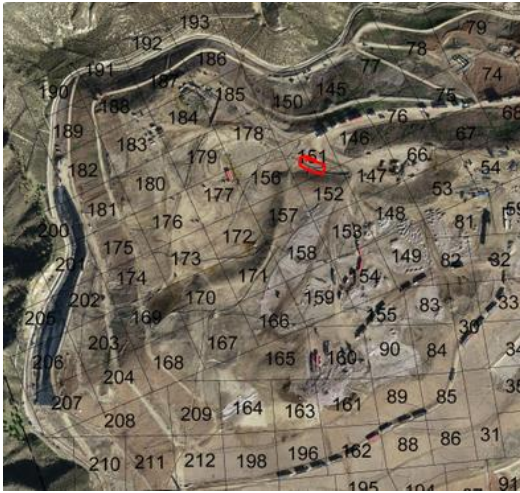
151

Yes

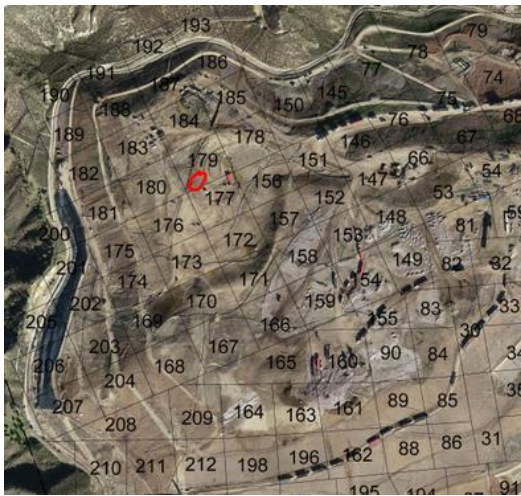
179

Yes

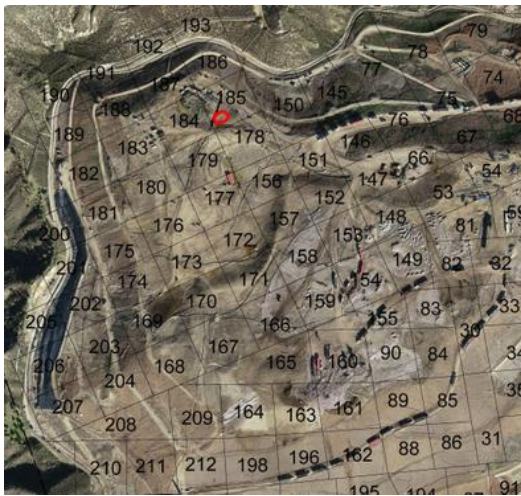
185

Yes

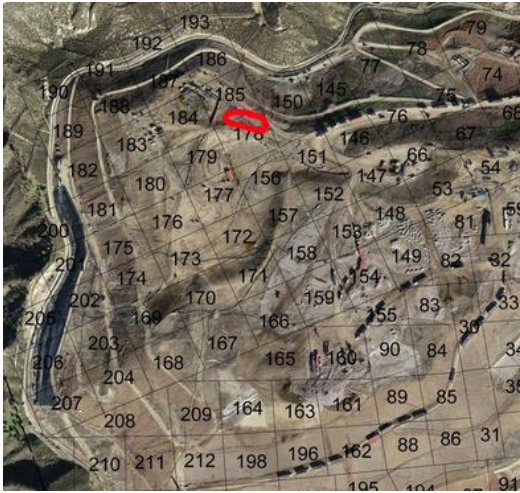
185.178

Yes

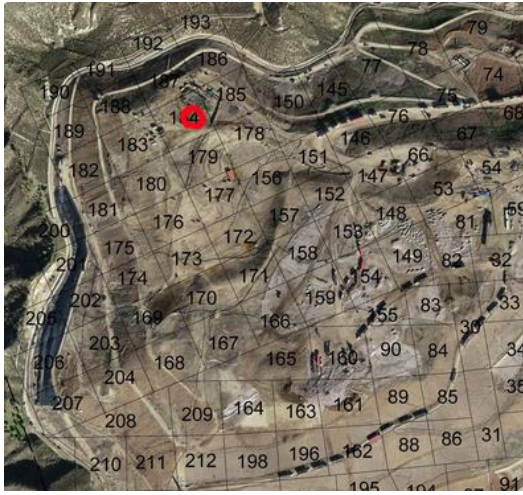
184

**Fissure or Tension Crack Found?** Yes

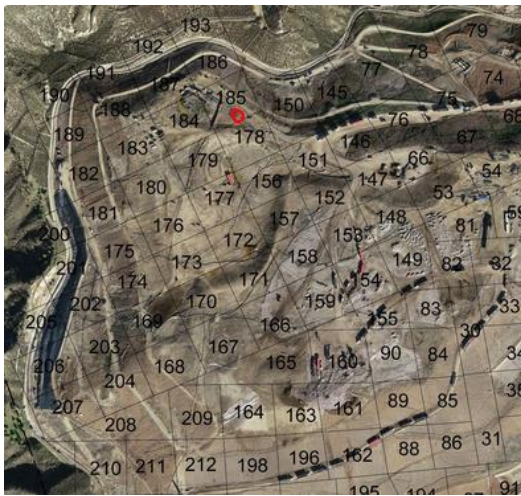
185

Yes

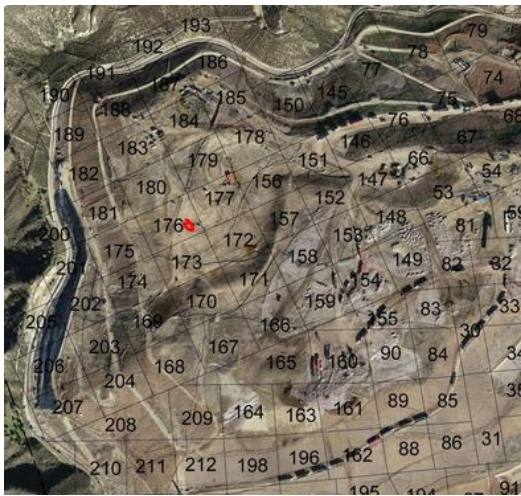
176

Yes

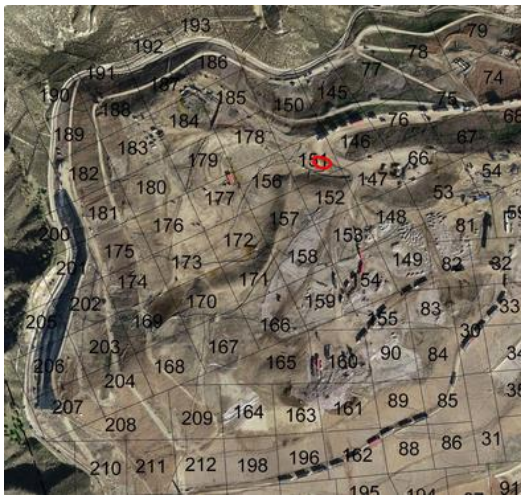
151

Yes

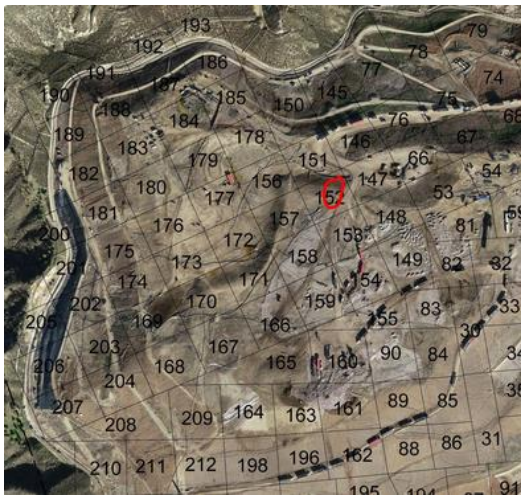
152

Yes

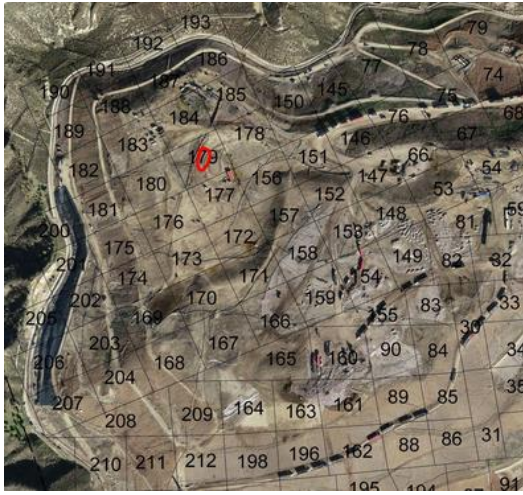
179

Yes

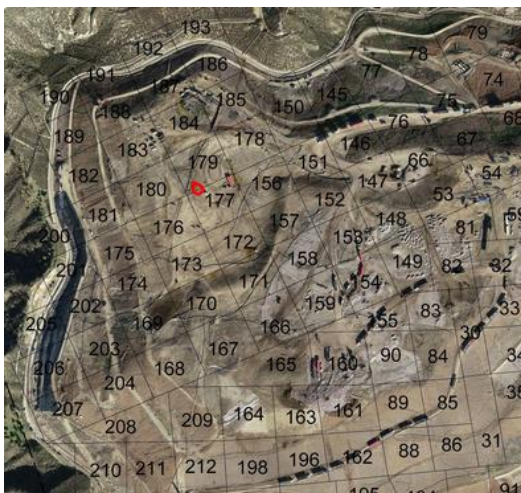
179

Yes

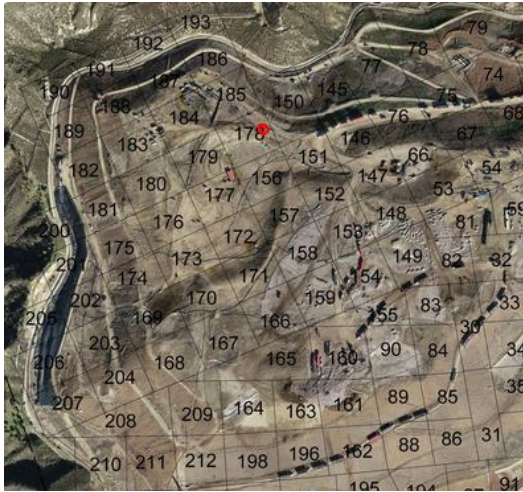
178

Yes

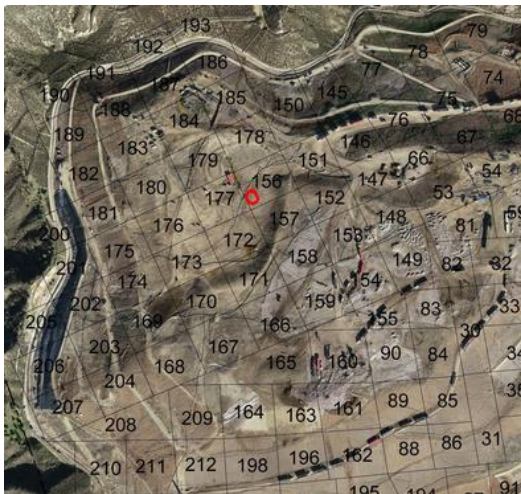
156

Yes

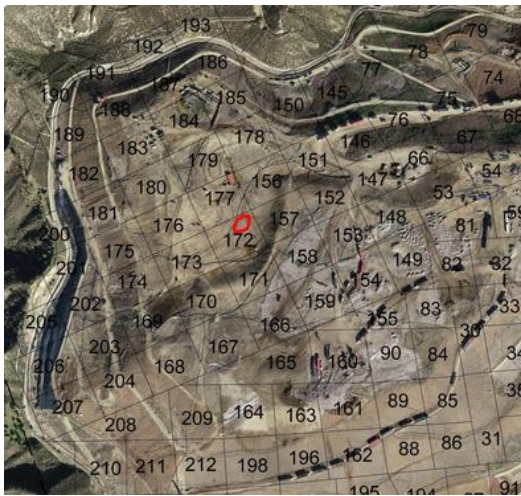
172

Yes

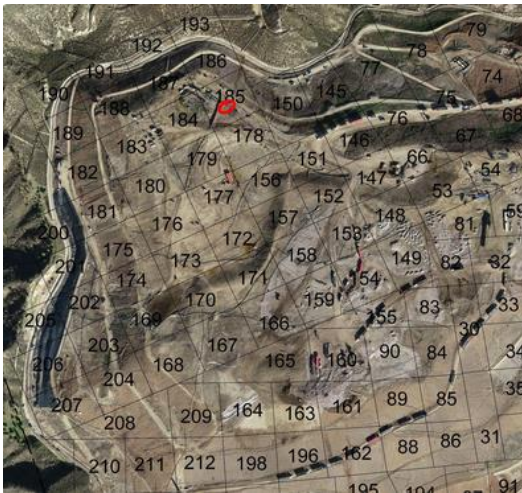
185

Yes

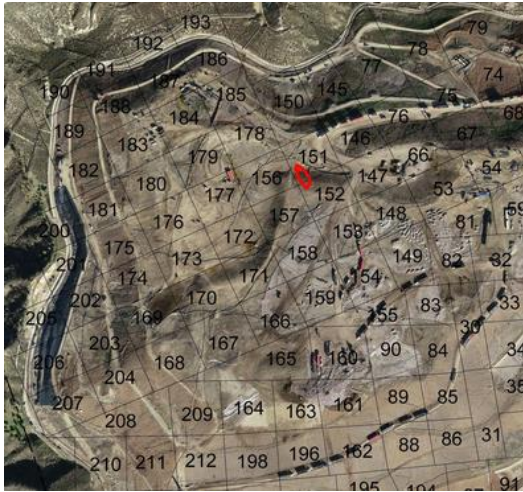
151

Yes

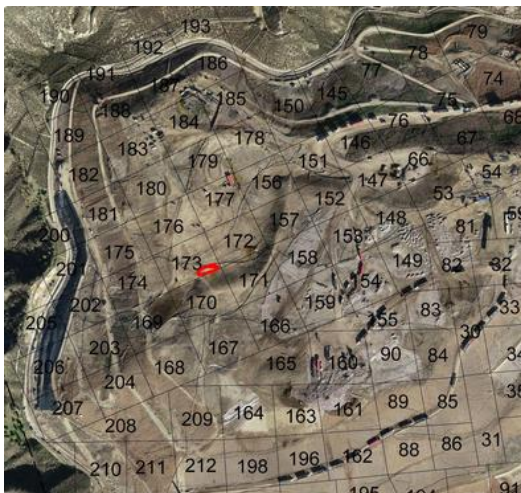
173

Yes

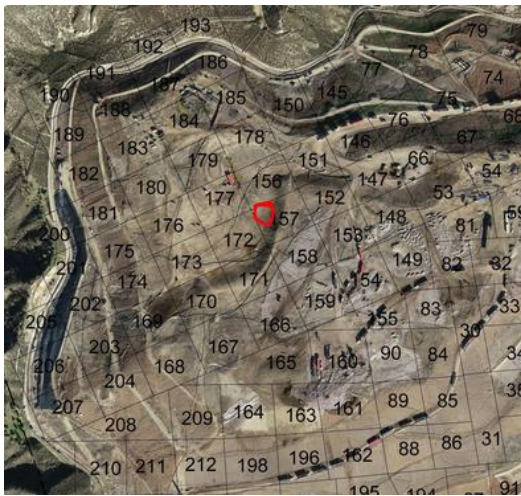
157

Yes

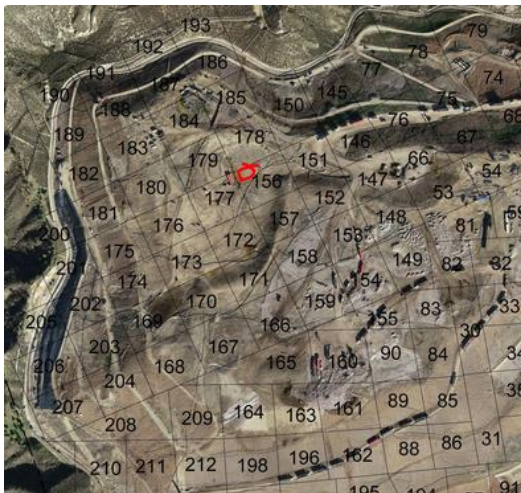
156

Yes
