**SOUTH COAST AQMD
CLERK OF THE BOARDS**

**PROJECT: EXIDE TECHNOLOGIES FACILITY ID NO. 124838,
ORDER OF ABATEMENT CASE NO. 3151-32
RE: WEEKLY STATUS REPORT # 98 (7/21/16 – 7/27/16)**

EXIDE Technologies
 Automotive Recycling Division
 2700 S. Indiana St., Vernon, CA 90058

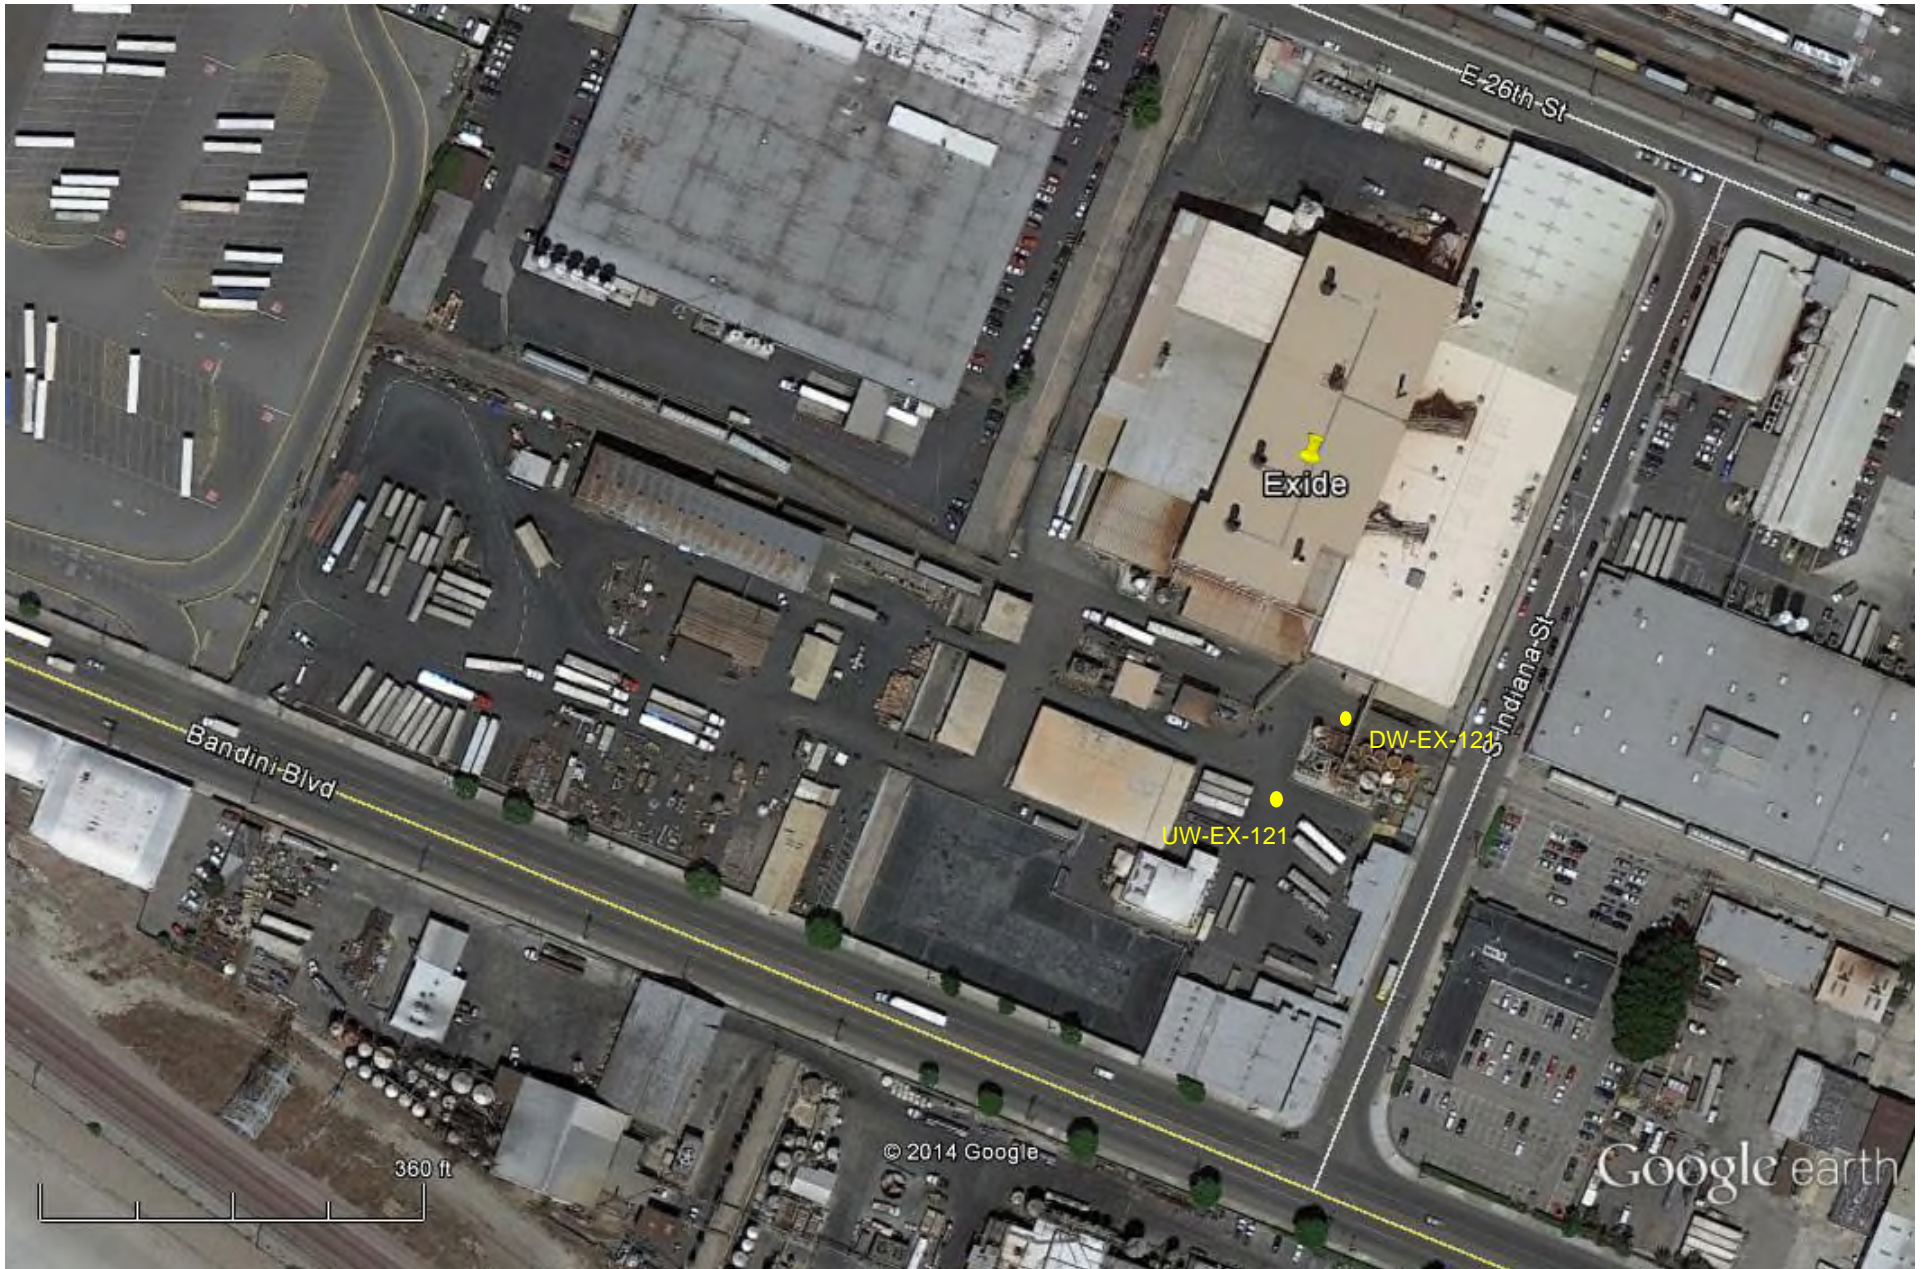
Monitoring Results / Reports
(Wednesday, July 27, 2016)

ACTIVITY	SERIAL NUMBER	LOCATION
WWTP Floor Coating Repair	8530100933	Upwind
WWTP Floor Coating Repair	8533143804	Downwind

7/27/2016 Repair WWTP Floor
Coating

- Visual observation of the installation activities to verify compliance with the SCAQMD approved mitigation plan.
- Downwind Dust Trak monitoring of the areas when activities were conducted, to monitor for fugitive dust emissions. Review of Dust Trak data did not indicate that work associated with repairs to the WWTP floor coating was generating fugitive dust emissions.
