April 22, 2024  
File No. 01204123.25, Task 10

Subject: March 2024 Monthly Report for Modified Stipulated Order for Abatement (Case No. 6177-4), Chiquita Canyon Landfill (Facility ID 119219), Castaic, California

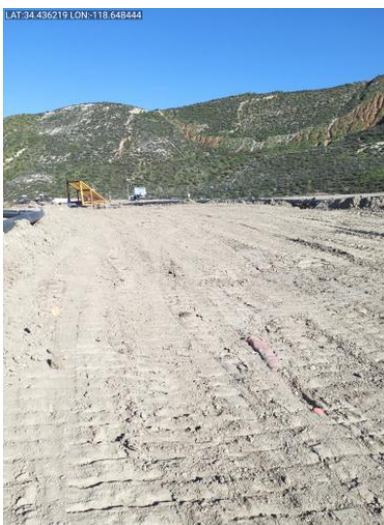
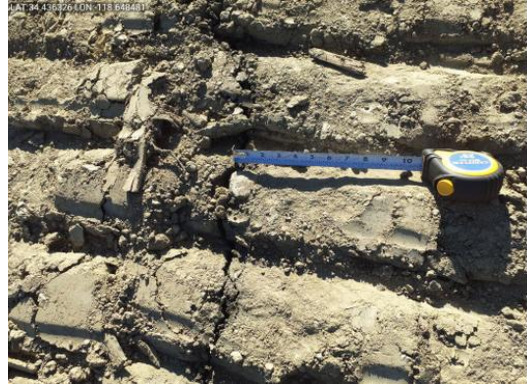
Chiquita Reaction Area Tracking of Fissures and Tension Cracks  
1

**Length of crack (ft) or area containing multiple cracks (ft x ft)**

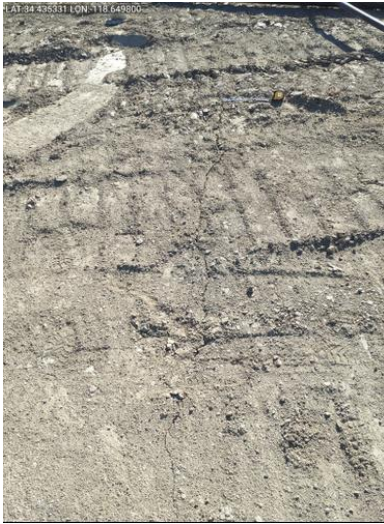
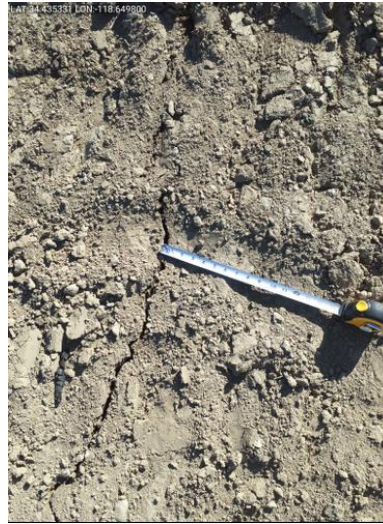
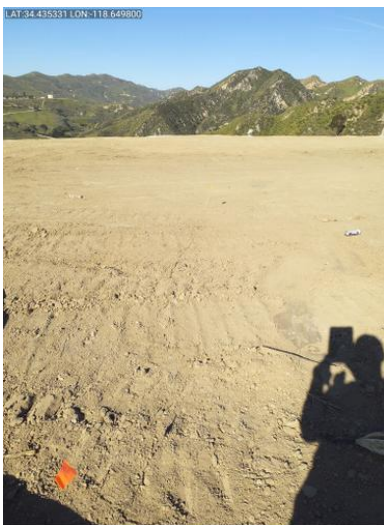
Chiquita Reaction Area Tracking of Fissures and Tension Cracks  
3

**Length of crack (ft) or area containing multiple cracks (ft x ft)** 20 ft

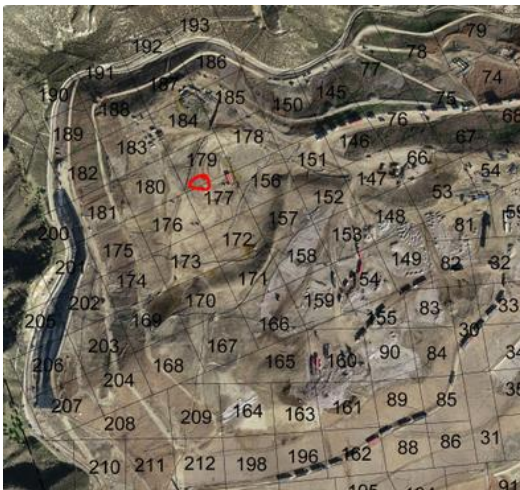
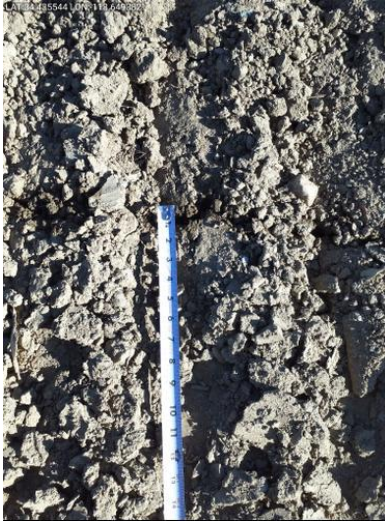
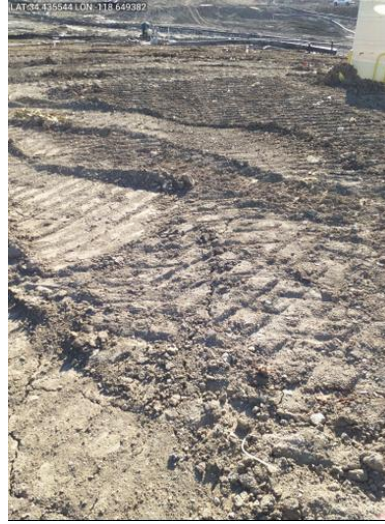
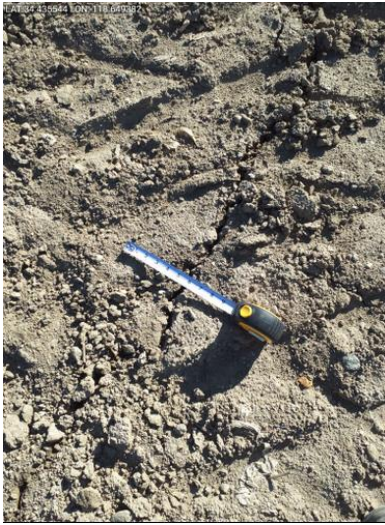
179

Yes

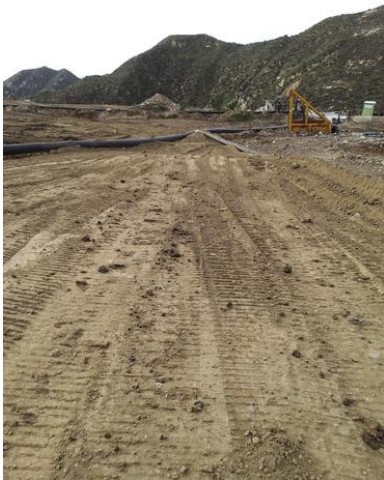
Photo 1

Images of area where cracks have been previously found near grid 177.

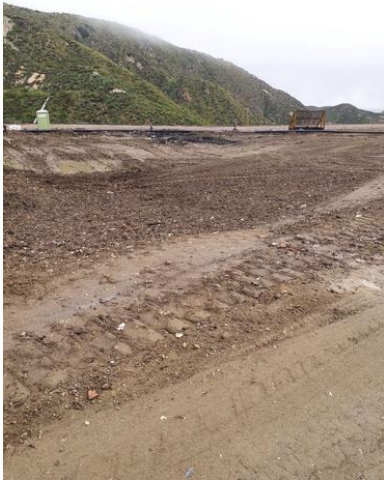
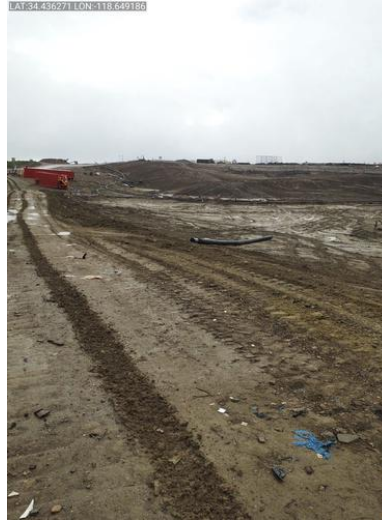
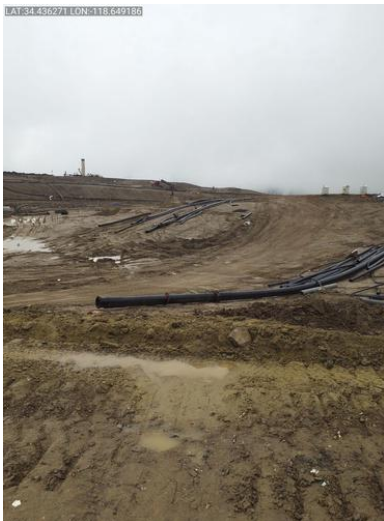
Images of area where cracks have been previously found near grid 177.

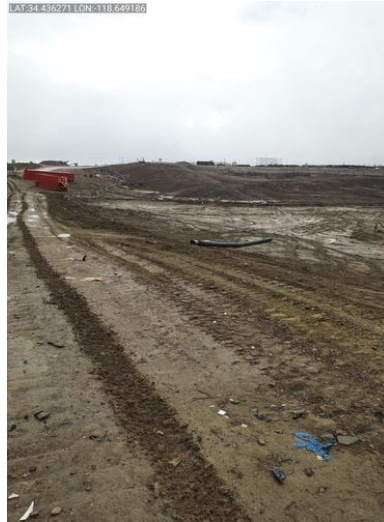
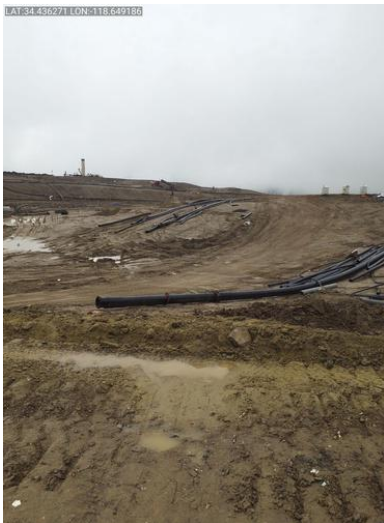
Images of area where cracks have been previously found near grid 177.

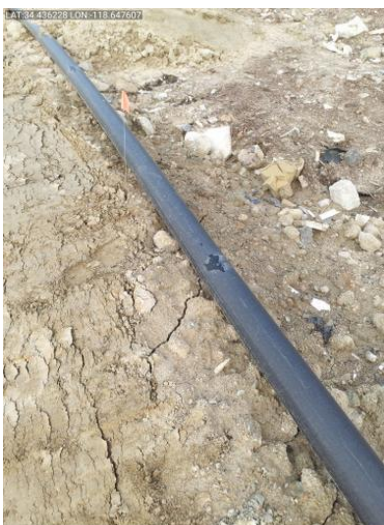
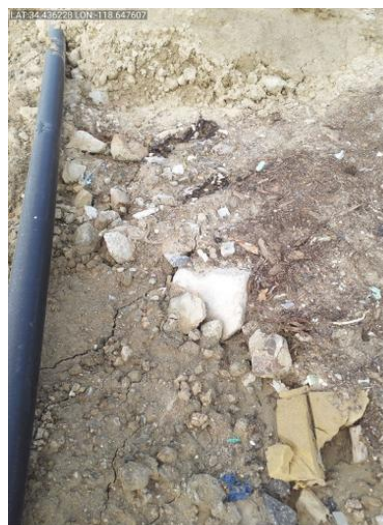
**Fissure or Tension Crack Found?**

Was Fissure or Crack fixed? If yes, add photo and description of repairs performed

Yes

Cracks were track walked.

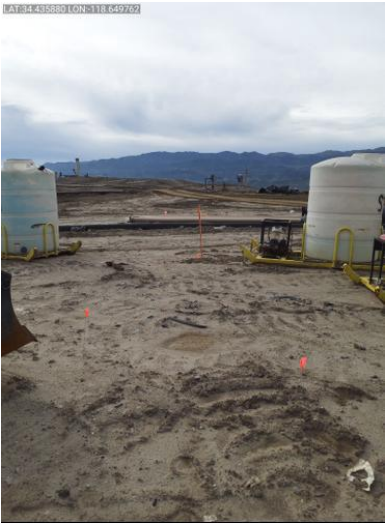
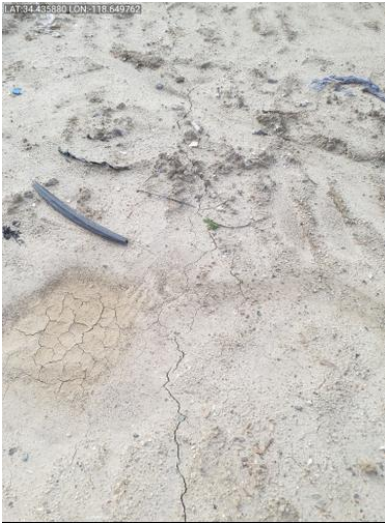
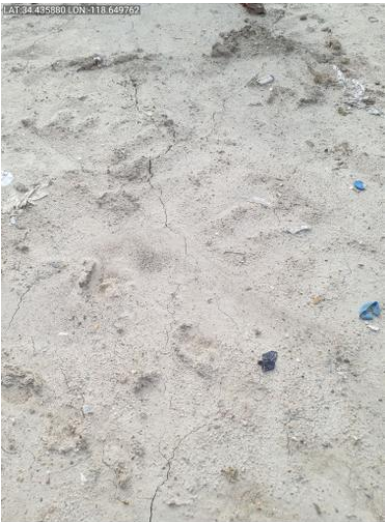
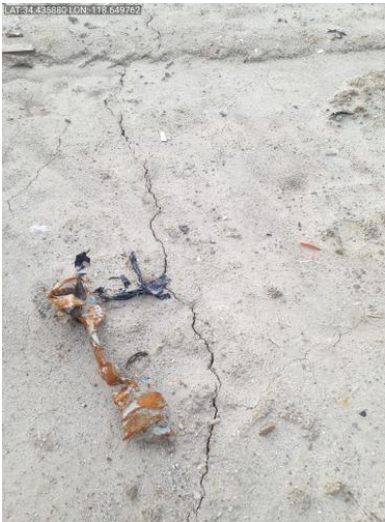
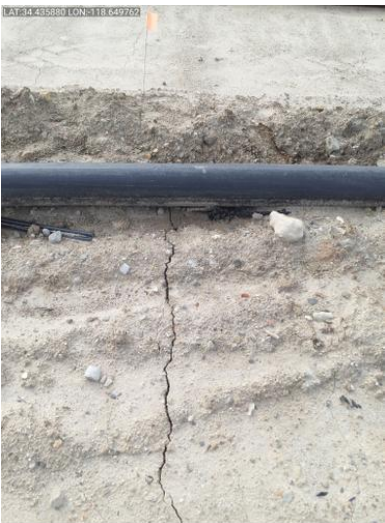
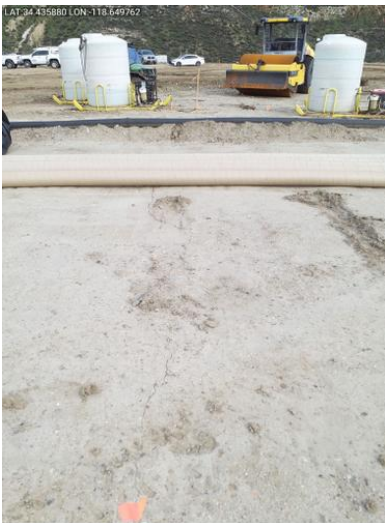
Yes

Multiple Cracks

Cracks were track walked.

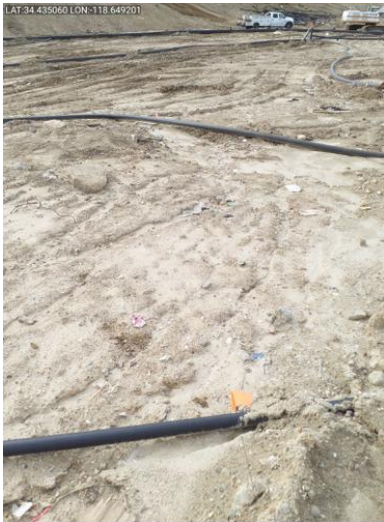
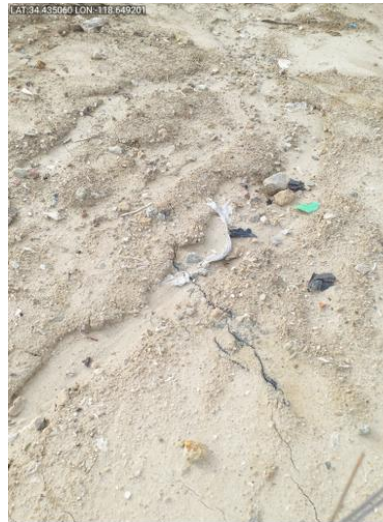
**Fissure or Tension Crack Found?**

Cracks were track walked.

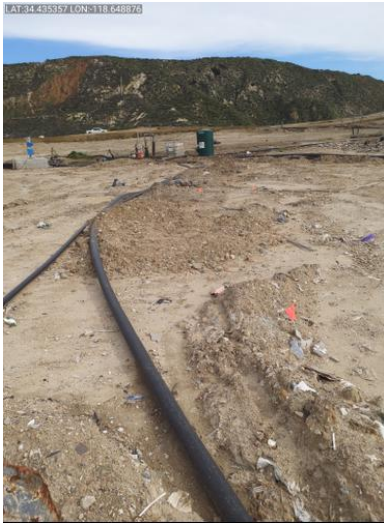
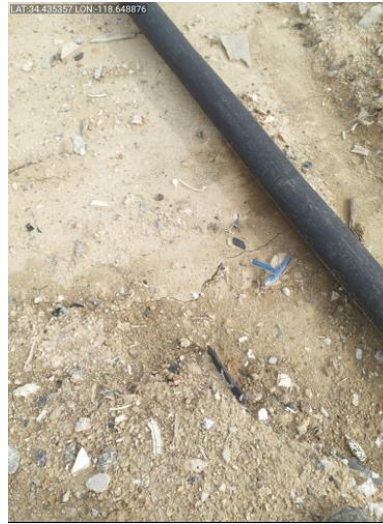
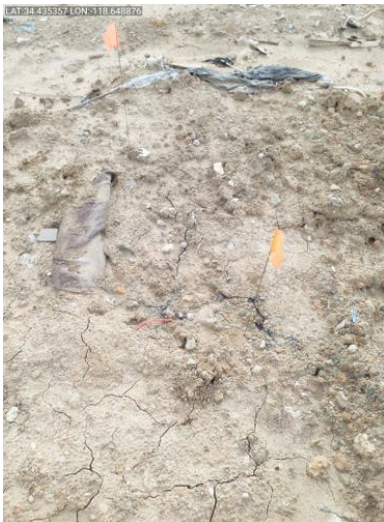
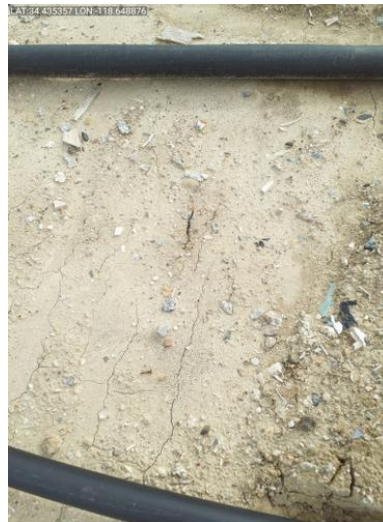
A few small cracks

Cracks were track walked.

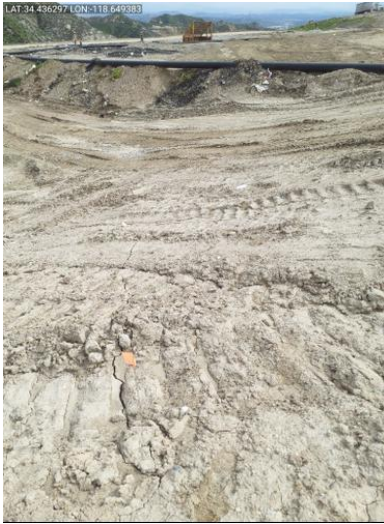
Photo 24

**Fissure or Tension Crack Found?**

Cracks were track walked

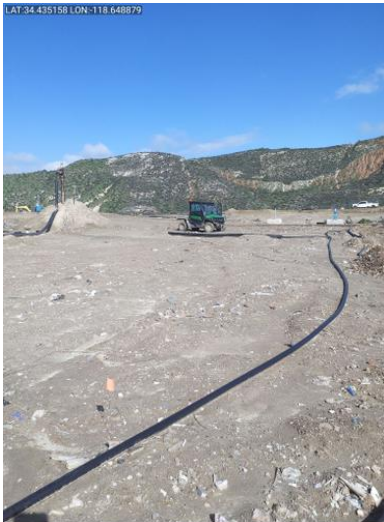
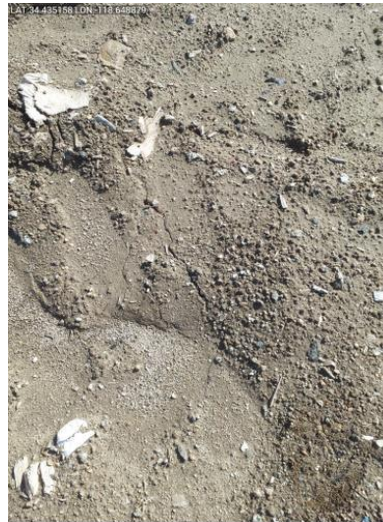
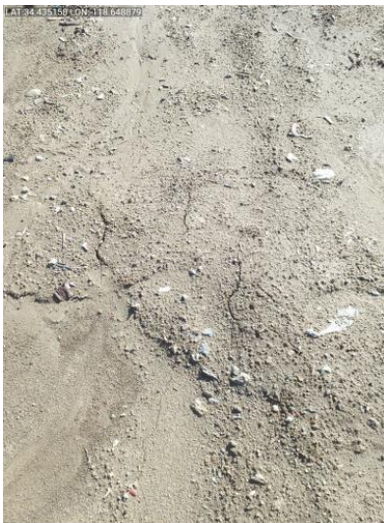
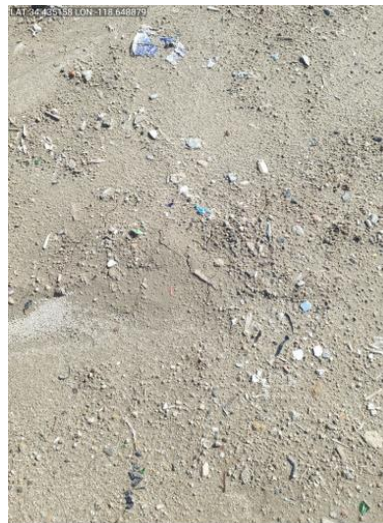
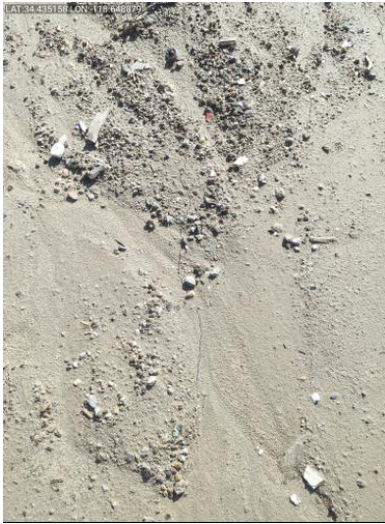
Multiple small cracks.

Yes

Area with cracks was track walked.

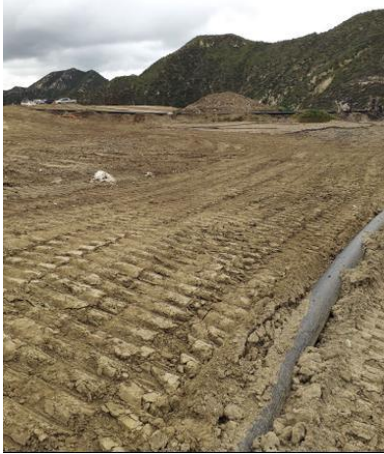
**Photo 1**

Cracks/fissures were identified previously in this location although none were identified today. Image taken from grid 177, 178, 179.

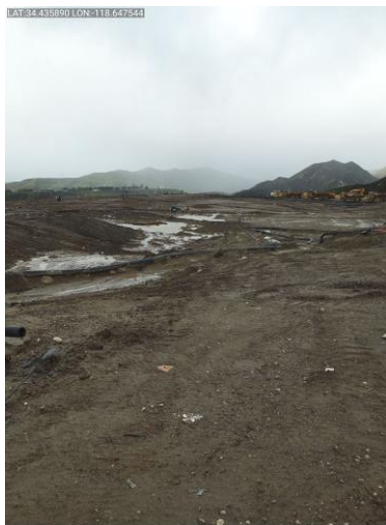
Photo 1

Due to rain, I walked as much of the area as I could safely. The mud in a lot of the area was thick and my boots were starting to come off my feet. I was around grid 180, and I stopped when conditions felt unsafe.

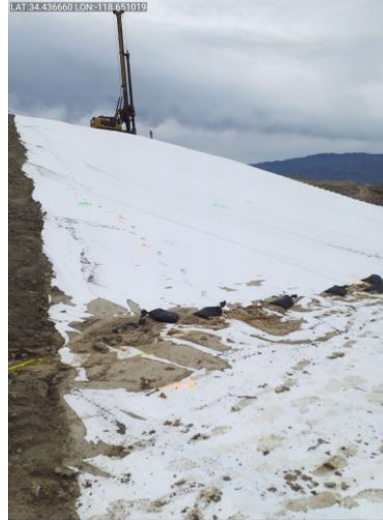
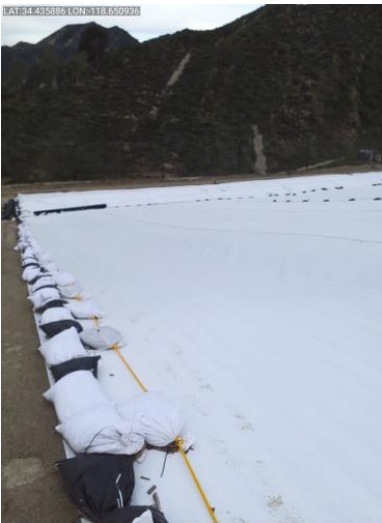
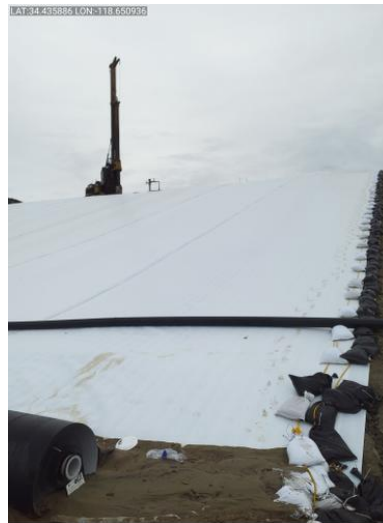
Are there any issues with the geosynthetic cover?

No

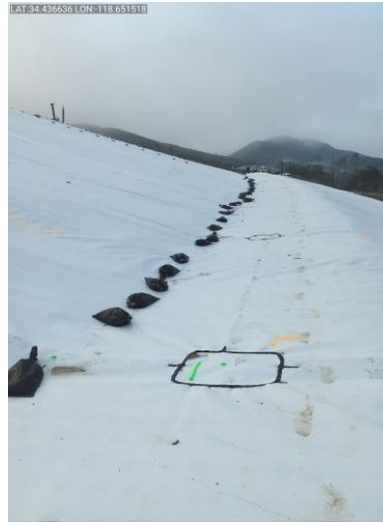
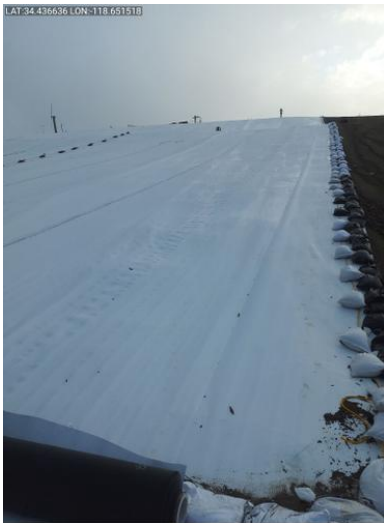
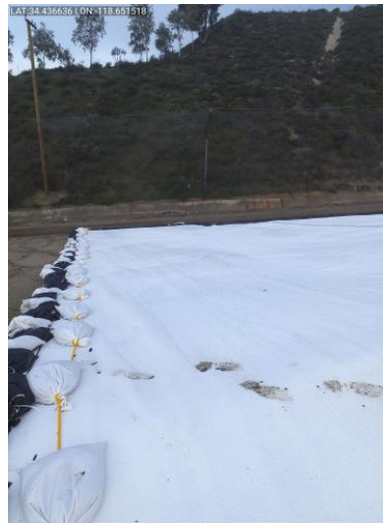
Are there any issues with the geosynthetic cover?

No

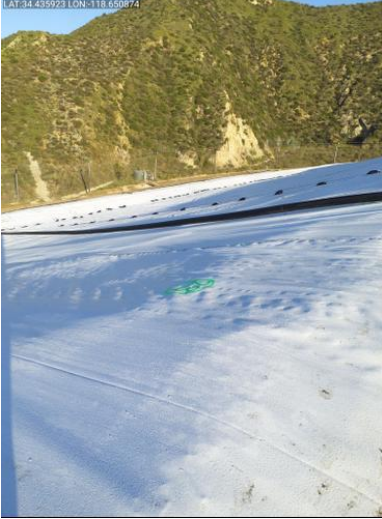
Photo 1

Are there any issues with the geosynthetic cover?

No

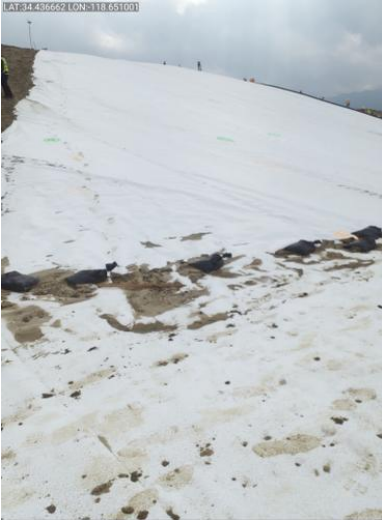
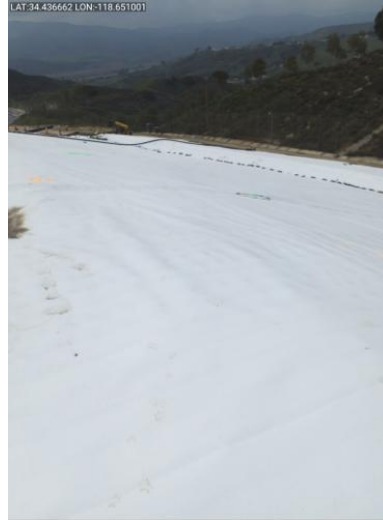
Are there any issues with the geosynthetic cover?

No

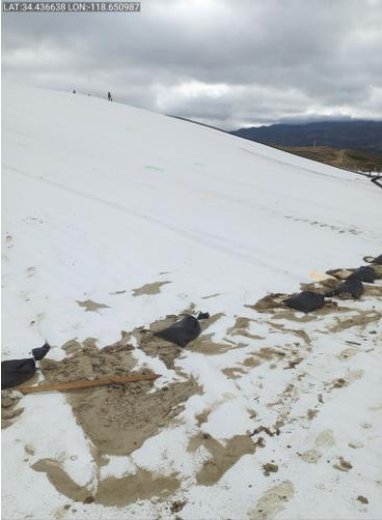
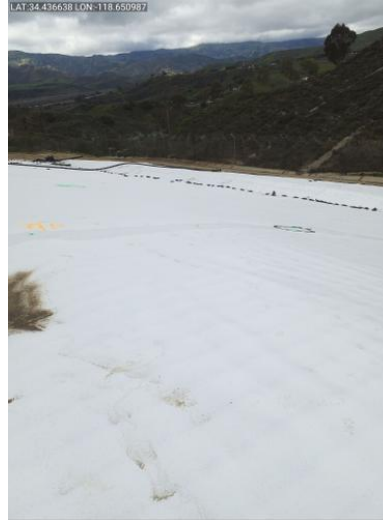
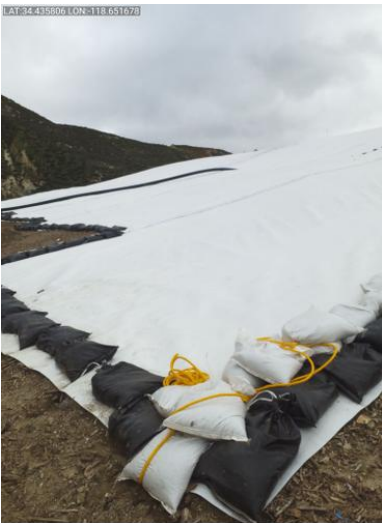
Are there any issues with the geosynthetic cover?

No

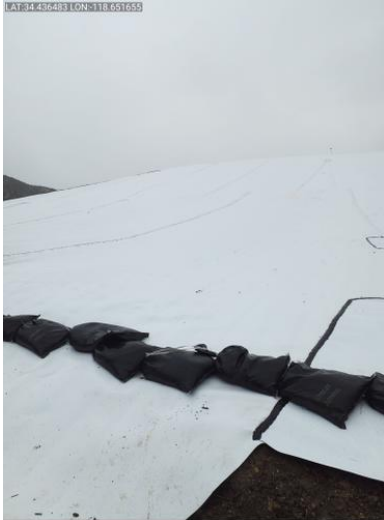
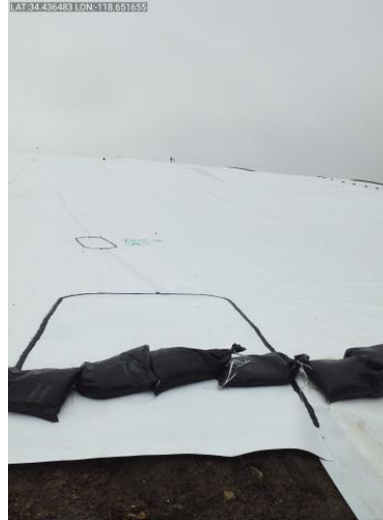
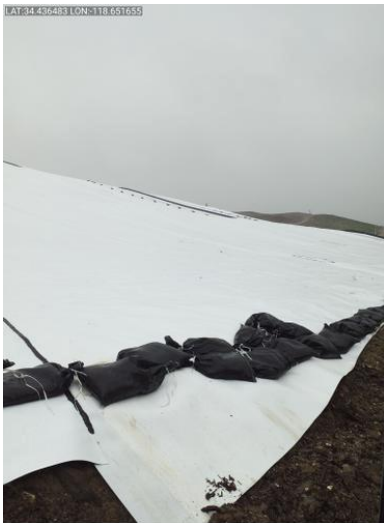
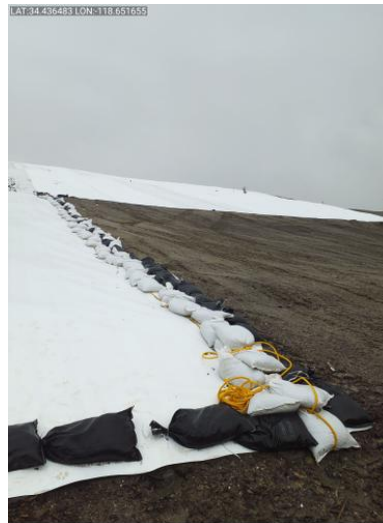
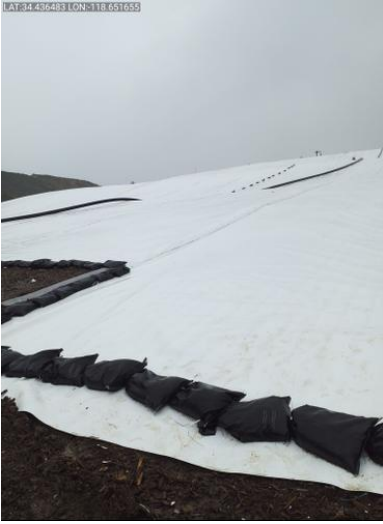
Are there any issues with the geosynthetic cover?

No

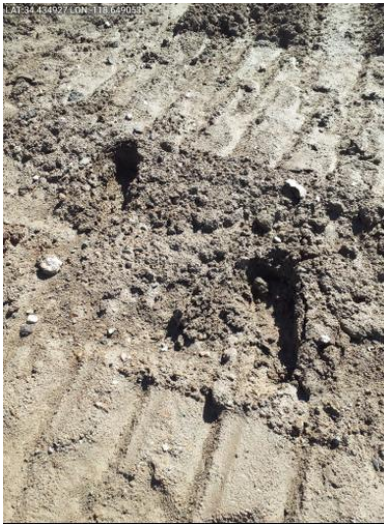
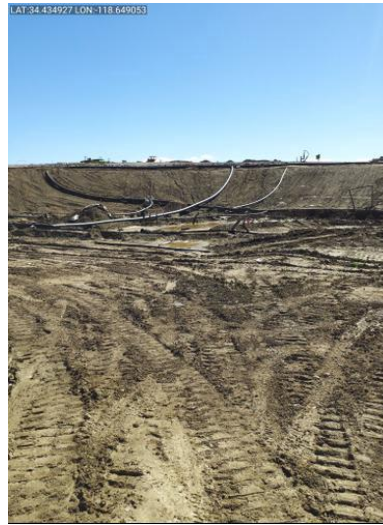
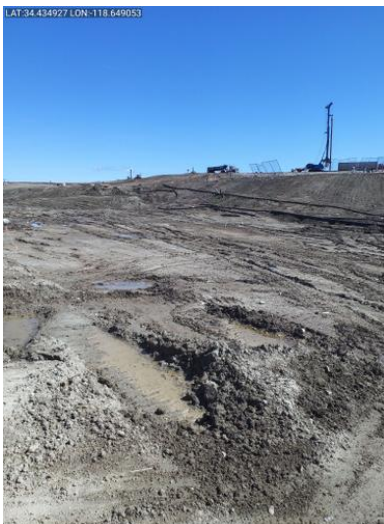
No

I was able to inspect a majority the reaction area but some parts were still too wet and muddy to safely walk. Images from grids 177 and 180.

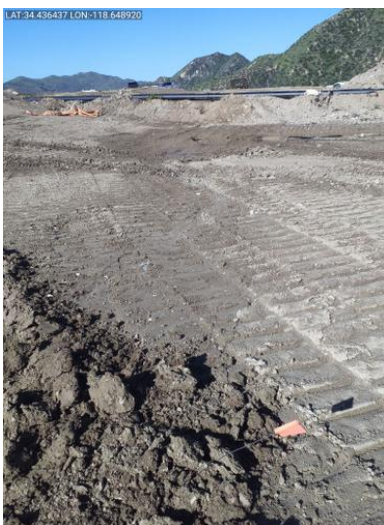
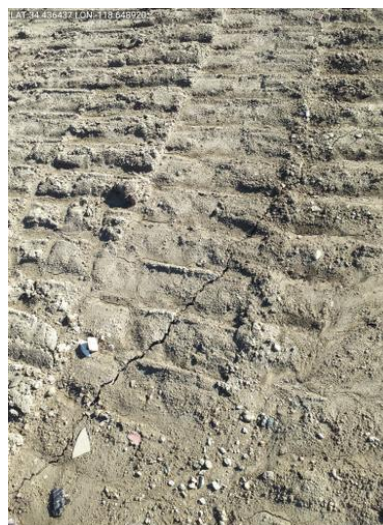
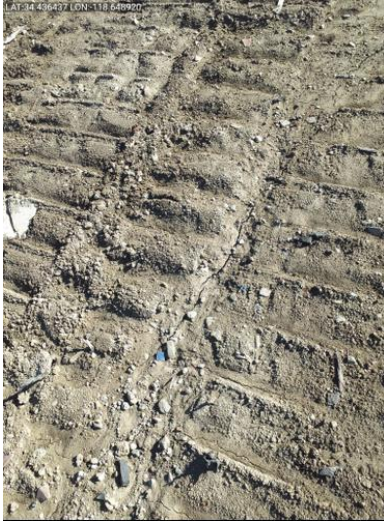
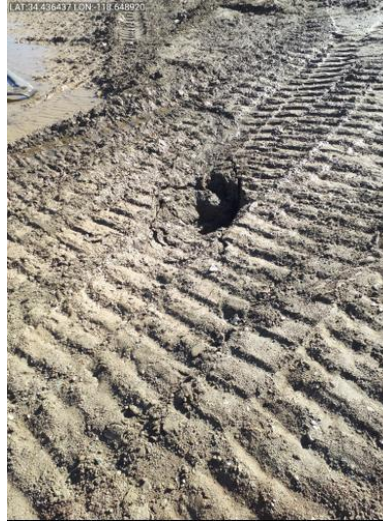
5 Mar 2024 9:00 AM PST

Larger hole was filled with dirt and then the hole and cracks were track walked.

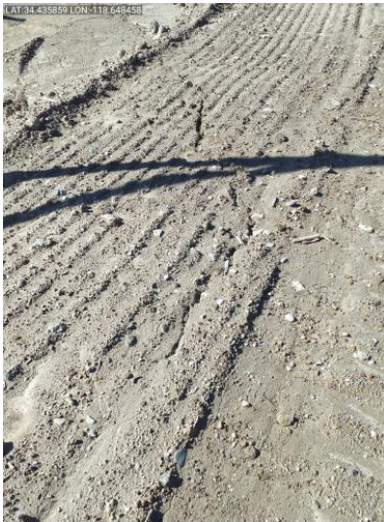
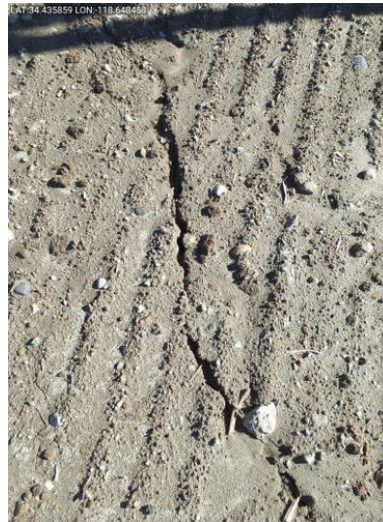
5 Mar 2024 9:34 AM PST

Crack was track walked.

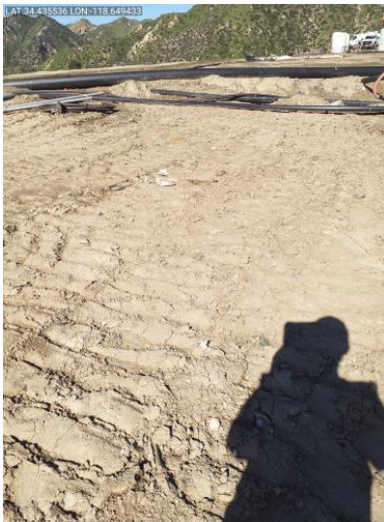
5 Mar 2024 9:42 AM PST

Crack was track walked.

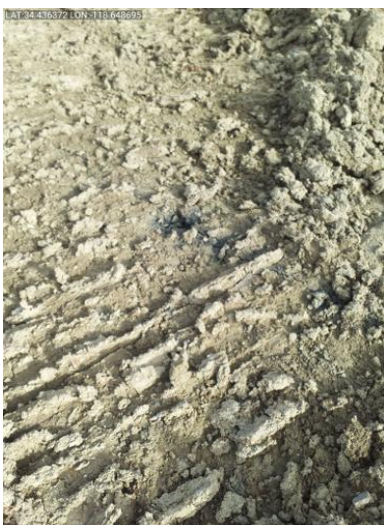
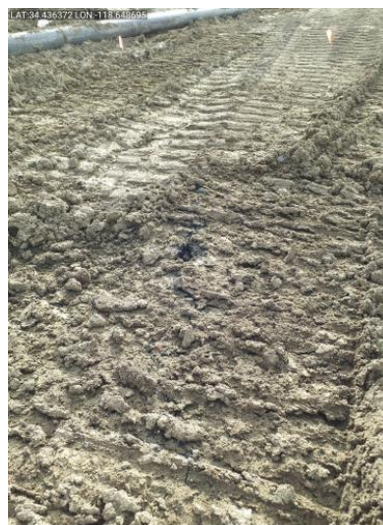
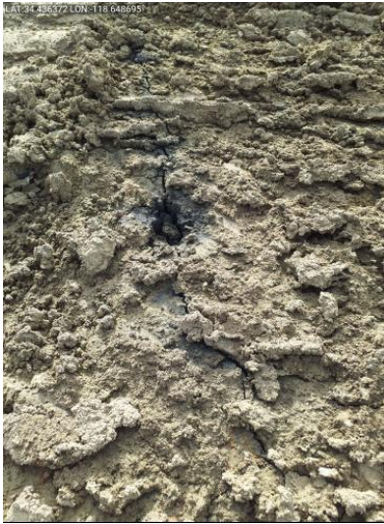
**Length of crack (ft) or area containing multiple cracks (ft xft)** 3ft

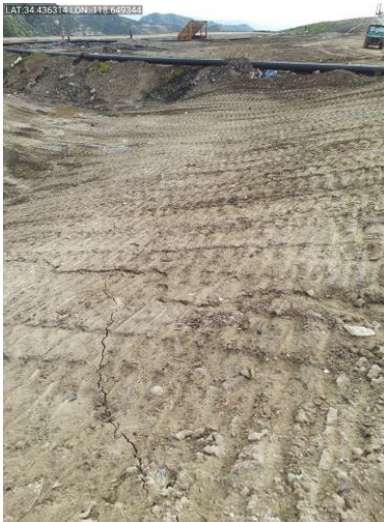
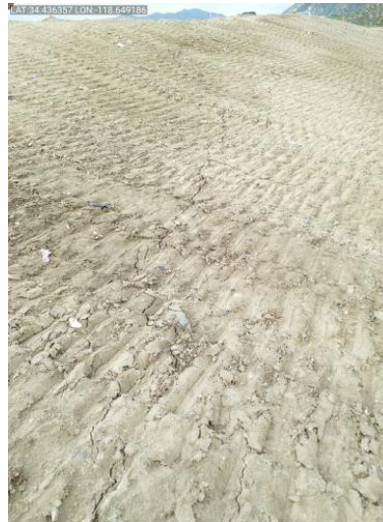
**Fissure or Tension Crack Found?** Yes

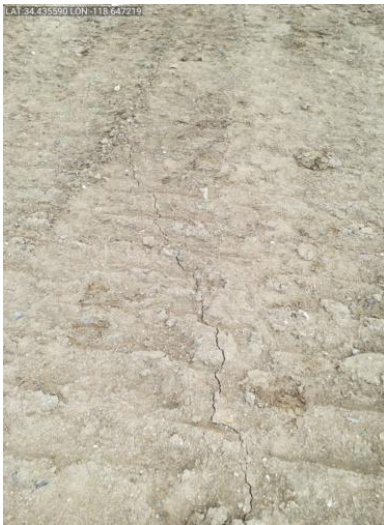
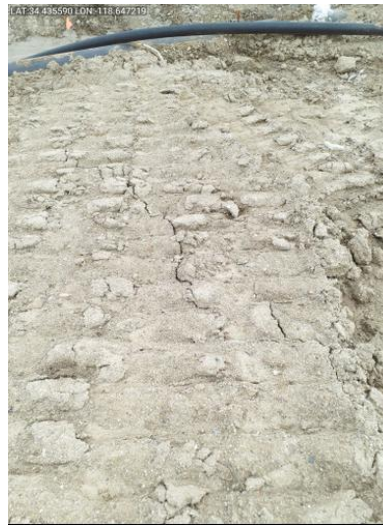
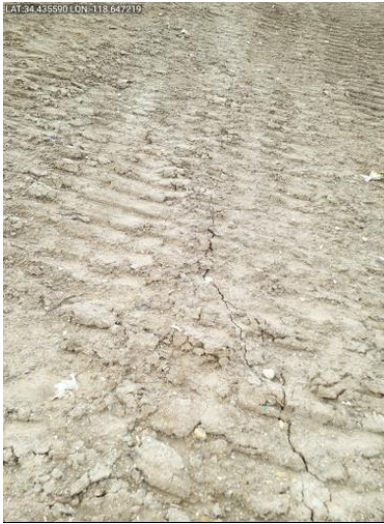
20ft x 20ft

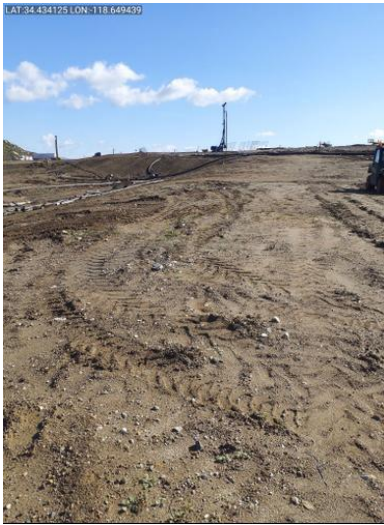
Photo 1

Cracks/fissures were identified previously in this location although none were identified today. Image taken from grid 177, 178, 179.

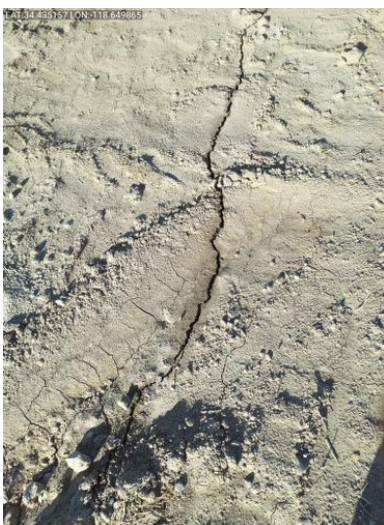
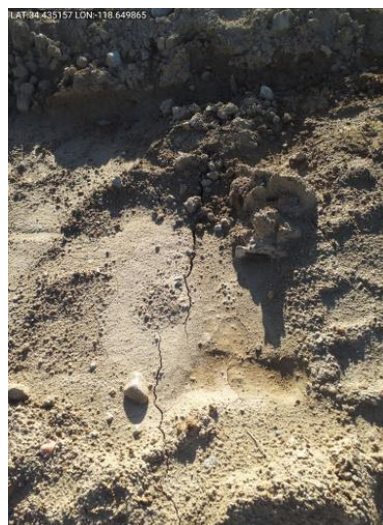
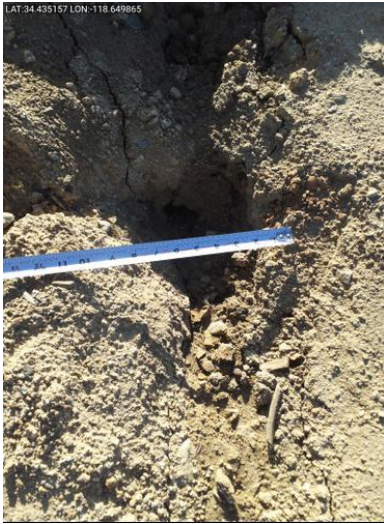
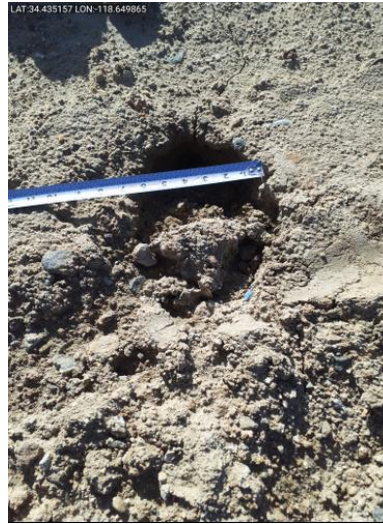
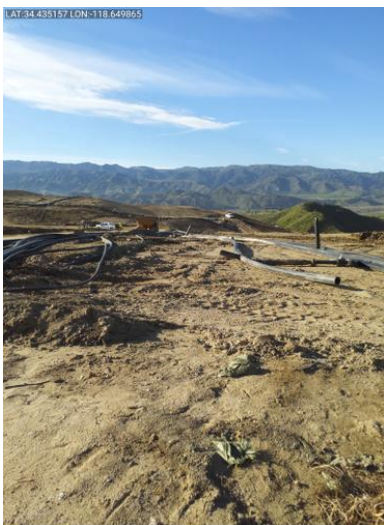
## Chiquita Reaction Area Tracking of Fissures and Tension Cracks

Using the Media link below, attach the before photo of the fissure or tension crack.

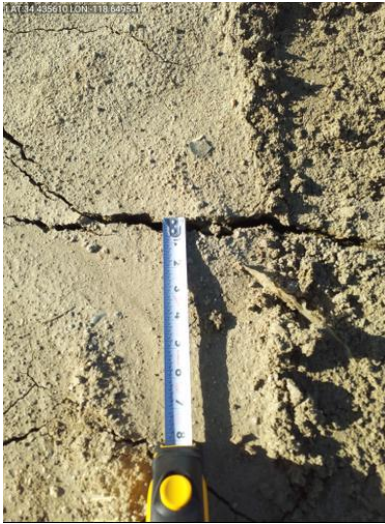
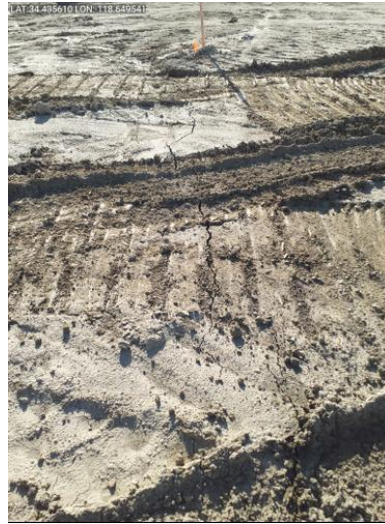
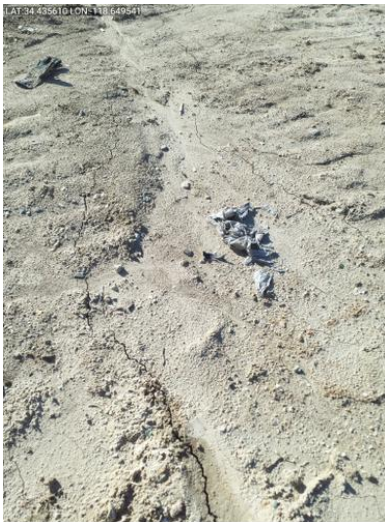
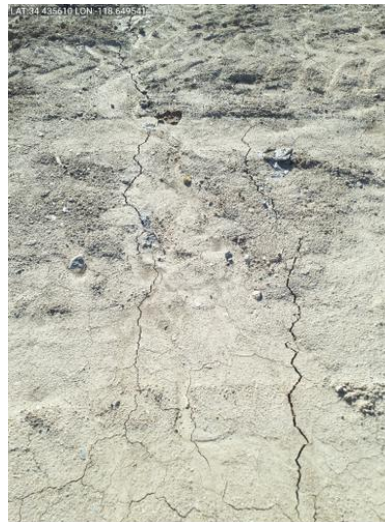
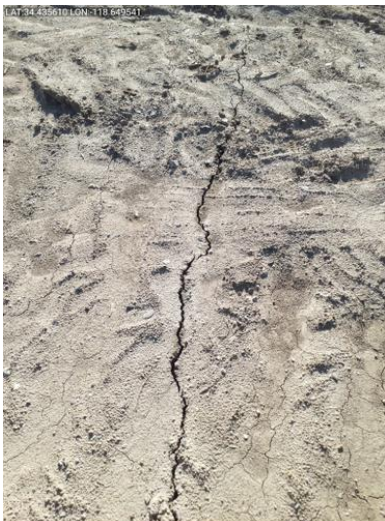
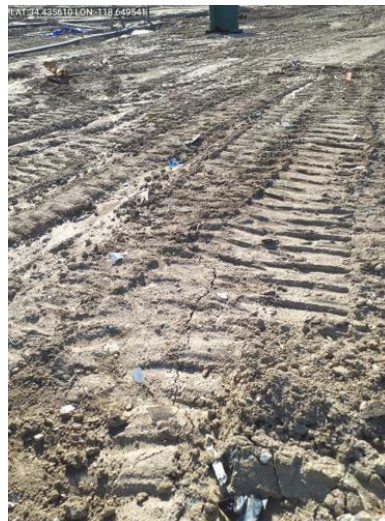
## Chiquita Reaction Area Tracking of Fissures and Tension Cracks 2

Using the Media link below, attach the before photo of the fissure or tension crack.

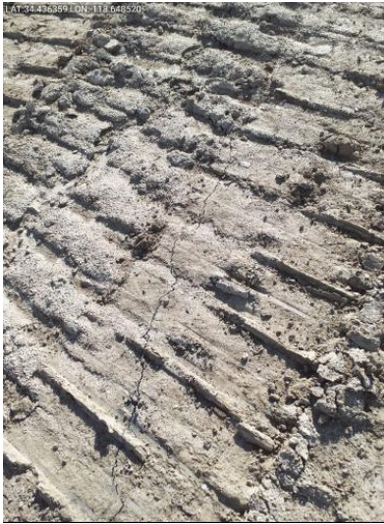
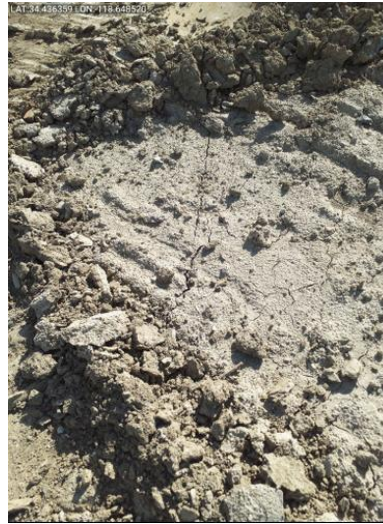
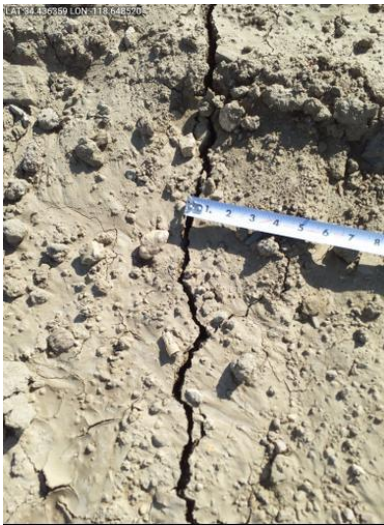
Chiquita Reaction Area Tracking of Fissures and Tension Cracks  
3

Photo with tape measure is at widest point of crack.

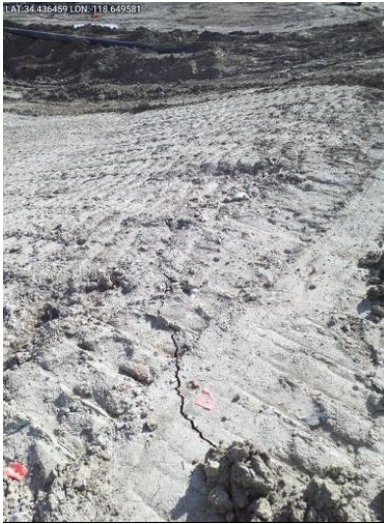
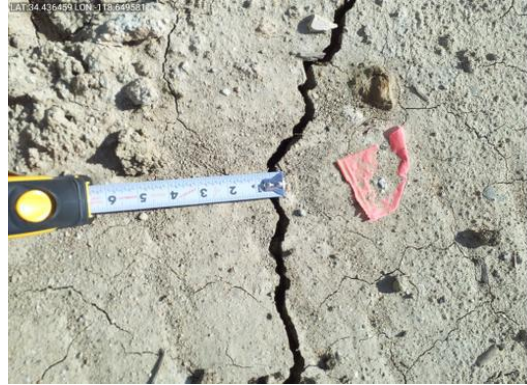
### Chiquita Reaction Area Tracking of Fissures and Tension Cracks 4

**Using the Media link below, attach the before photo of the fissure or tension crack.**

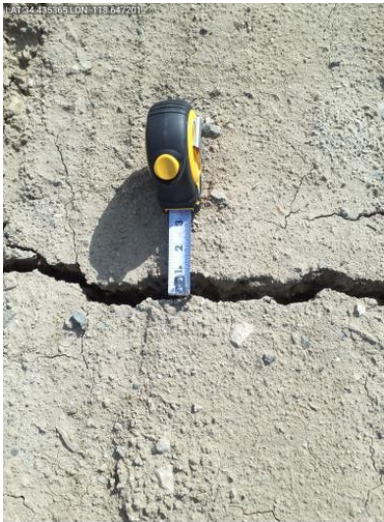
Photo 25

Chiquita Reaction Area Tracking of Fissures and Tension Cracks  
5

**Using the Media link below, attach the before photo of the fissure of tension crack.**

Cracks were track walked.

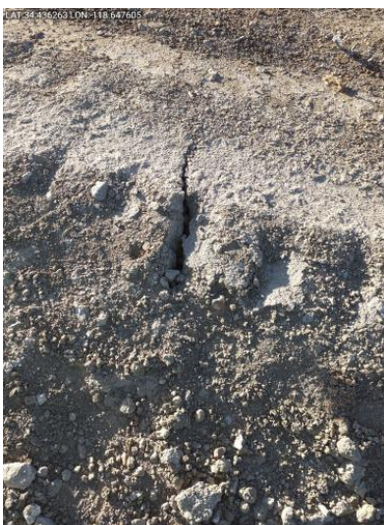
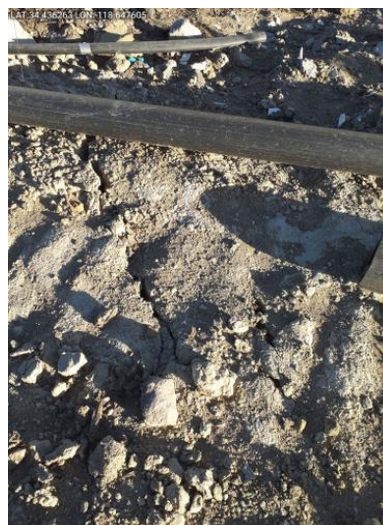
14 Mar 2024 8:37 AM PDT

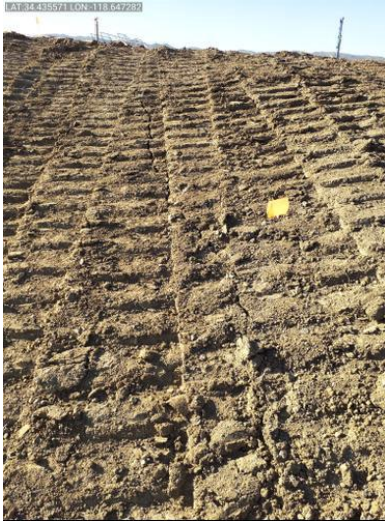
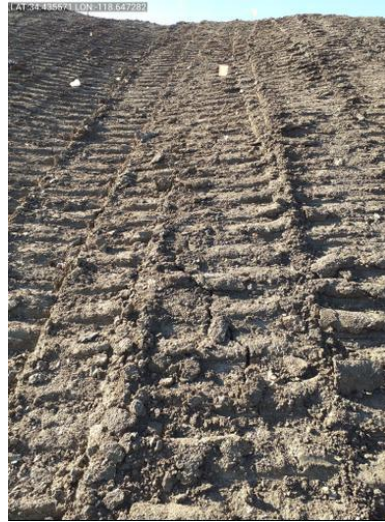
152

Yes

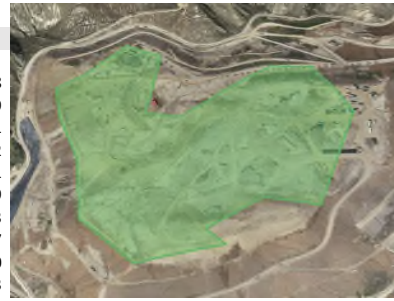
**Location 1**

\*Waste fill near reaction area

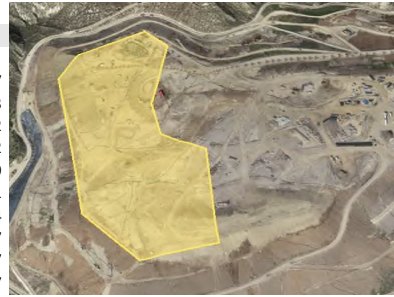
**Location 2**

\*Waste fill near reaction area

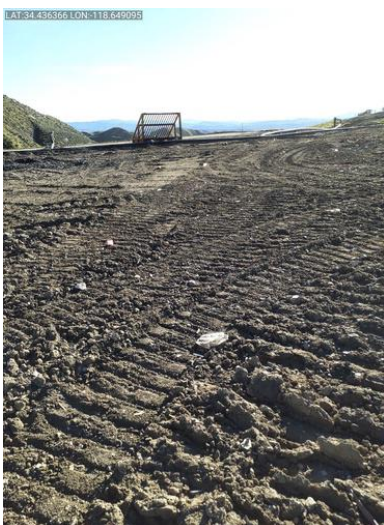
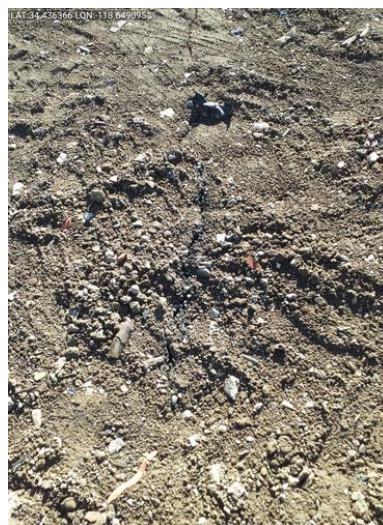
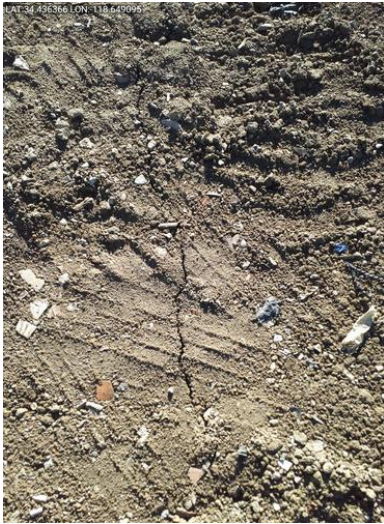
Chiquita Reaction Area Tracking of Fissures and Tension Cracks  
1

**Length of crack (ft) or area containing multiple cracks (ft x ft)** 125 ft

**Was Fissure or Crack fixed? If yes, add photo and description of repairs performed** Yes

Crack was track walked.

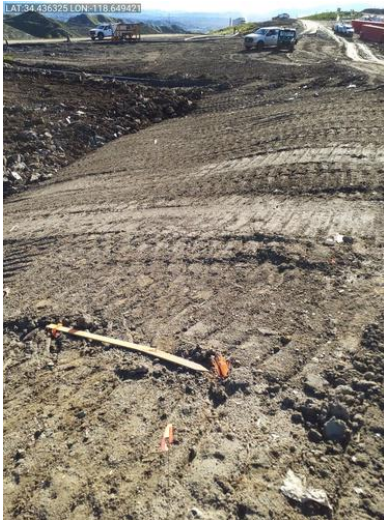
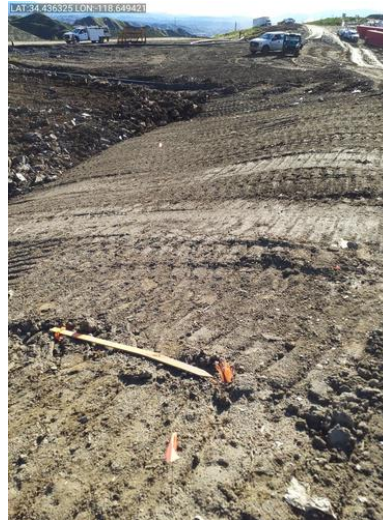
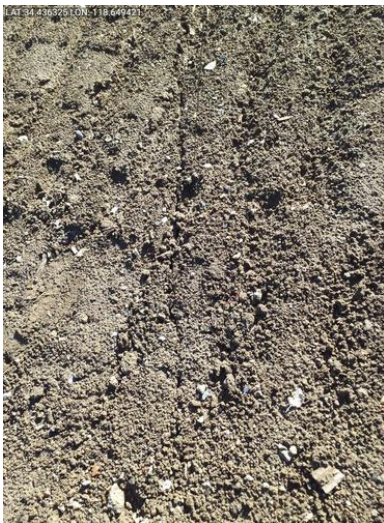
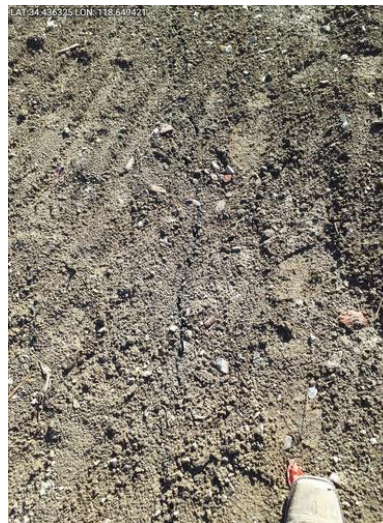
Chiquita Reaction Area Tracking of Fissures and Tension Cracks  
2

**Fissure or Tension Crack Found?** Yes

Yes

Crack was track walked.

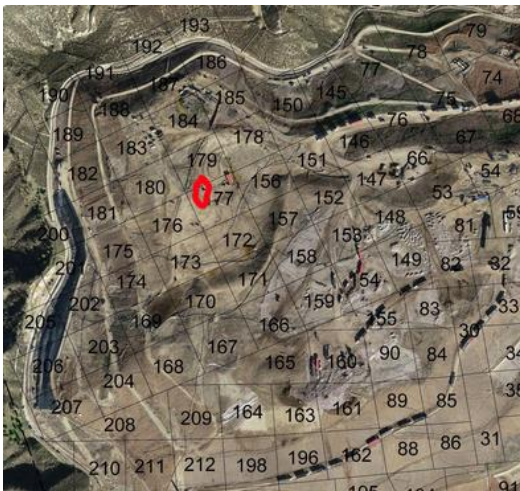
Grid Location

Fissure or Tension Crack Found?

Yes

179.177

Crack was track walked.

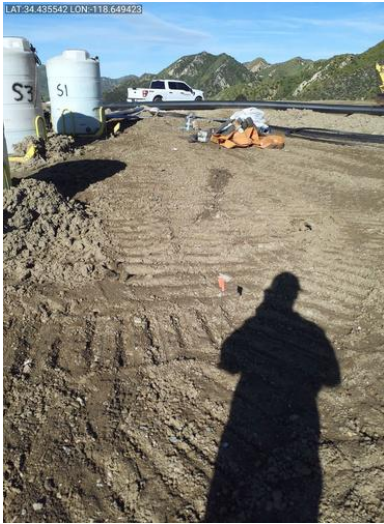
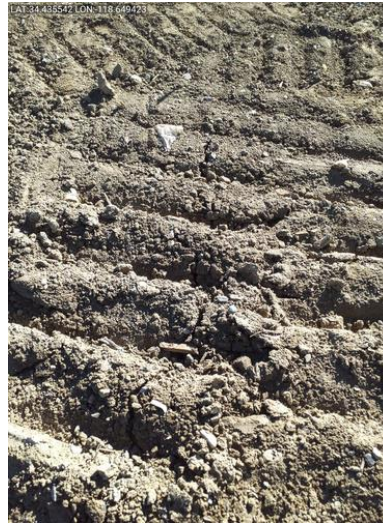
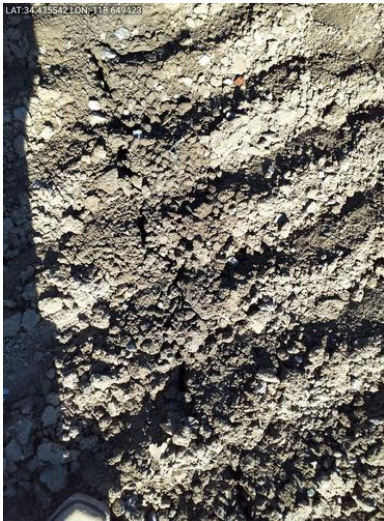
Chiquita Reaction Area Tracking of Fissures and Tension Cracks  
3

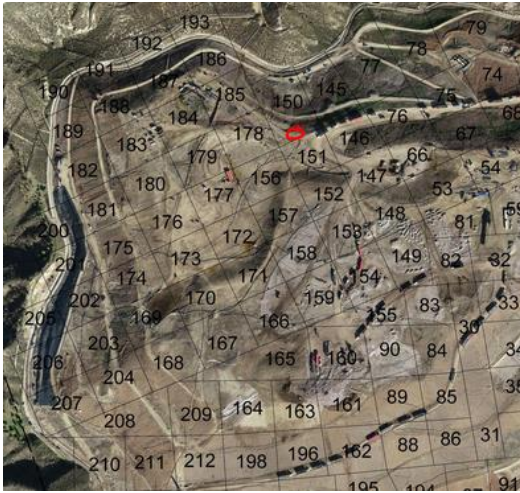
Grid Location

150
