April 22, 2024  
File No. 01204123.25, Task 10

Subject: March 2024 Monthly Report for Modified Stipulated Order for Abatement (Case No. 6177-4), Chiquita Canyon Landfill (Facility ID 119219), Castaic, California

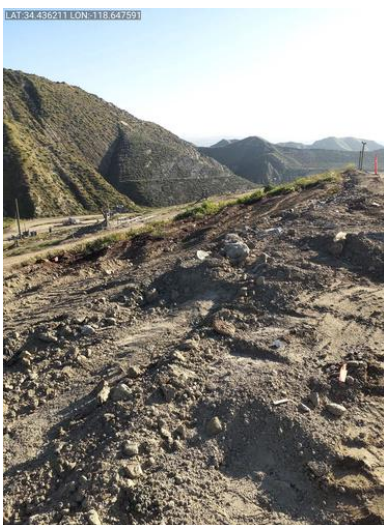
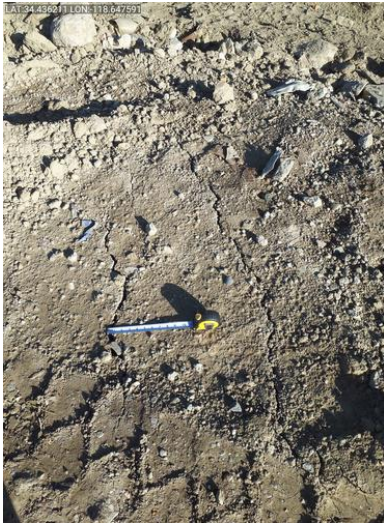
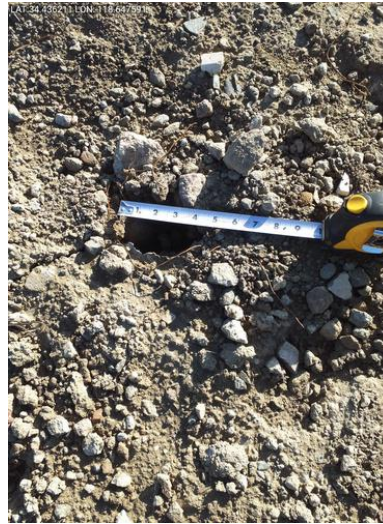
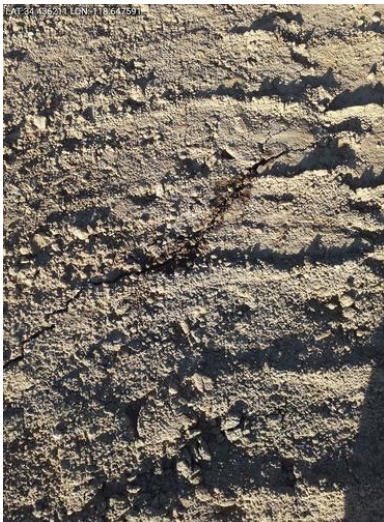
Chiquita Reaction Area Tracking of Fissures and Tension Cracks  
1

Yes

Cracks were track walked.

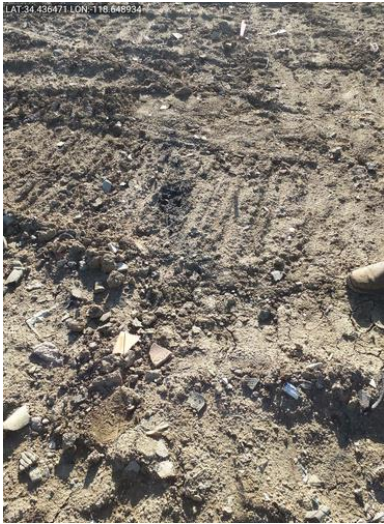
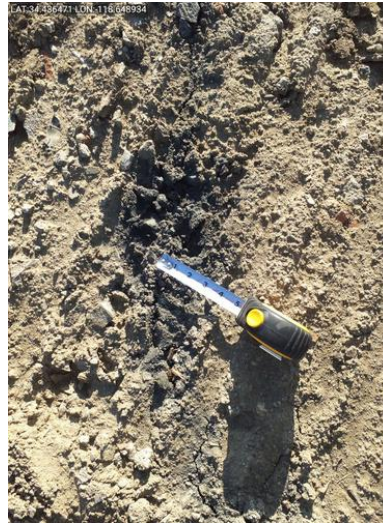
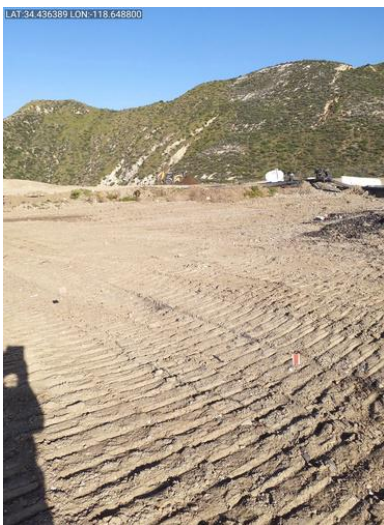
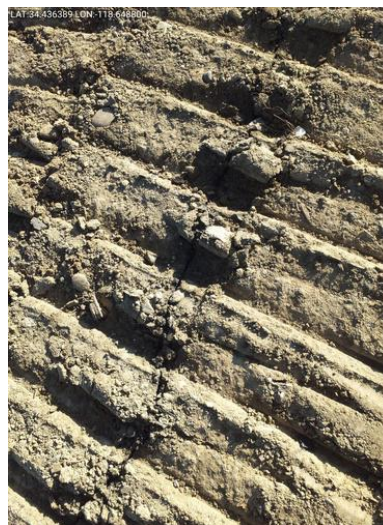
## Chiquita Reaction Area Tracking of Fissures and Tension Cracks 2

Cracks were track walked.

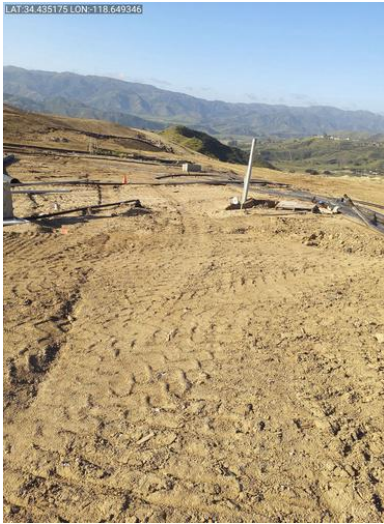
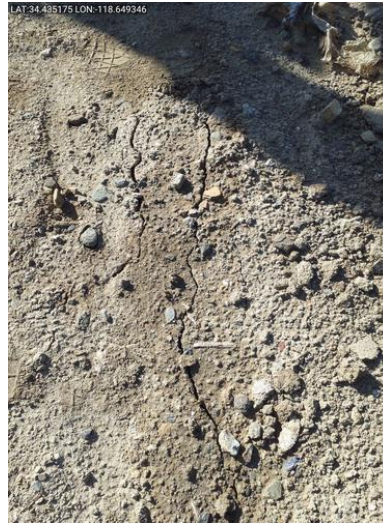
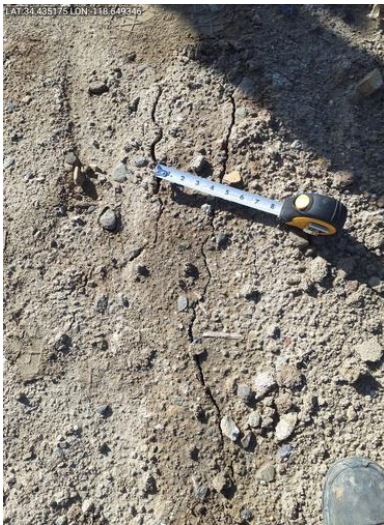
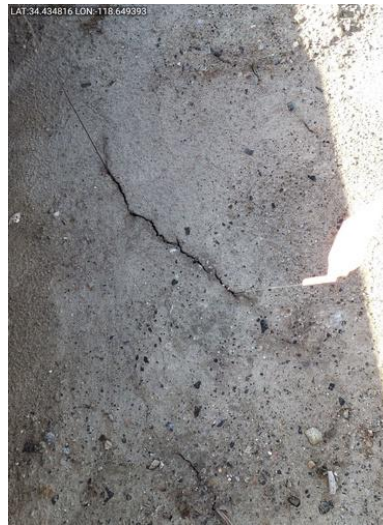
### Chiquita Reaction Area Tracking of Fissures and Tension Cracks 3

Cracks were track walked.

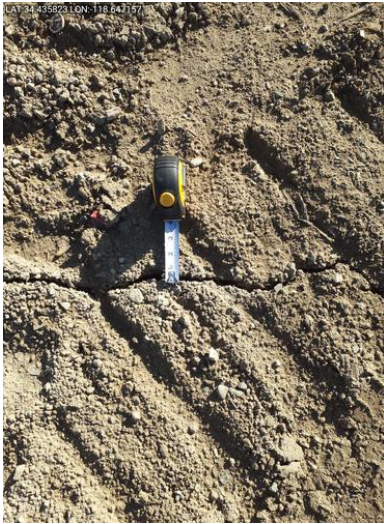
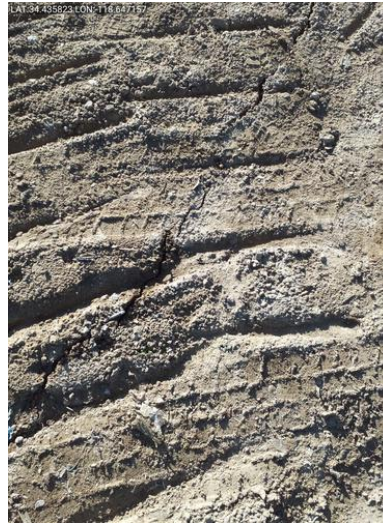
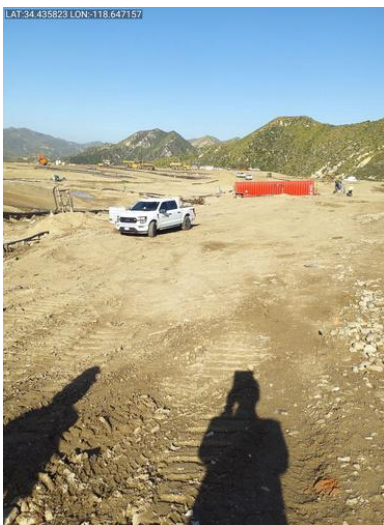
### Chiquita Reaction Area Tracking of Fissures and Tension Cracks 4

Cracks were track walked.

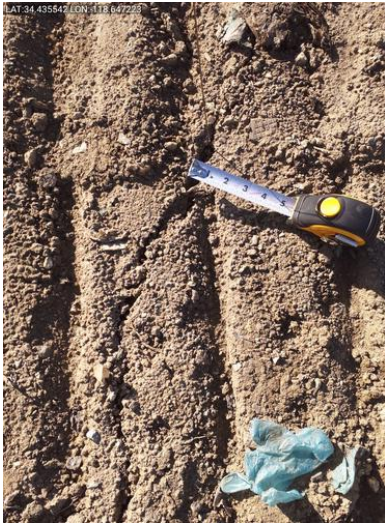
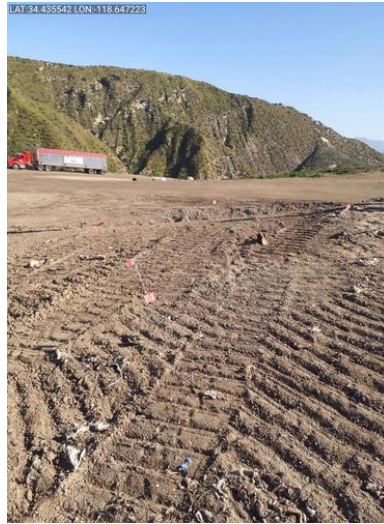
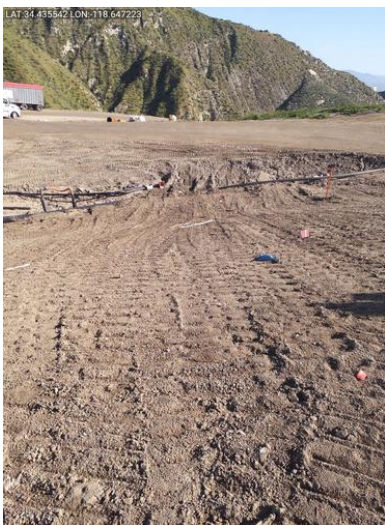
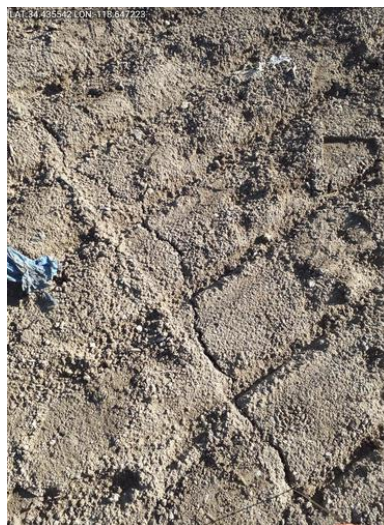
### Chiquita Reaction Area Tracking of Fissures and Tension Cracks 5

Cracks were track walked.

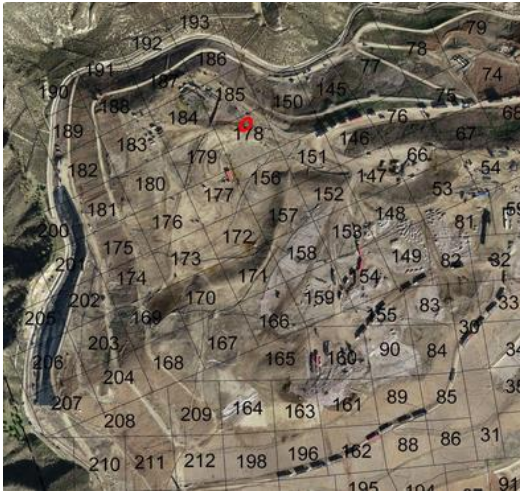
**Grid Location**

178

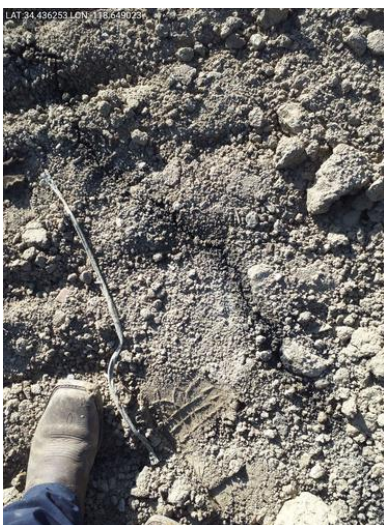
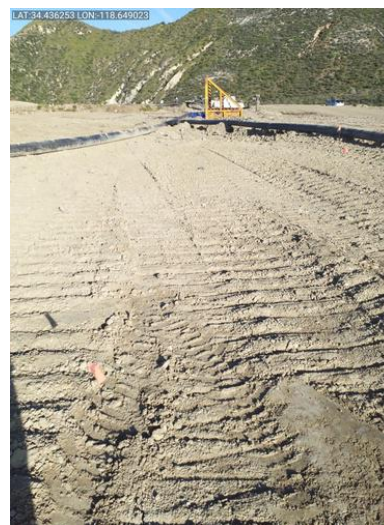
Chiquita Reaction Area Tracking of Fissures and Tension Cracks  
1

Yes

Cracks were track walked

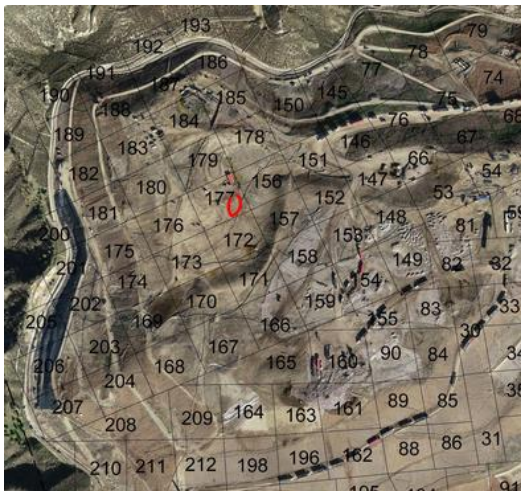
177

Yes

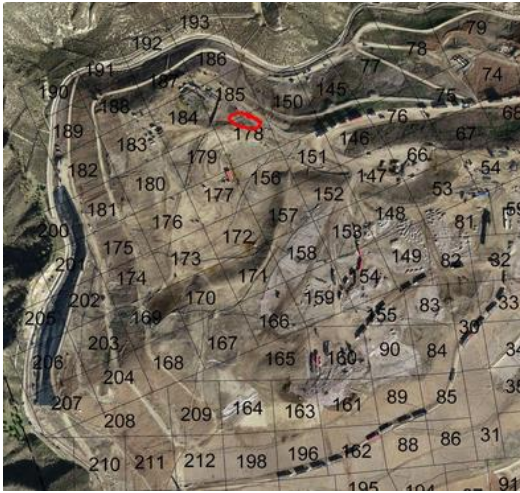
178

Yes

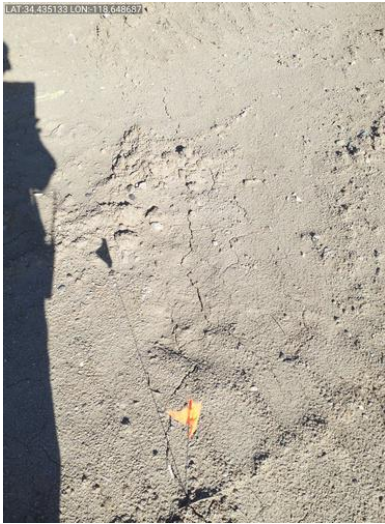
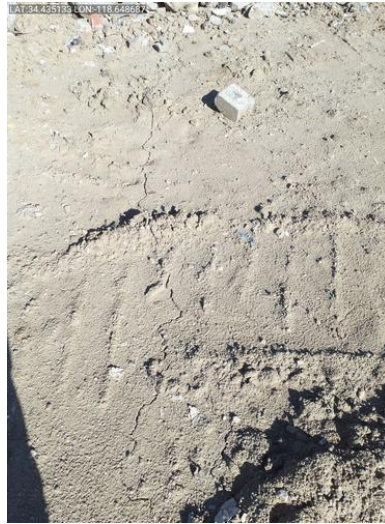
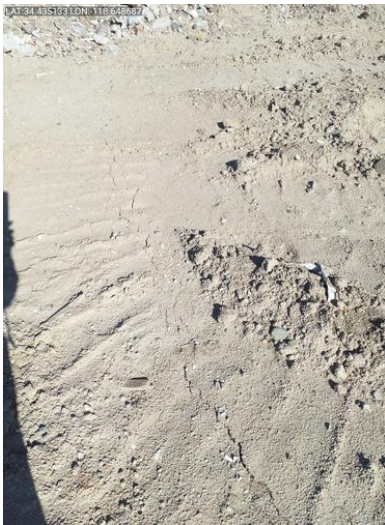
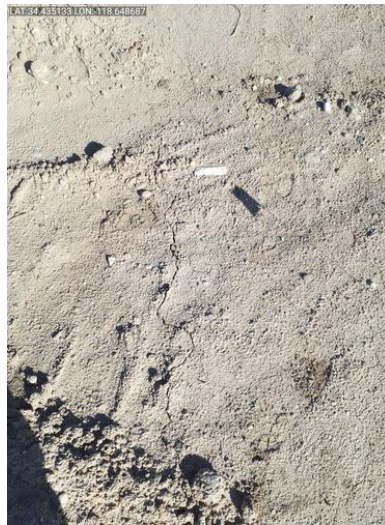
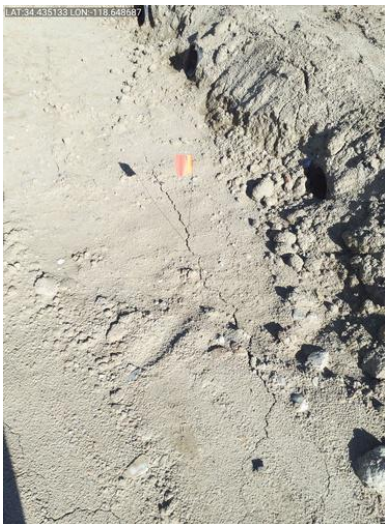
**Length of crack (ft) or area containing multiple cracks (ft x ft)**

Cracks were track walked.

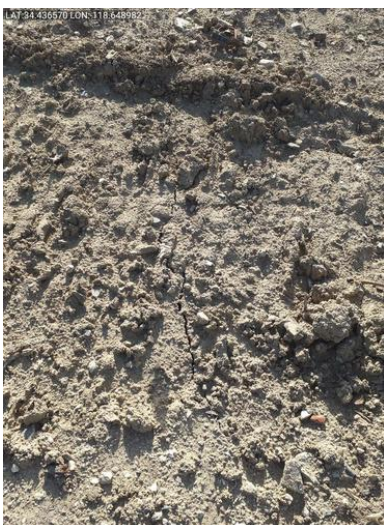
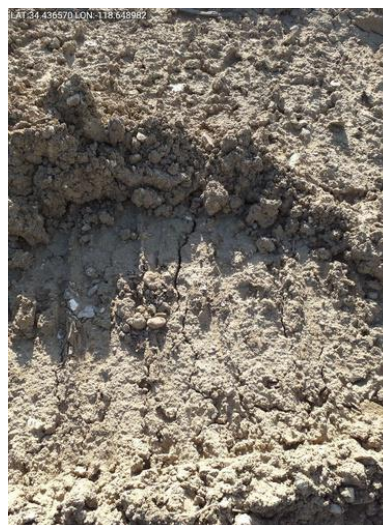
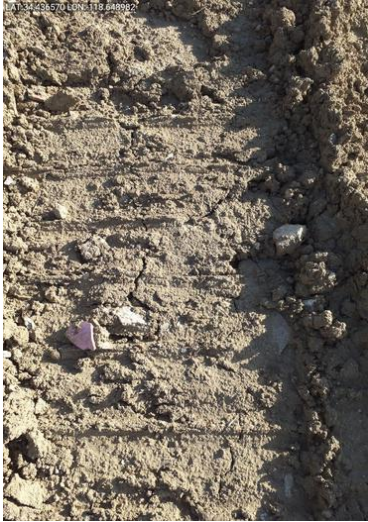
**Length of crack (ft) or area containing multiple cracks (ft x ft)**

Cracks were track walked.

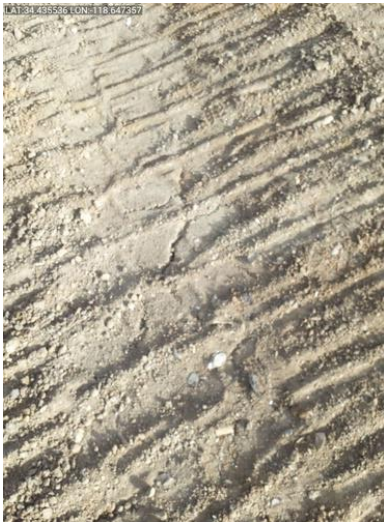
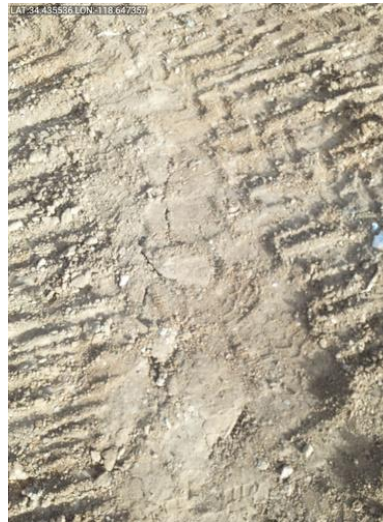
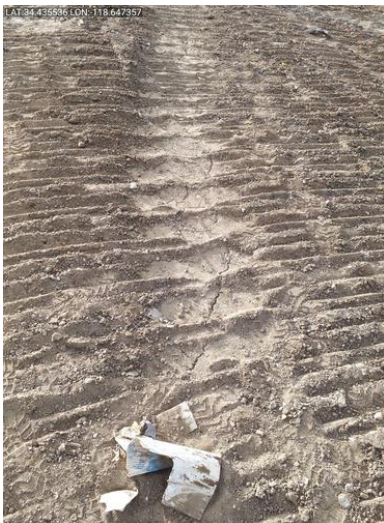
**Length of crack (ft) or area containing multiple cracks (ft x**

Cracks were track walked.

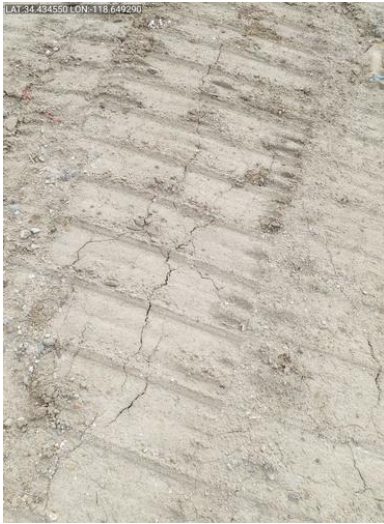
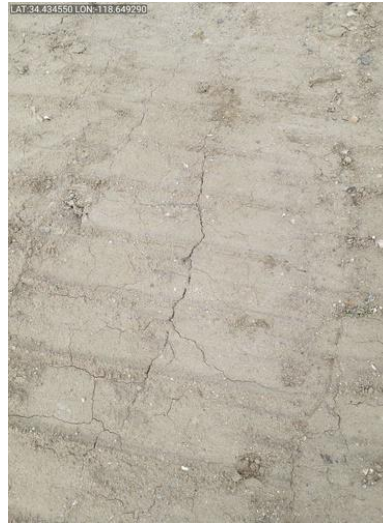
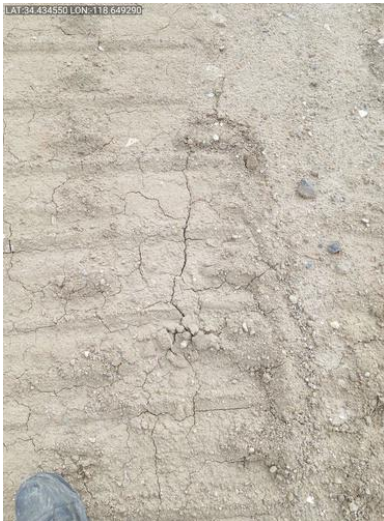
**Length of crack (ft) or area containing multiple cracks (ft x ft)**

Cracks were track walked.

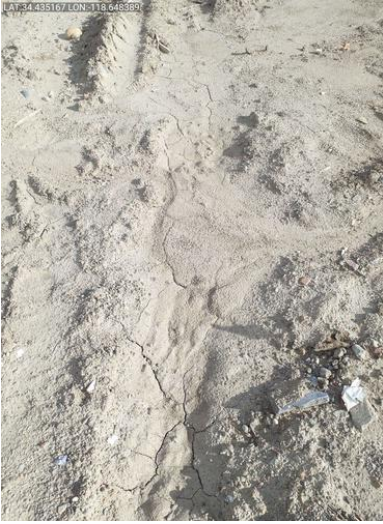
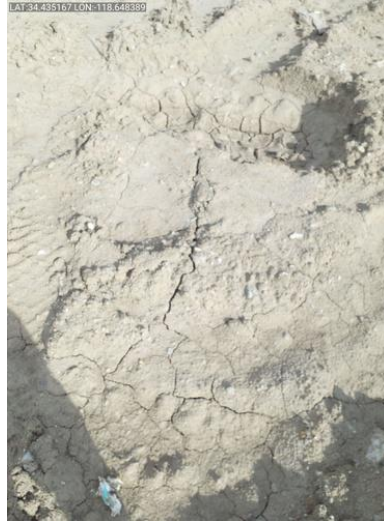
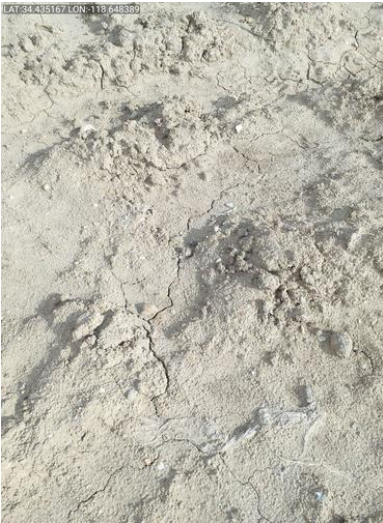
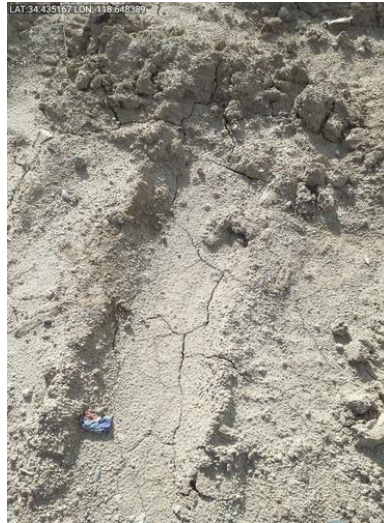
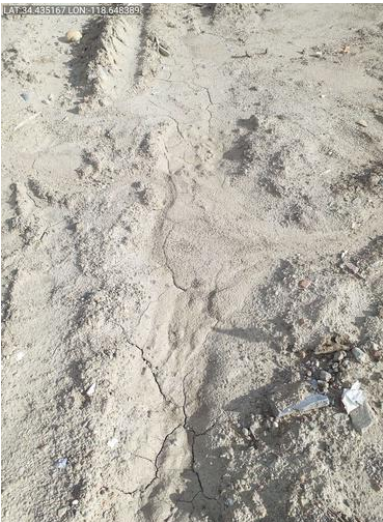
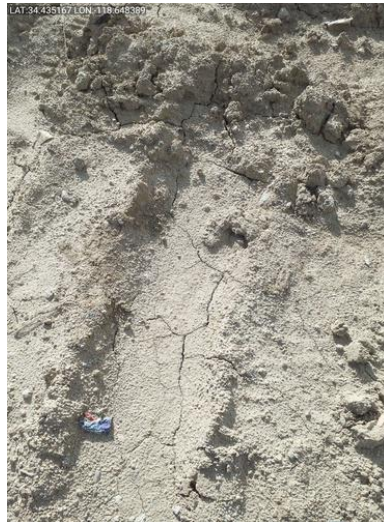
**Length of crack (ft) or area containing multiple cracks (ft x ft)**

Cracks were track walked.

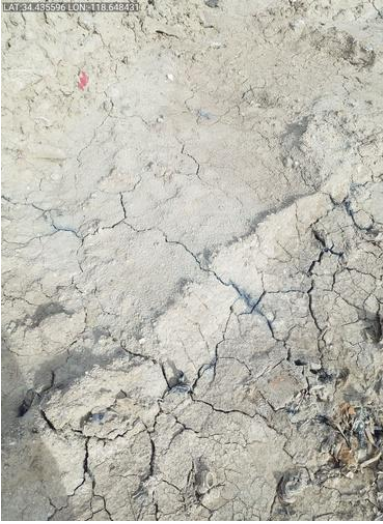
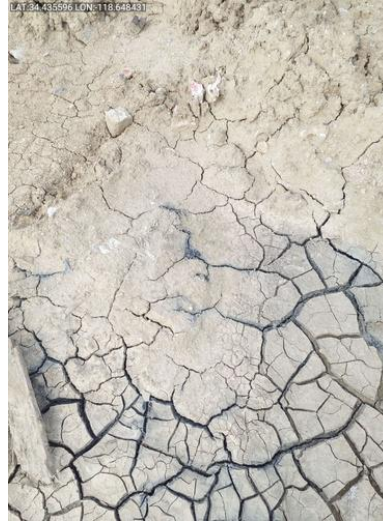
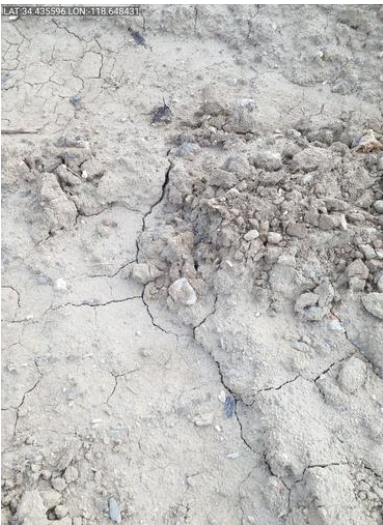
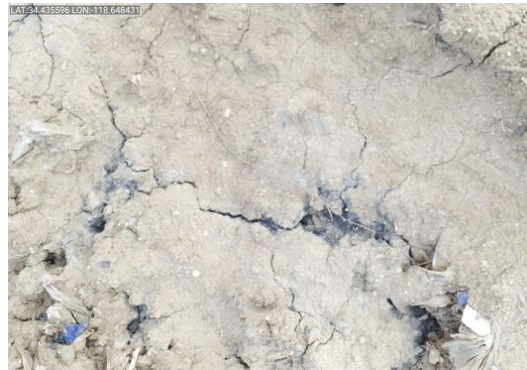
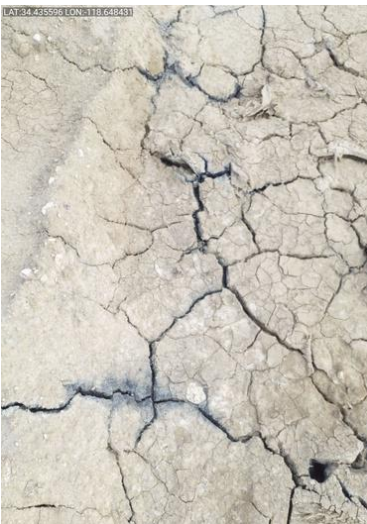
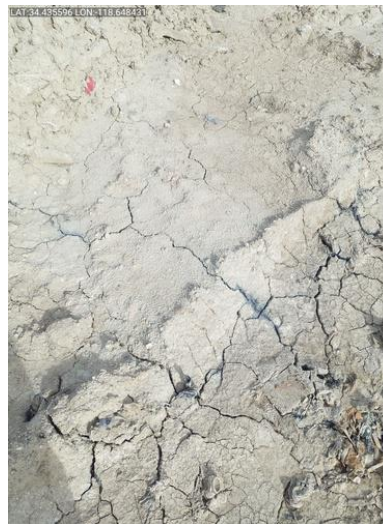
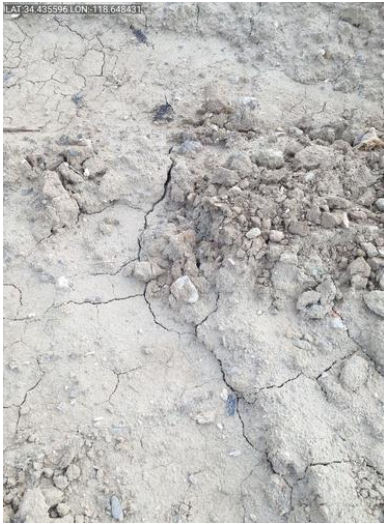
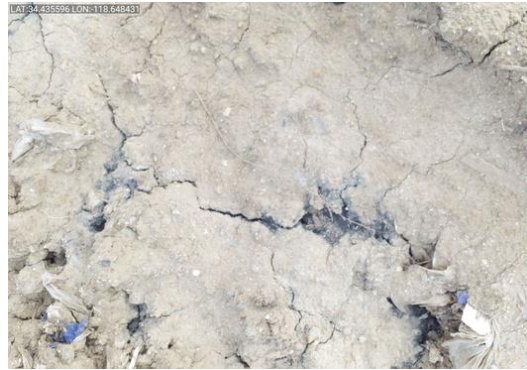
**Length of crack (ft) or area containing multiple cracks (ft x ft)**

Fresh dirt was added and cracks were track walked.

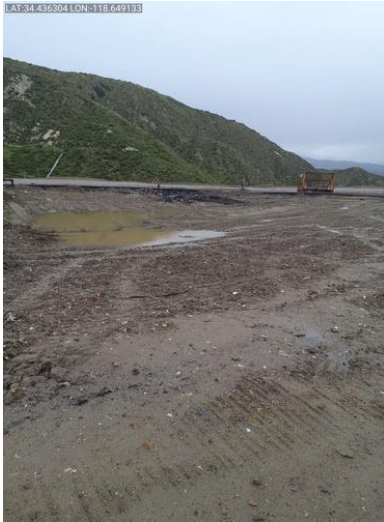
Photo 1

No

No cracks found, image was taken from grid 178 where cracks have been previously found.

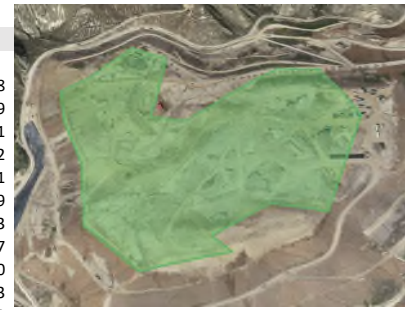
**Location 1**

\*Waste fill near reaction area

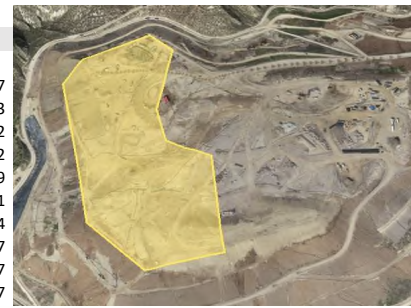
**Location 2**

\*Waste fill near reaction area

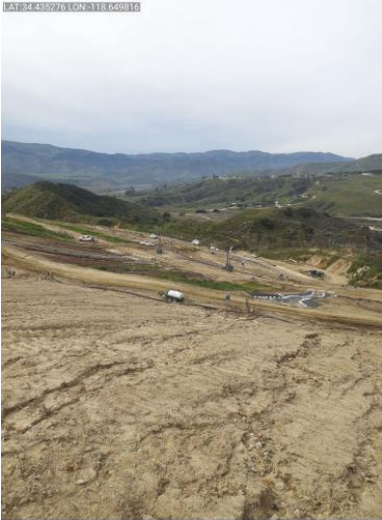
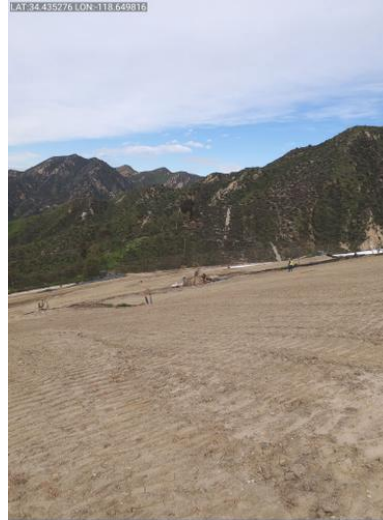
No

View of the perimeter road from above. No seepage or pooling found.

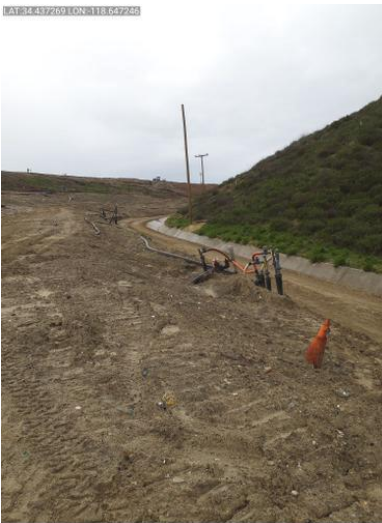
Photo 2

Various views of perimeter road.  
No seepage or pooling found.

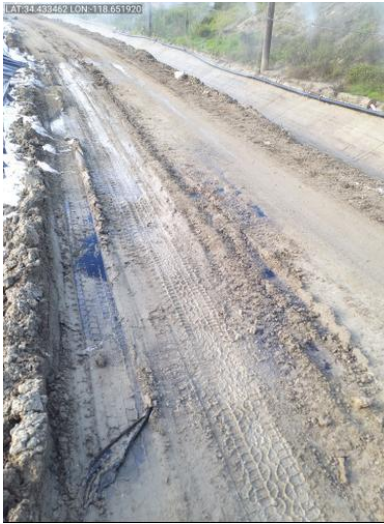
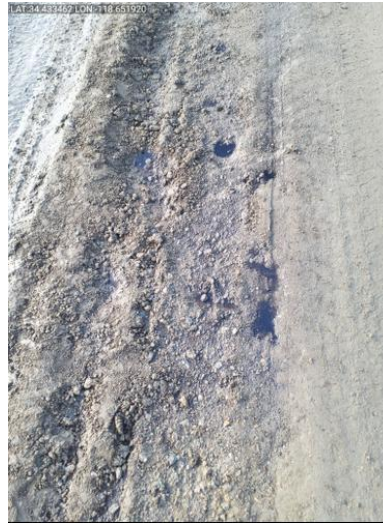
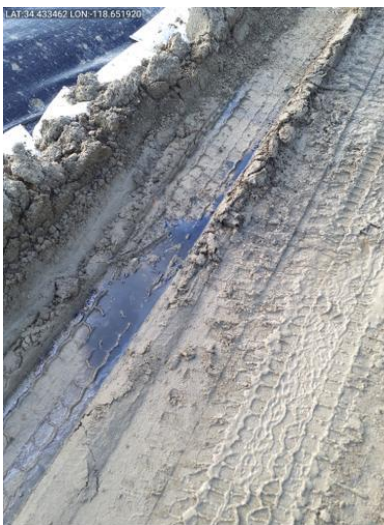
Standing free liquid

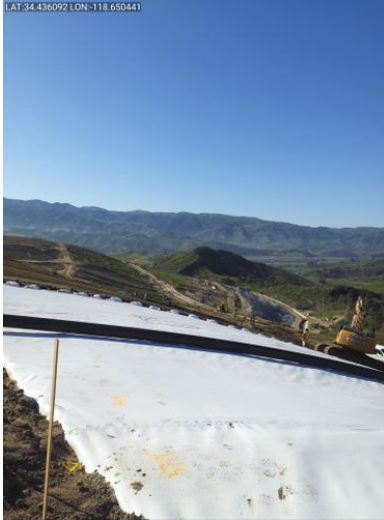
Photo 1

View from the top deck of the perimeter road. No seeps or pooling found.

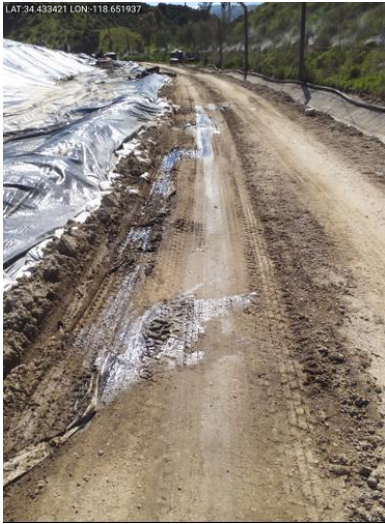
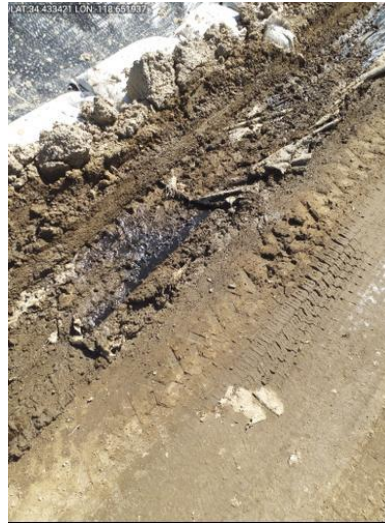
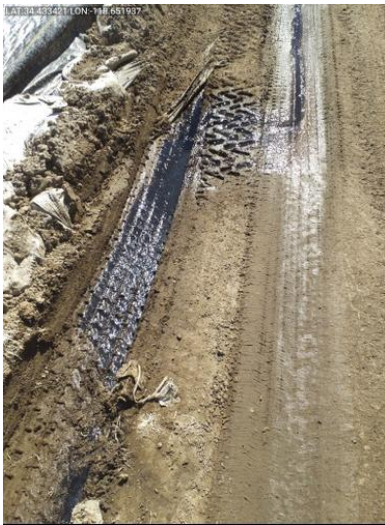
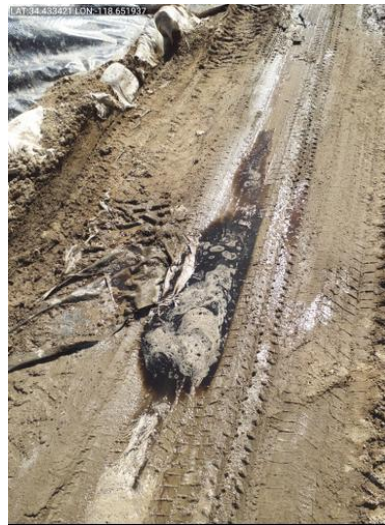
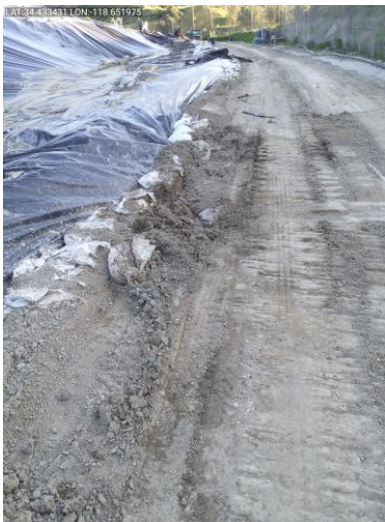
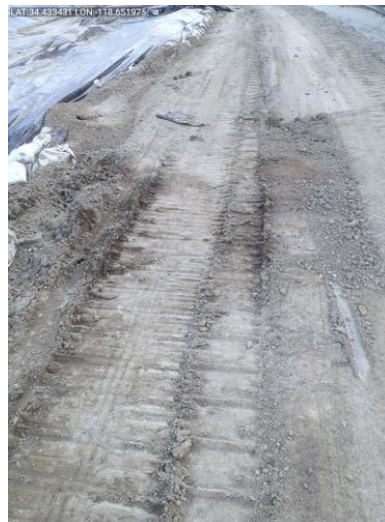
Standing free liquid

Scrim was pulled up and channel was dug out. Scrim and sandbags were replaced.

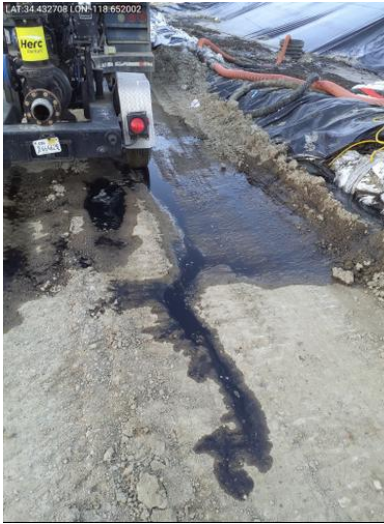
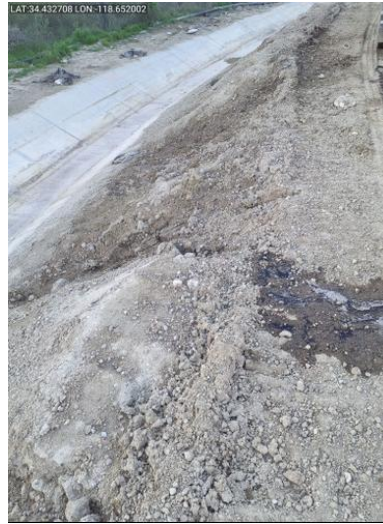
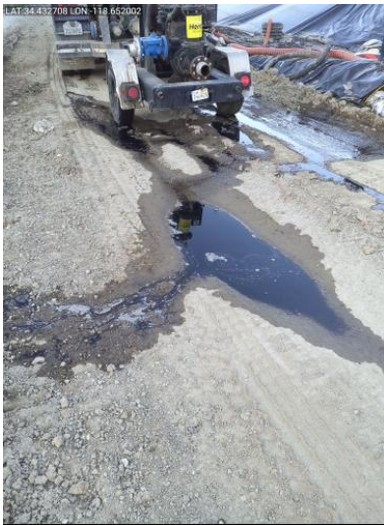
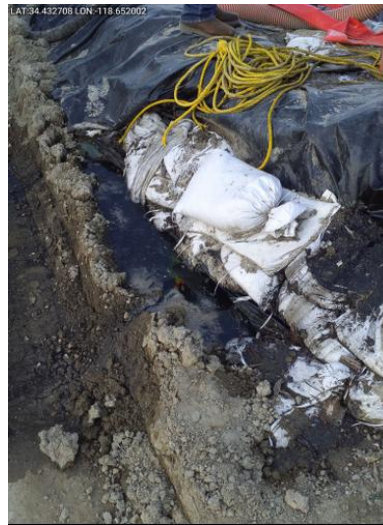
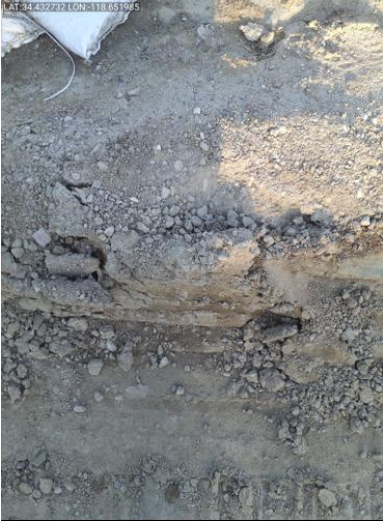
Pump was failing and leachate was leaking out of a connection.

Pump has been repaired. Standing leachate has been vacuumed off the road and fresh dirt applied to the road.

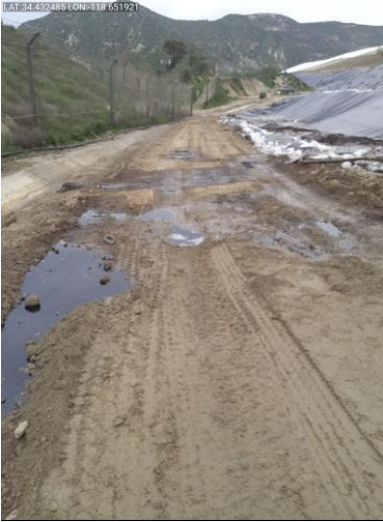
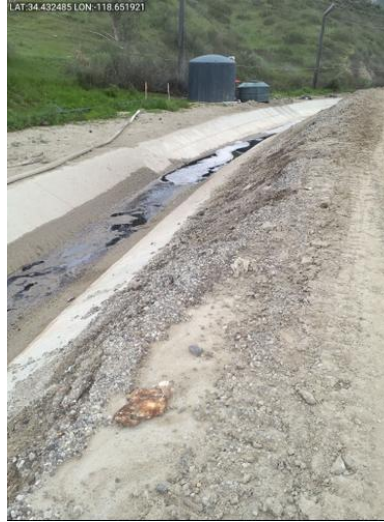
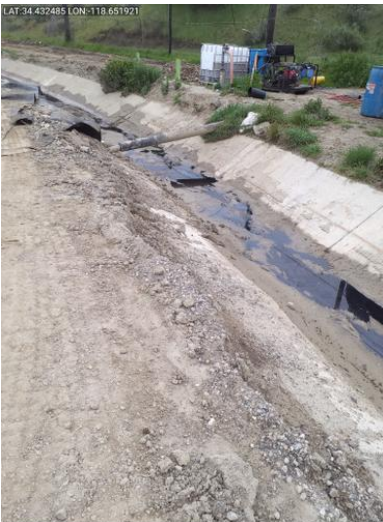
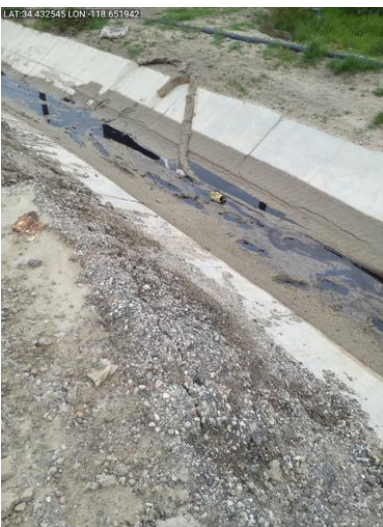
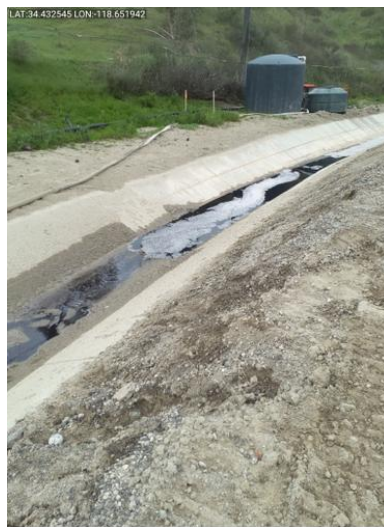
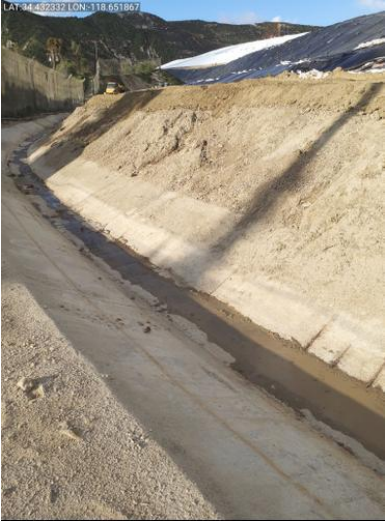
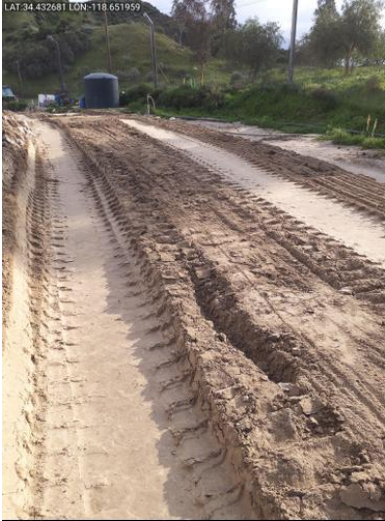
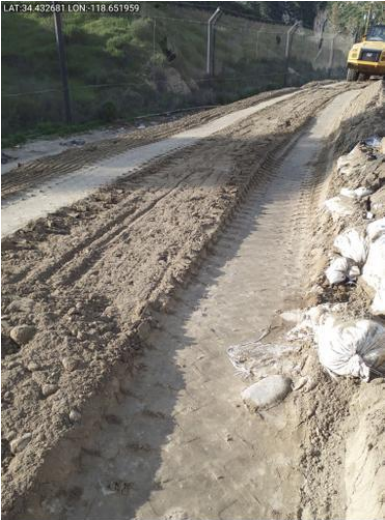
Standing free liquid

Failure with the pump, it was fixed and restarted. Leachate was vacuumed off the road and stormwater channel and new dirt added to road and track walked.

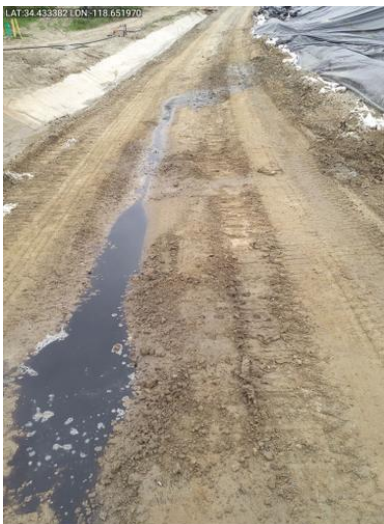
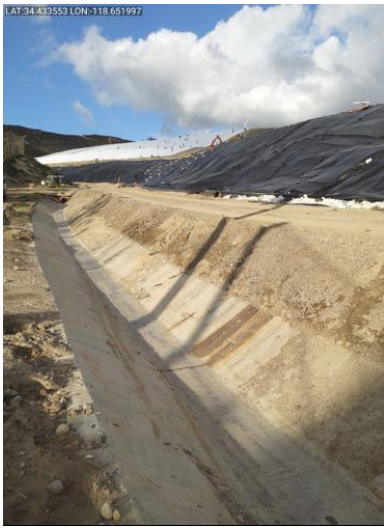
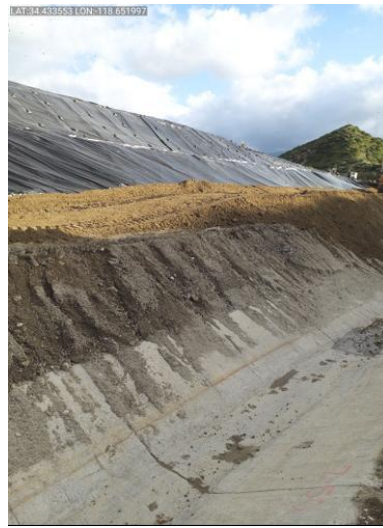
Standing free liquid

Failure with the pump, it was fixed and restarted. Leachate was vacuumed off the road and stormwater channel and new dirt added to road and track walked.

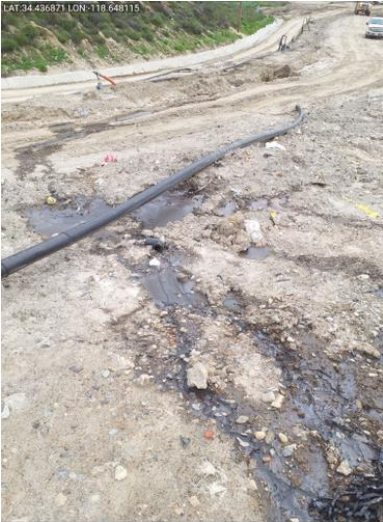
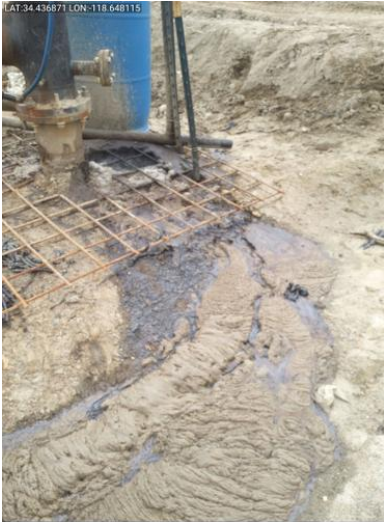
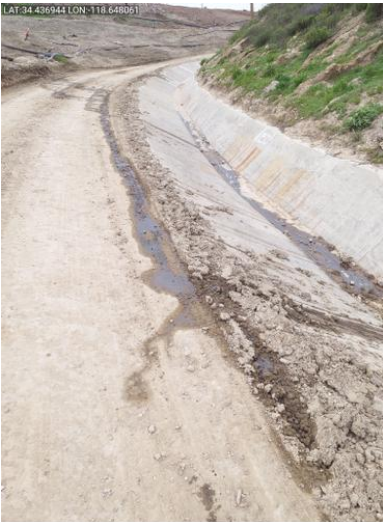
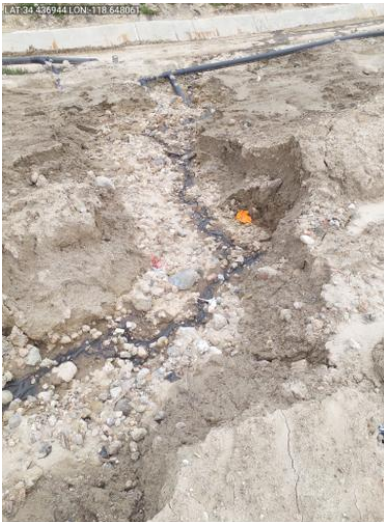
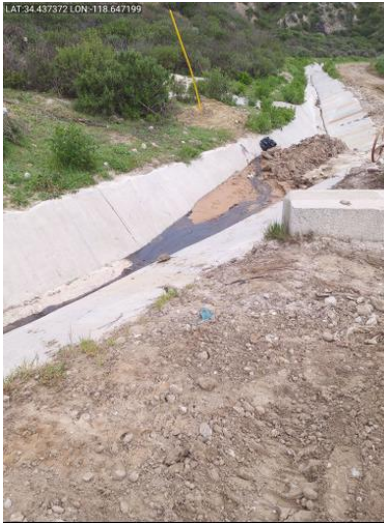
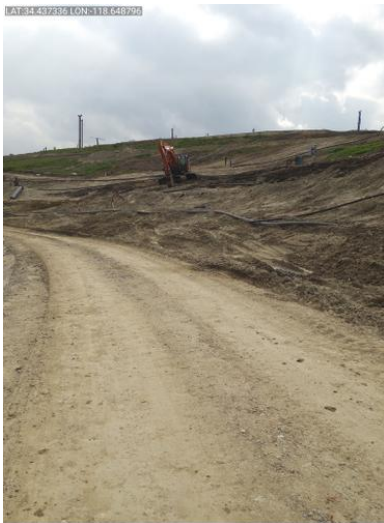
Standing free liquid

Pump within the sump was fixed. Leachate was vacuumed off the road and stormwater channel and new dirt added to road and track walked.

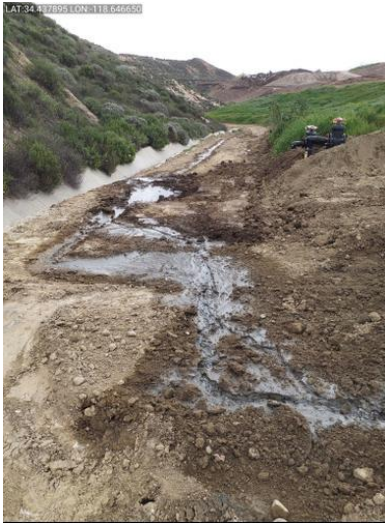
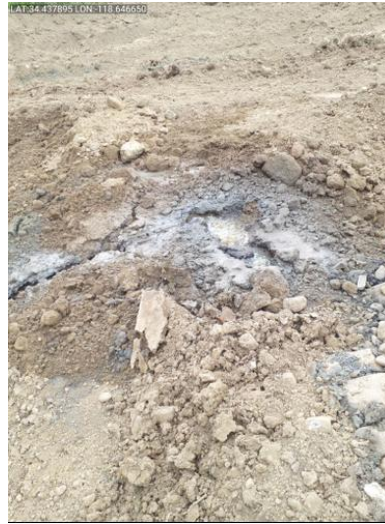
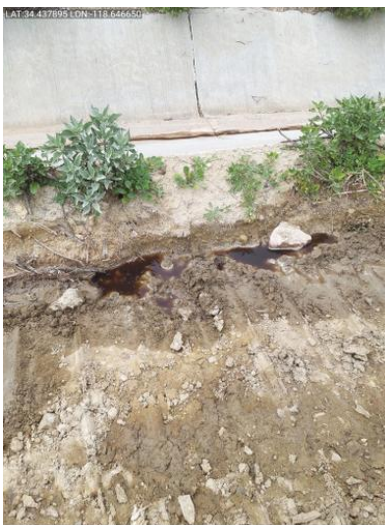
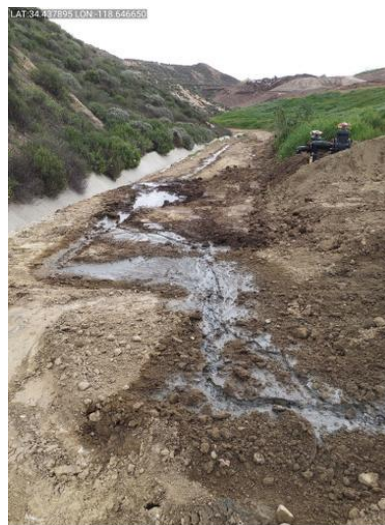
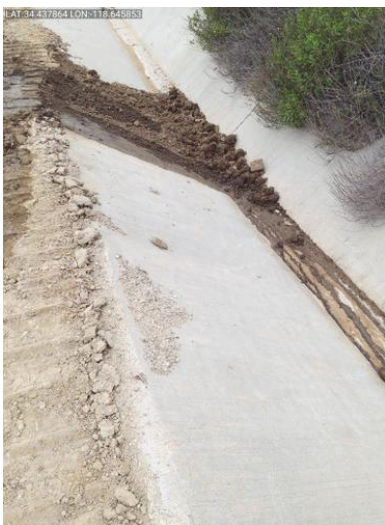
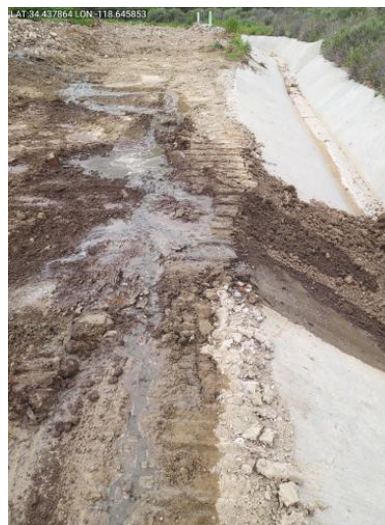
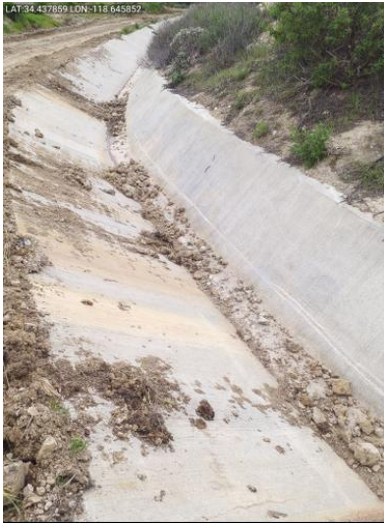
Standing free liquid

Fresh dirt added on top of the seep and was compacted into the hole where seep was found. Vacuum truck removed any excess leachate and stormwater channel was pressure washed.

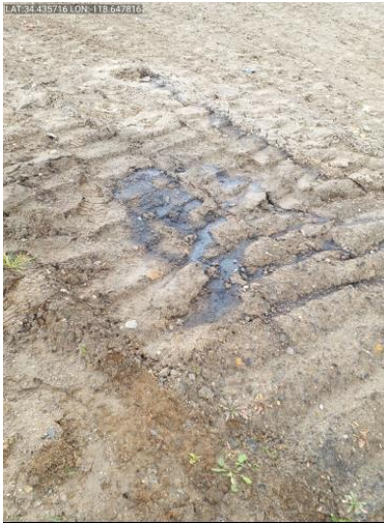
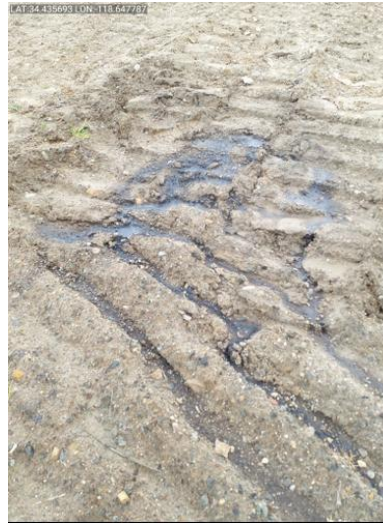
Saturated

Scraped away then new dirt added on top

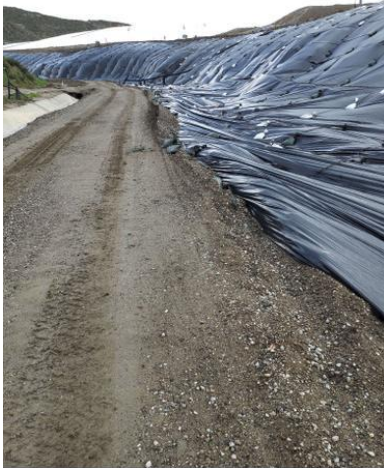
Photo 1

West side perimeter road. No seeps or pooling found.

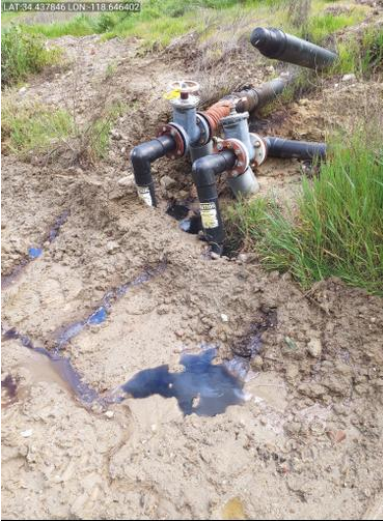
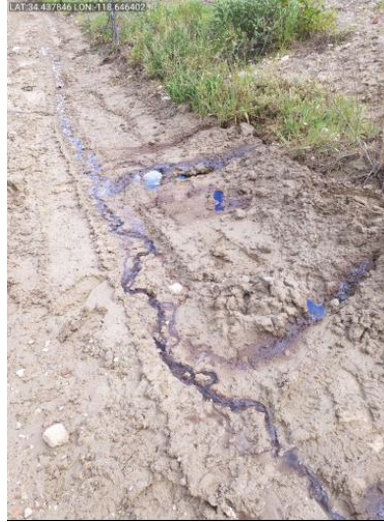
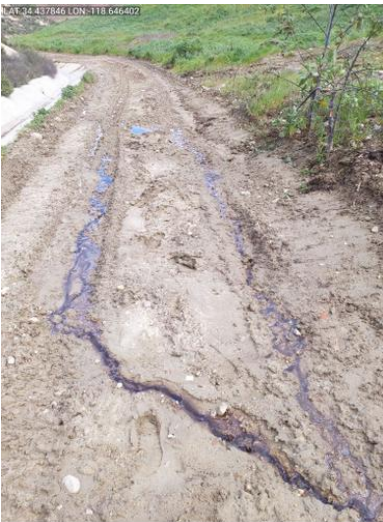
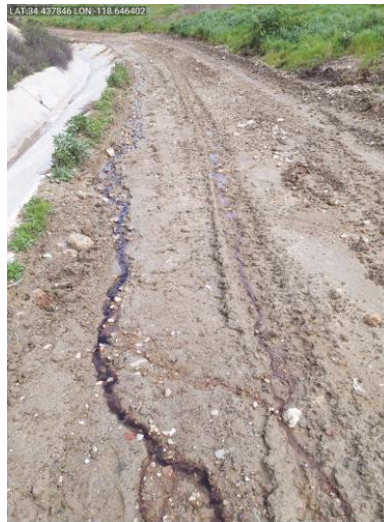
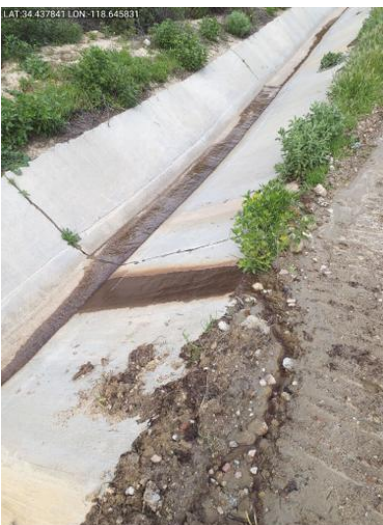
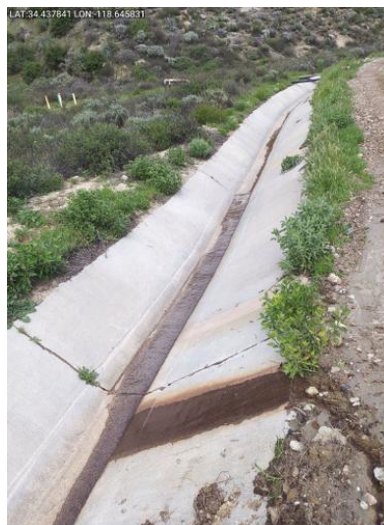
Sample port came off of well.  
There is some leachate seeping just up the road from the well.

A permanent cap was placed on the sample port as this port has come off before. Dirt was brought in to contain leachate seep.
