April 22, 2024  
File No. 01204123.25, Task 10

Subject: March 2024 Monthly Report for Modified Stipulated Order for Abatement (Case No. 6177-4), Chiquita Canyon Landfill (Facility ID 119219), Castaic, California

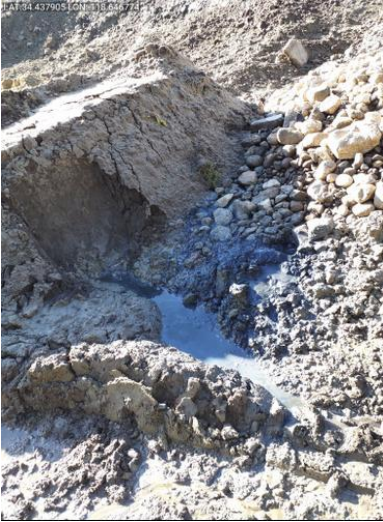
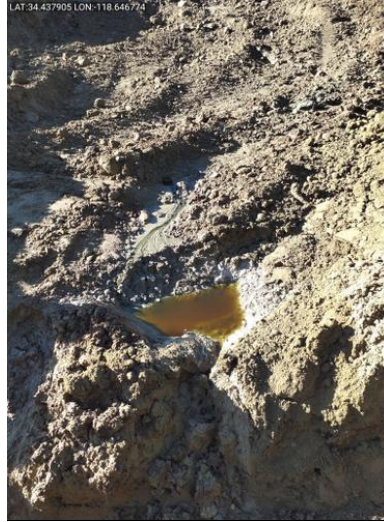
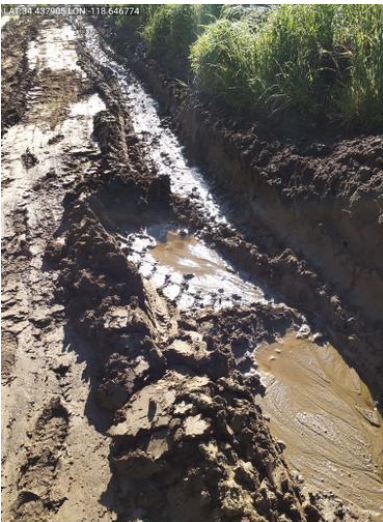
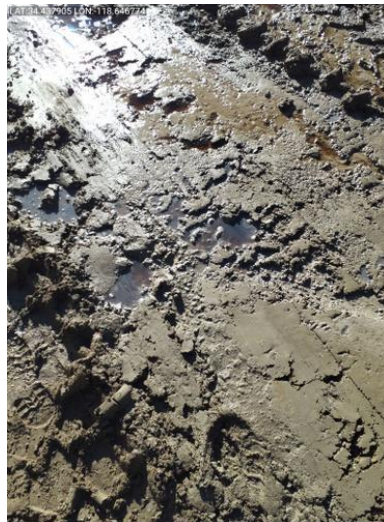
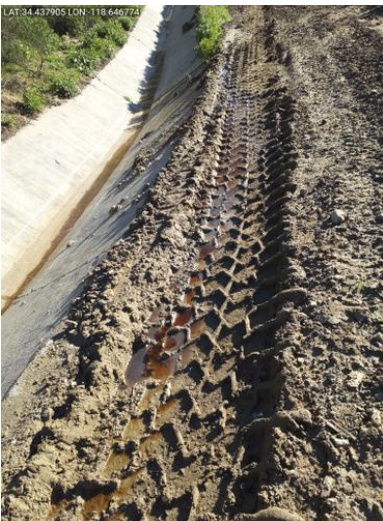
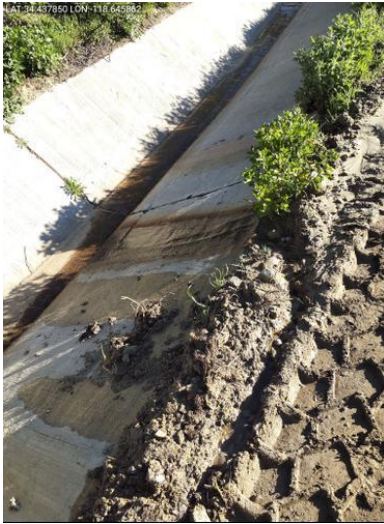
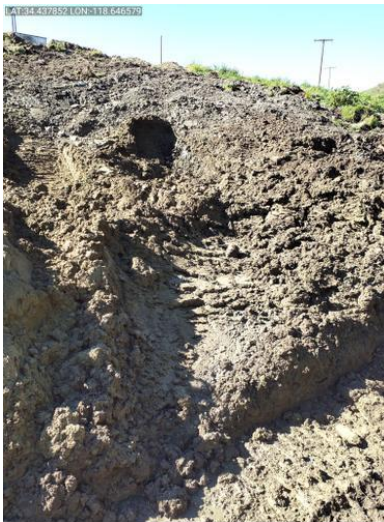
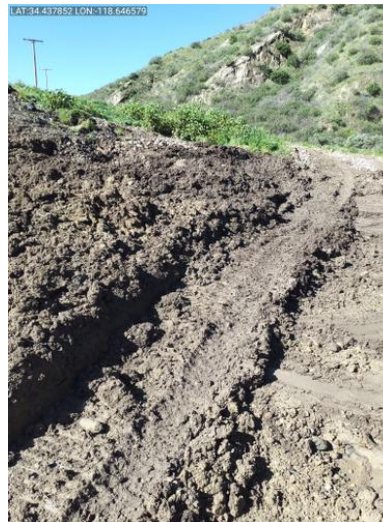
Standing free liquid

Area filled with dirt to contain seep, vac truck vacuumed out the stormwater channel.

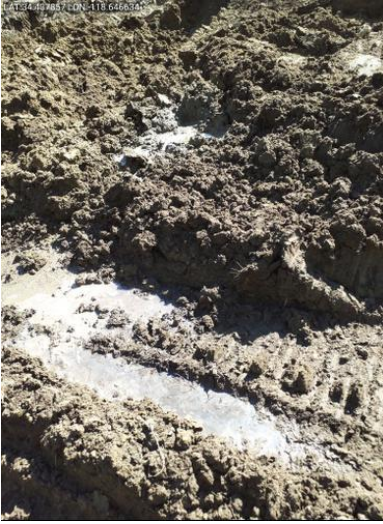
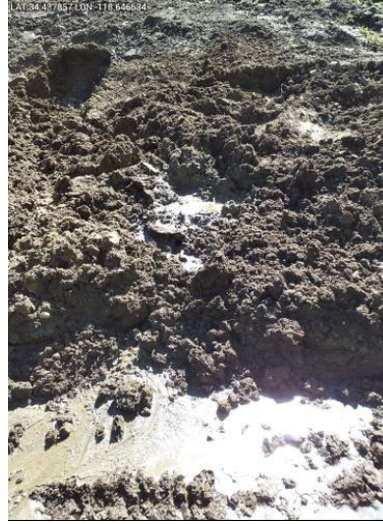
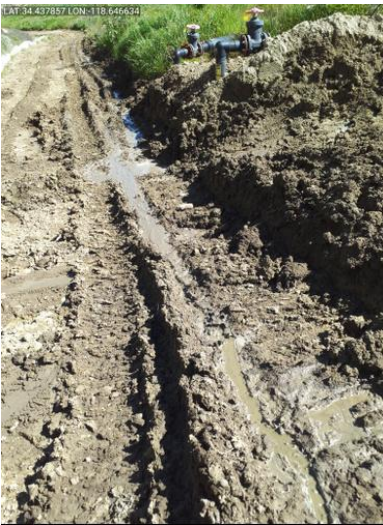
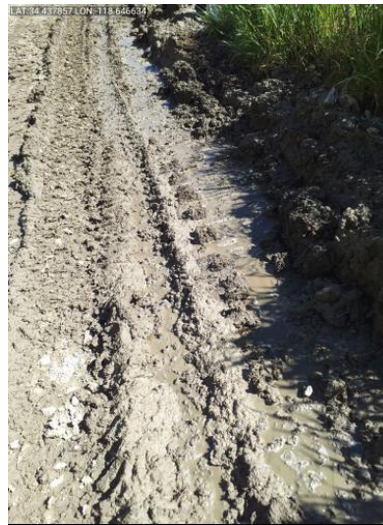
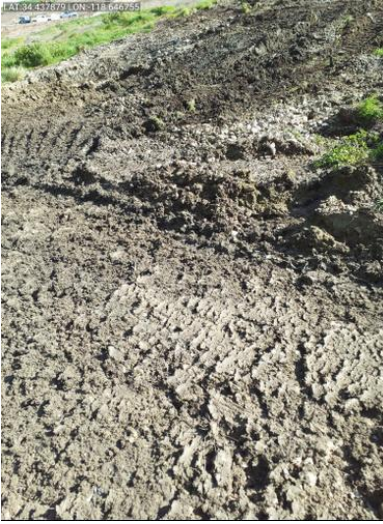
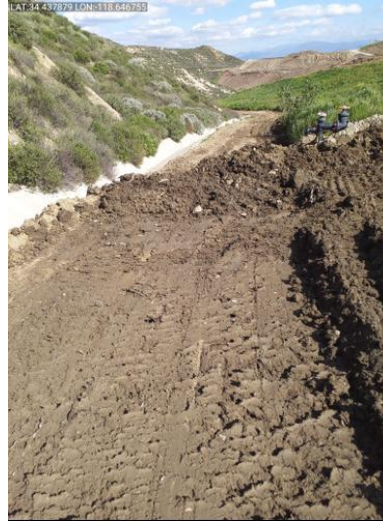
Standing free liquid

Soiled dirt was removed and fresh dirt was applied to the area. A dirt berm was created to assist in containing any future seep.

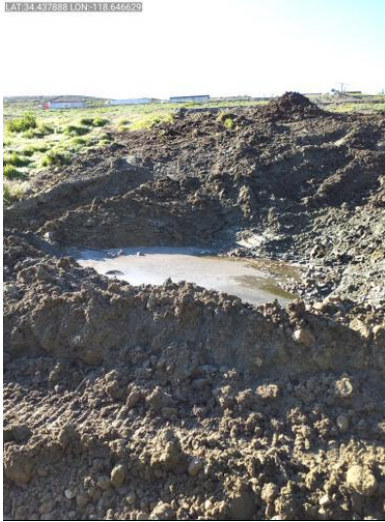
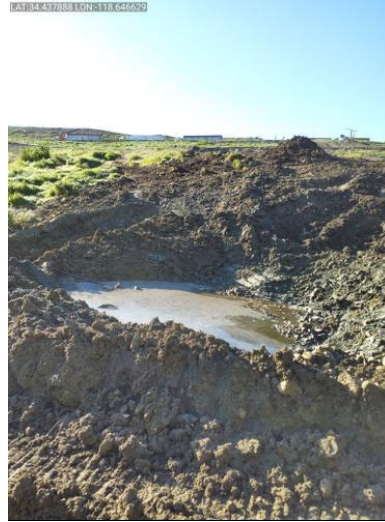
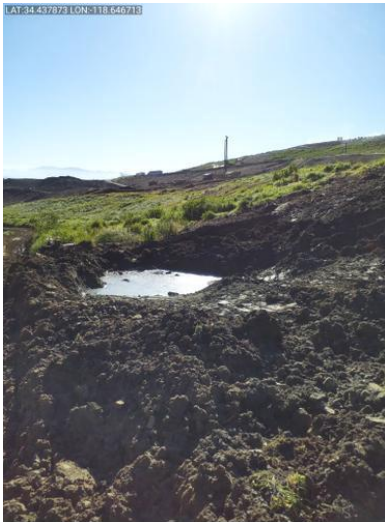
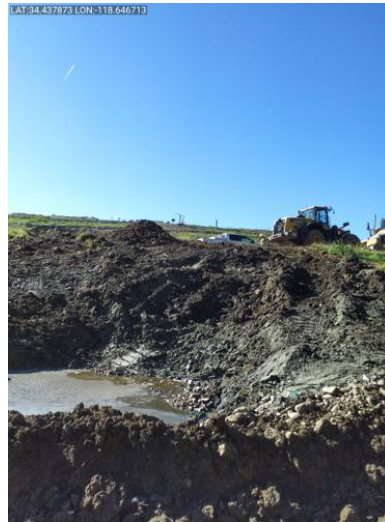
Standing free liquid

Work is underway to fix the seep in this area. Leachate is contained to this "pool" which is on the lined portion of the landfill. Vac trucks continuously vacuum out the liquid within the "pool" until the seep is completely repaired.

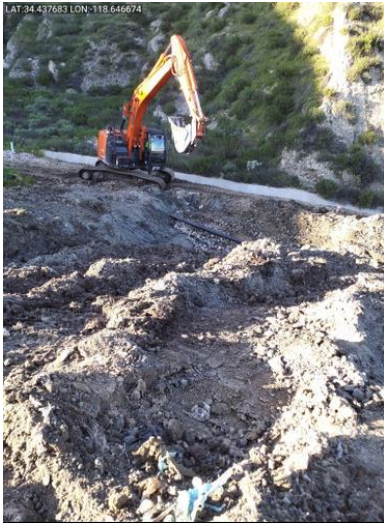
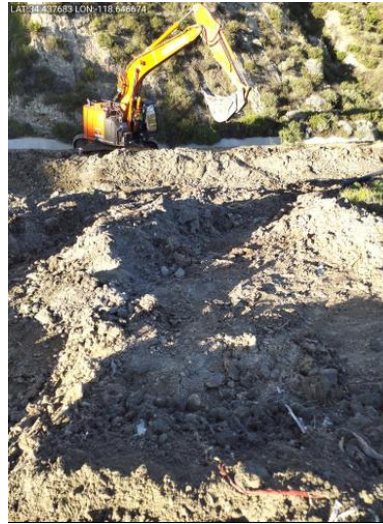
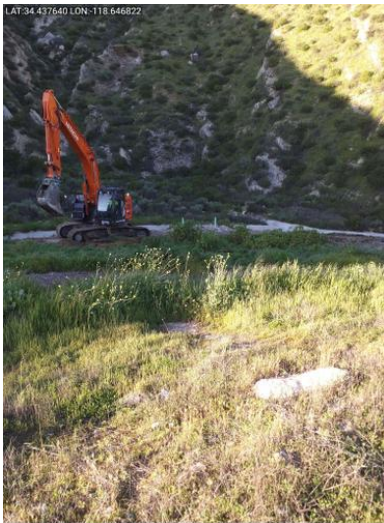
Standing free liquid

The team has been working on this seep and was able to get the liquids to drain into the leachate collection system under the soil.

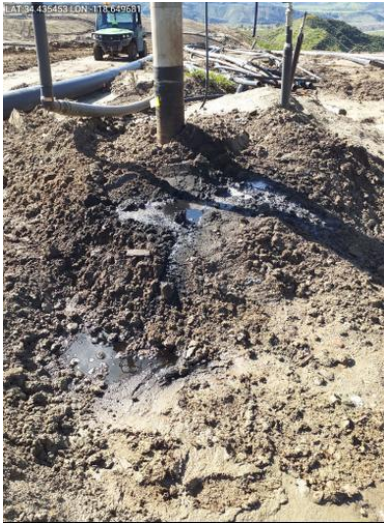
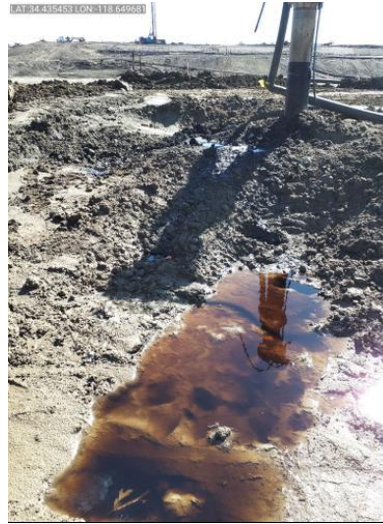
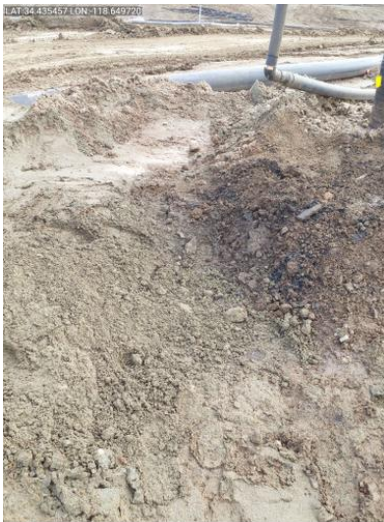
Standing free liquid

Vac truck vacuumed the standing liquid and area covered with fresh dirt.

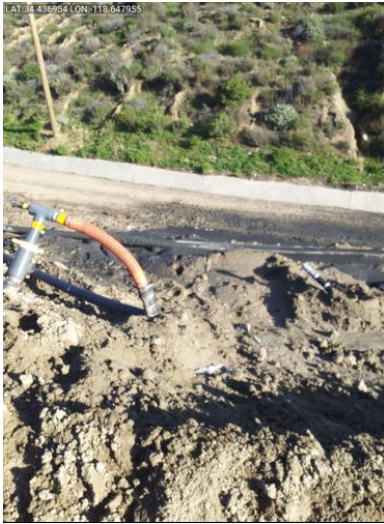
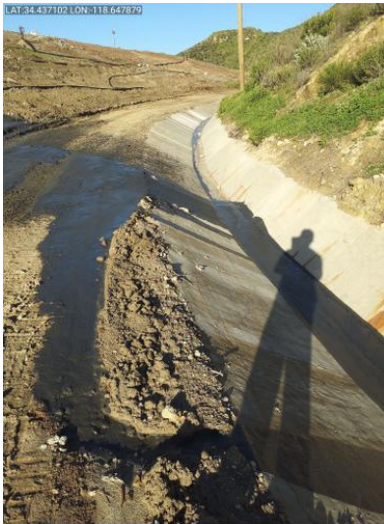
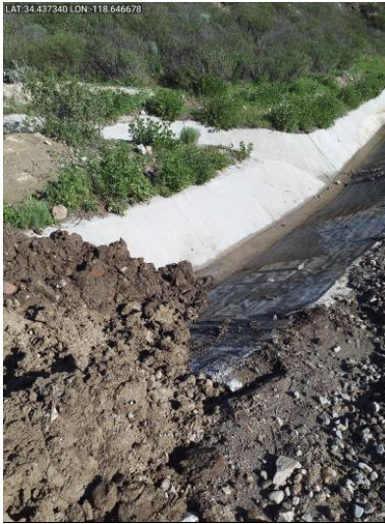
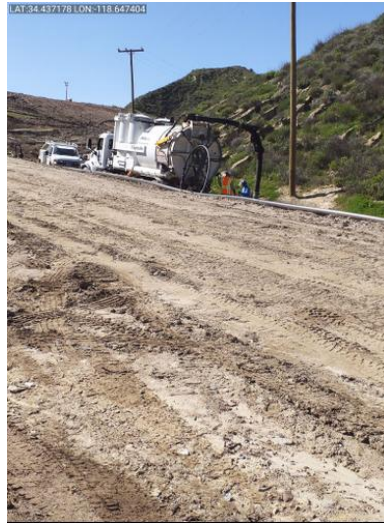
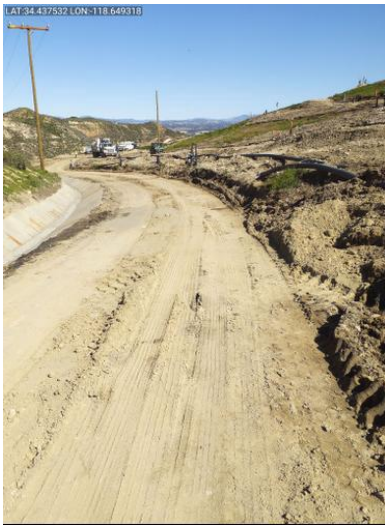
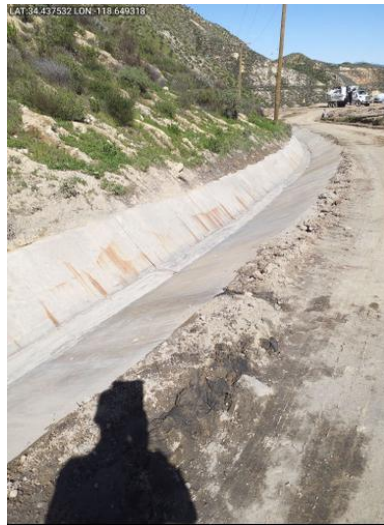
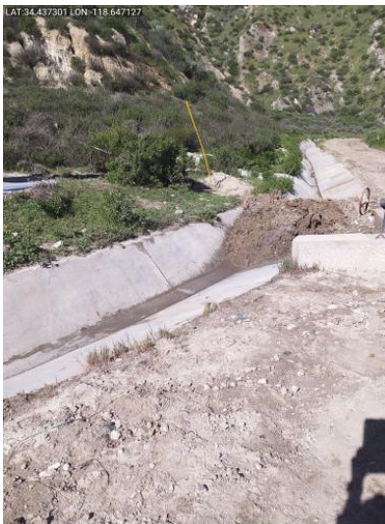
Standing free liquid

Broken pipe fixed, Check dam added to stormwater channel, leachate vacuumed out, new dirt added to cover area

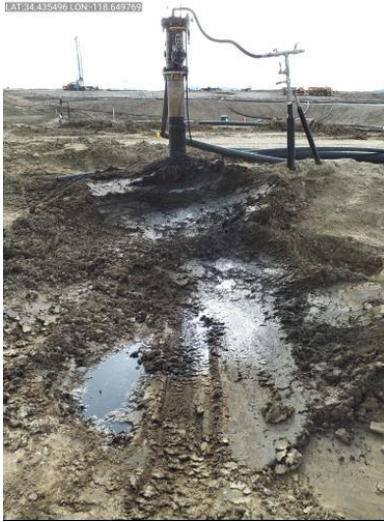
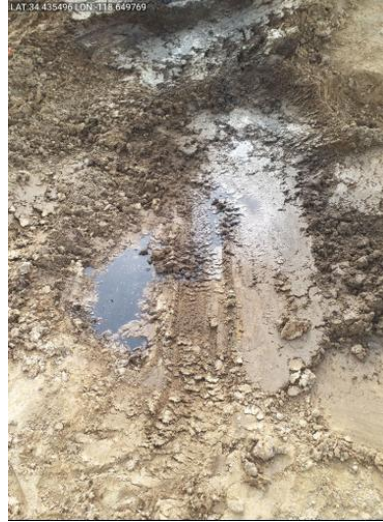
Leachate was coming from a leaking hose.

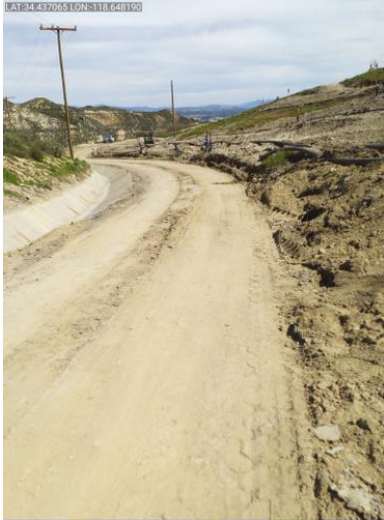
Photo 1

Image of west side perimeter road where seep/pooling was previously found.

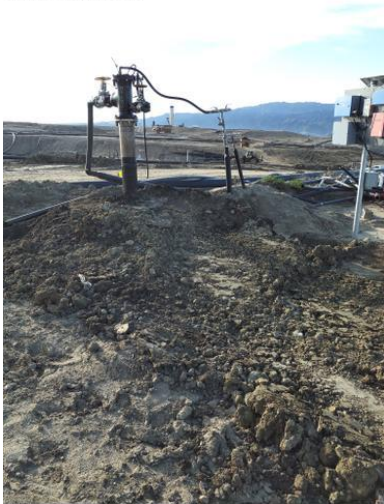
Photo 1

Chiquita observed less than one gallon of condensate (not leachate) leaking from the well. All repairs and cleanup were completed the same day.

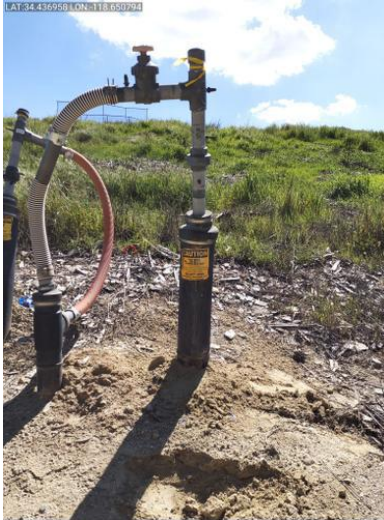
Photo 1

The well that had a leak earlier has been repaired. Foam that was coming out this morning was condensation and not leachate.

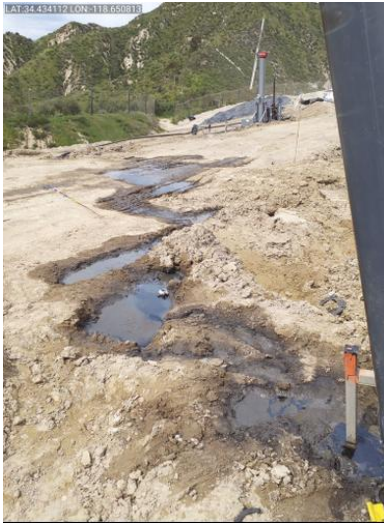
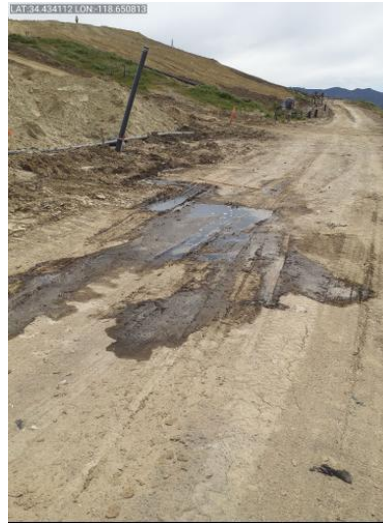
Standing free liquid

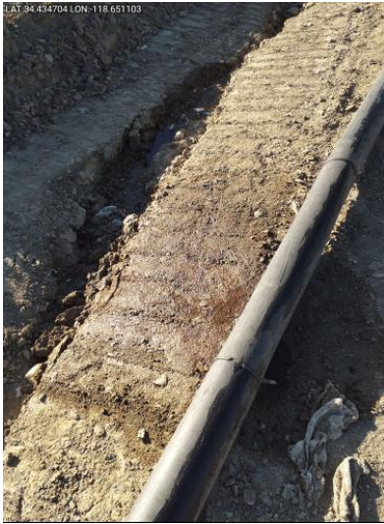
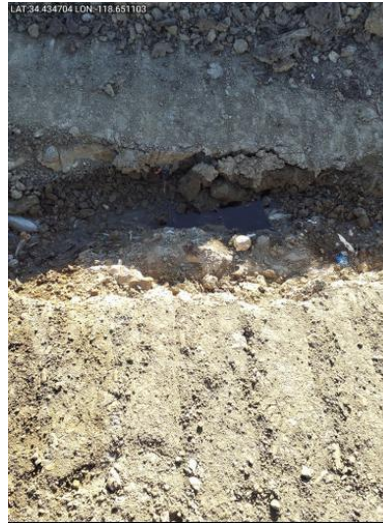
Standing free liquid

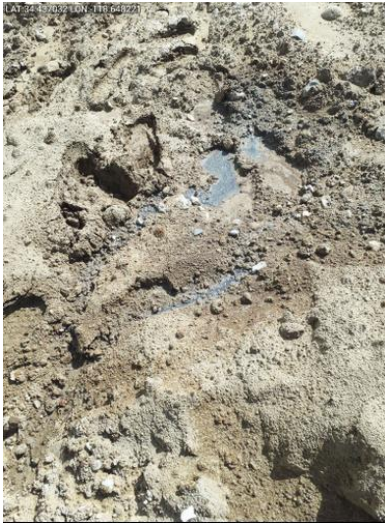
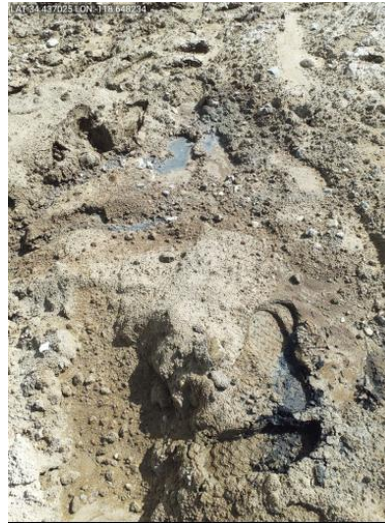
Standing free liquid

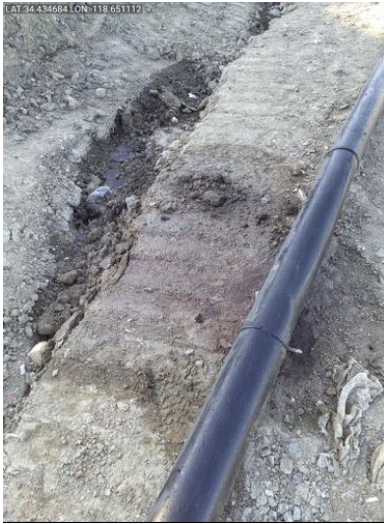
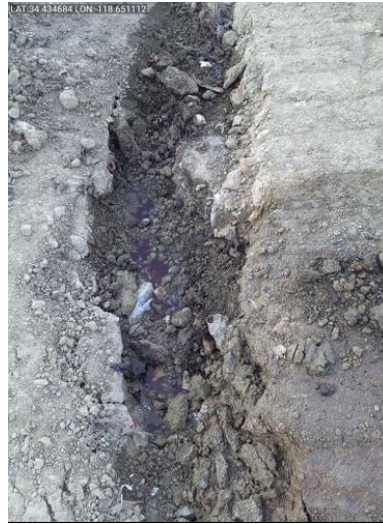
Standing free liquid

Pipe was repaired, and fresh dirt/soil was added to the area to address the seep.

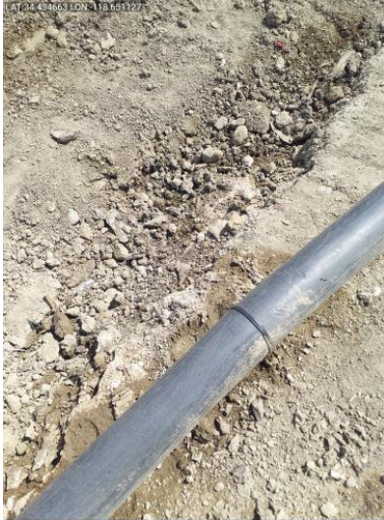
Photo 1

Leak in pipe has been repaired.

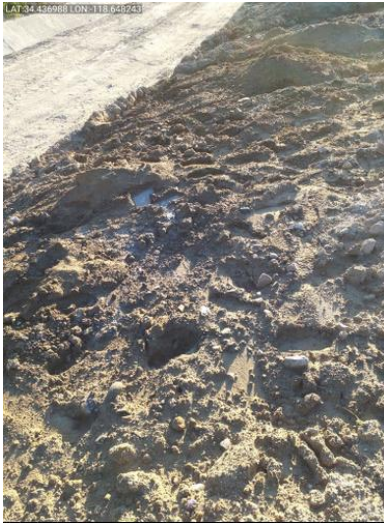
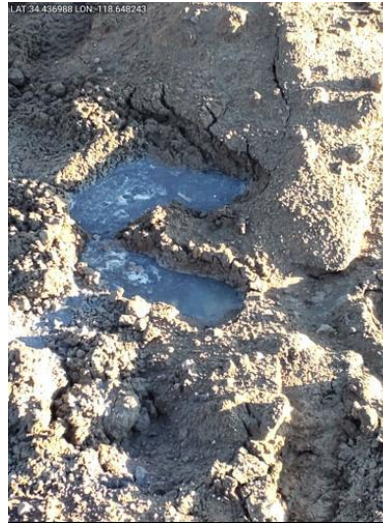
Standing free liquid

Berm was created to contain the seep, vacuum truck vacuumed out the remaining liquid.

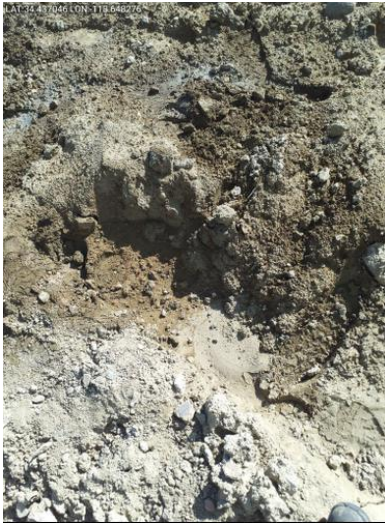
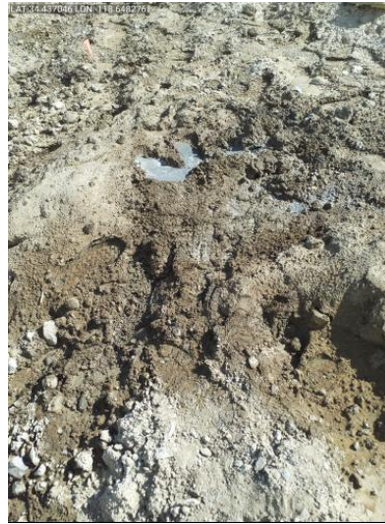
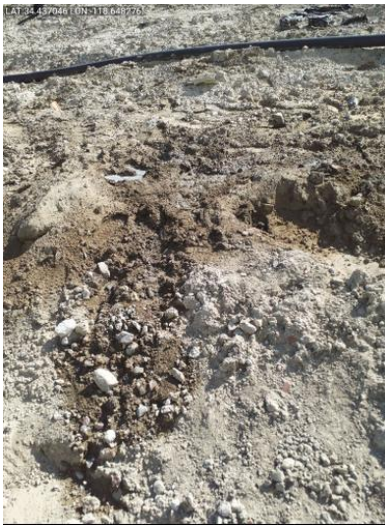
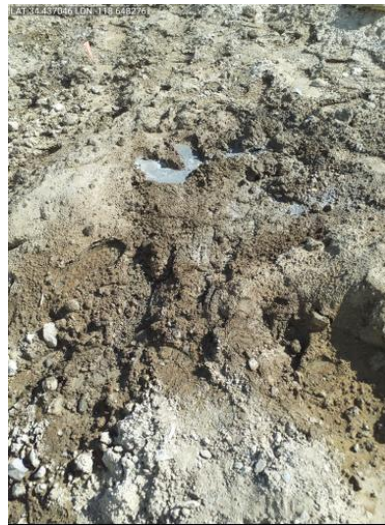
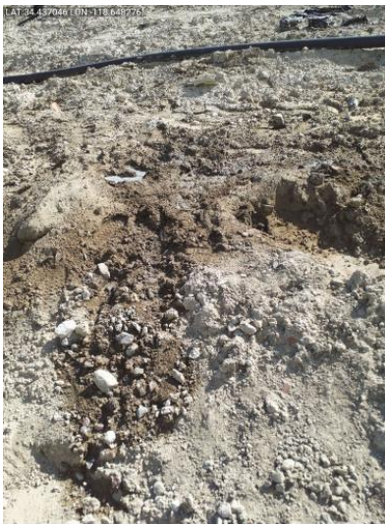
Standing free liquid

Dirt was brought in to cover and contain the seep.

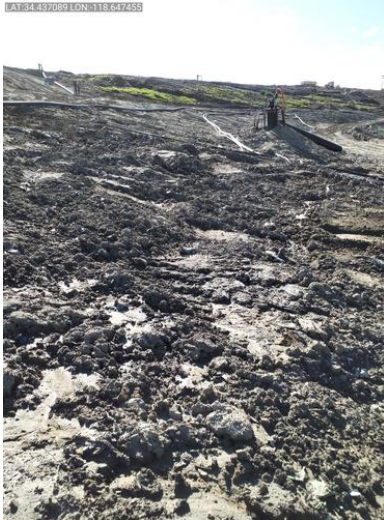
Photo 1

Image of the north side, no seeps found. Normal inspection of western slope not feasible because of safety concerns.

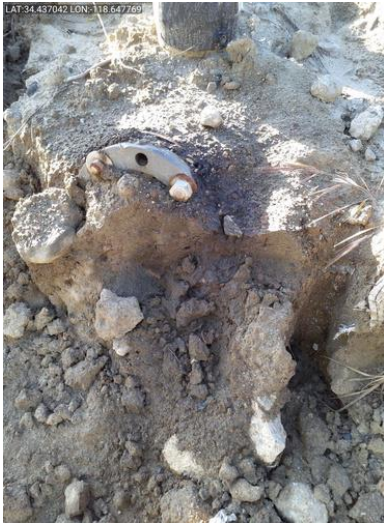
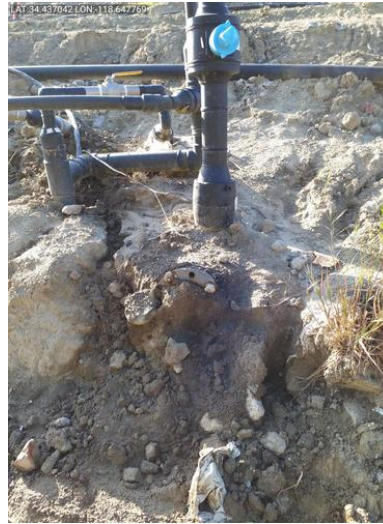
Saturated

Small amount of leachate was leaking from the pipe, it was contained to area around pipe. The crew repaired the pipe and soiled dirt was removed and fresh dirt was added to the area.

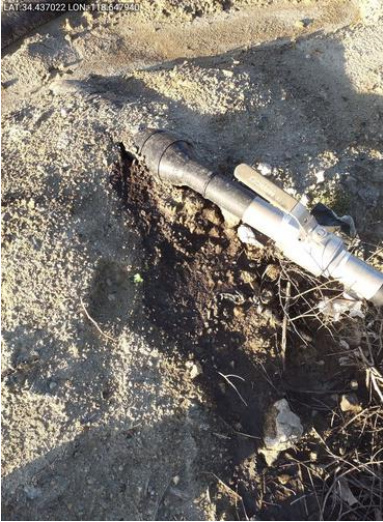
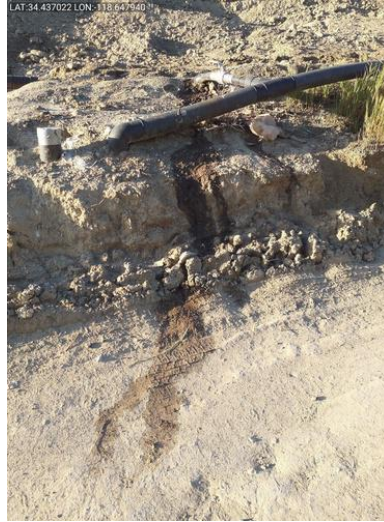
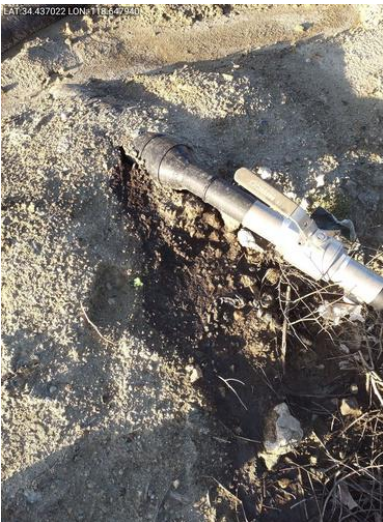
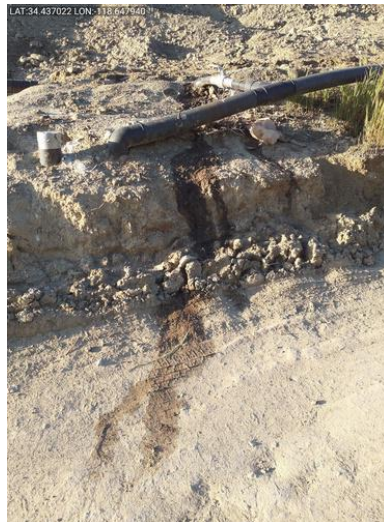
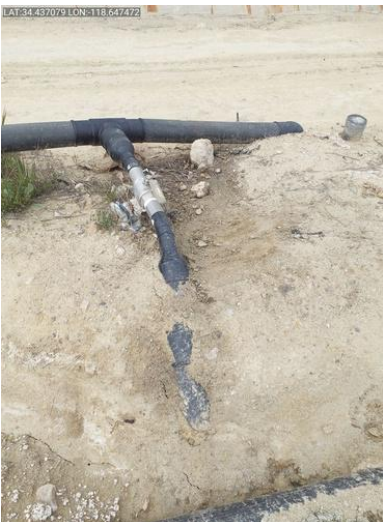
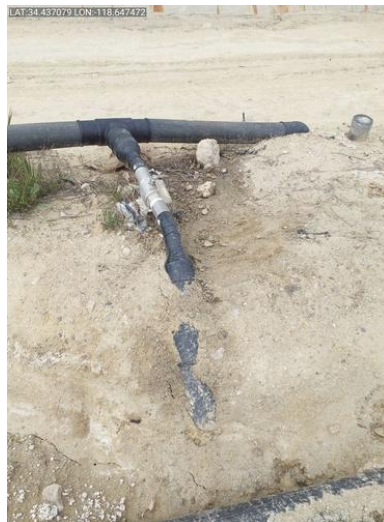
145

Semi-dry

Crews fixed pipe and fresh dirt was added to the area.

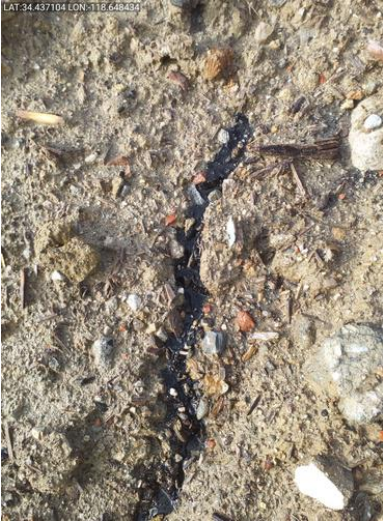
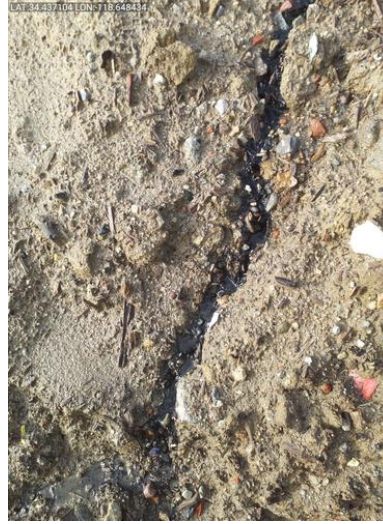
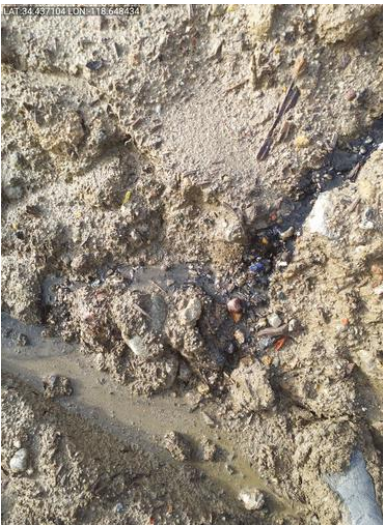
150

Standing free liquid
